## Technical Service Bulletin

<b>GROUP</b>	<b>NUMBER</b>
<b>RECALL</b>	<b>23-01-022G</b>
<b>DATE</b>	<b>MODEL(S)</b>
<b>MARCH, 2023</b>	<b>GV70 (JK1), GV80 (JX1), G80 (RG3)</b>

**SUBJECT:** FRONT SEAT BELT PRETENSIONER PROTECTION  
CAP INSTALLATION (RECALL 012G)

**Description:** The front seat belt pretensioner may deploy abnormally in the vehicles described below, causing the MGG (Micro Gas Generator) to detach from the assembly. This bulletin describes the procedure to install front seat belt pretensioner anti-separation protection caps.

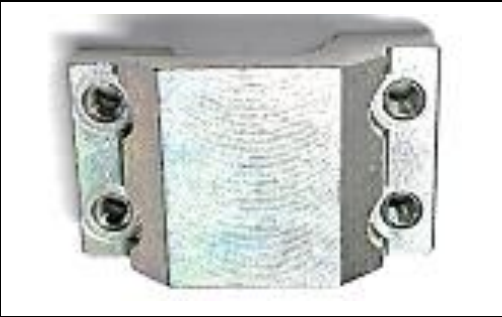
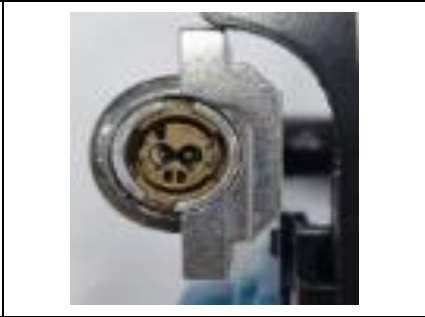
PART NAME	IDENTIFICATION METHOD		REMARKS	
	BEFORE INSTALLATION	AFTER INSTALLATION		
STD CAP A

Caps (A/B) are classified by type according to the marking groove position of the cap. (STD CAP A does not have a marking groove.)
STD CAP B

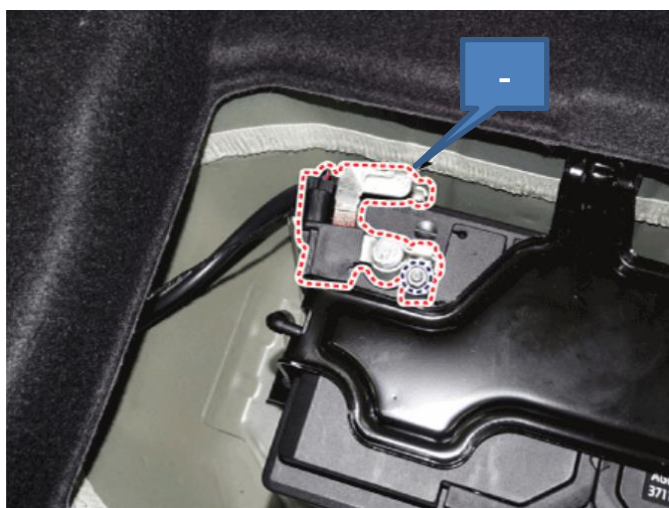
2. Disconnect the negative ( - ) battery terminal. Battery is located under luggage board.

**Negative Battery Terminal Tightening Torque:**  
**7.8 – 9.8 Nm (0.8 – 1.0 kgf.m, 5.8 – 7.2 lb-ft)**

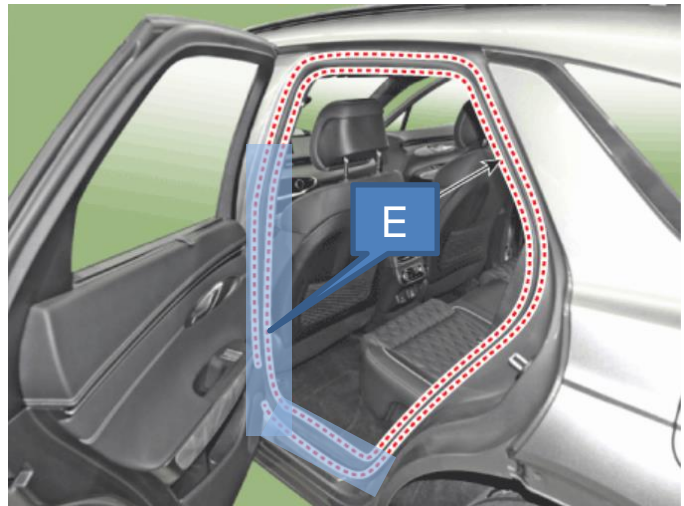
5. Partially remove the rear door body side weather strip (E).

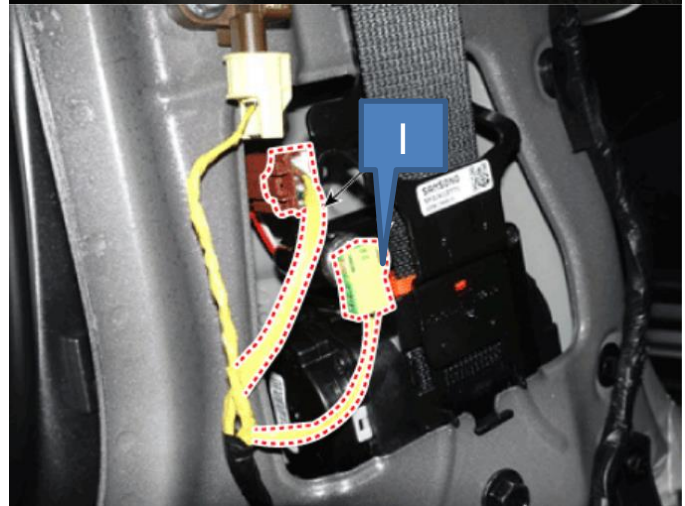
8. Press the lock pins (H) to disconnect the front seat belt pretensioner connector (I).

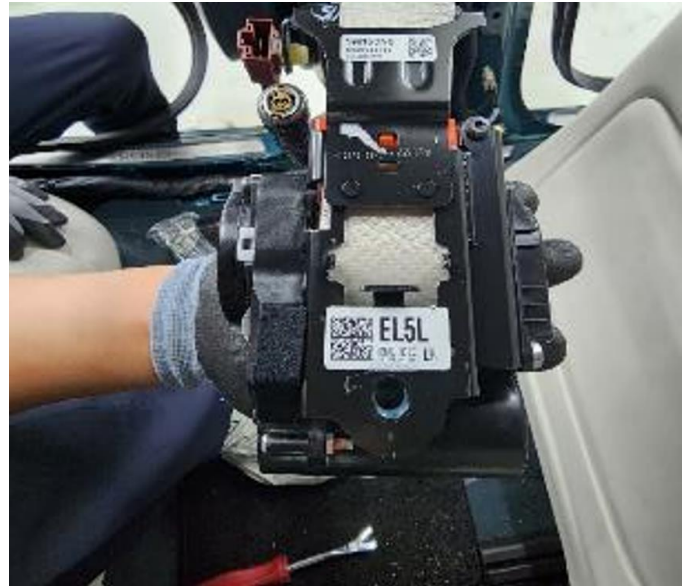
9. Loosen the mounting bolts (J & K) and remove the front seat belt pretensioner.

**Tightening Torque: bolt (J)**  
7.8 ~ 11.8 Nm (0.8 ~ 1.2 kgf.m, 5.8 ~ 8.7 lb-ft)

**Tightening Torque: bolt (K)**  
39.2 ~ 53.9 Nm (4.0 ~ 5.5 kgf.m, 28.9 ~ 39.8 lb-ft)

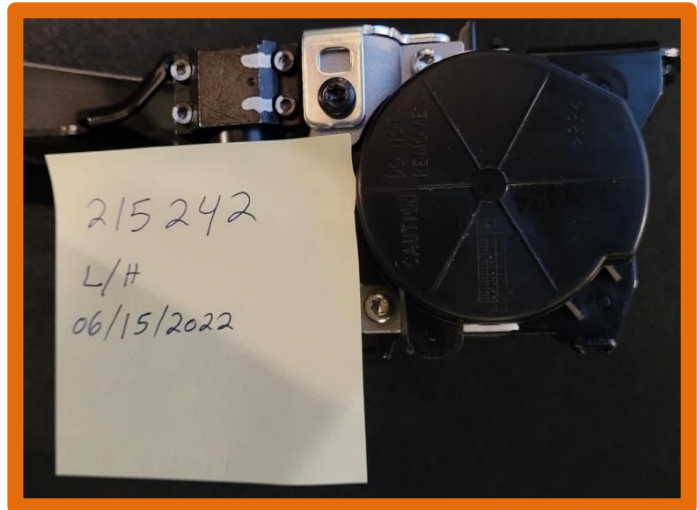
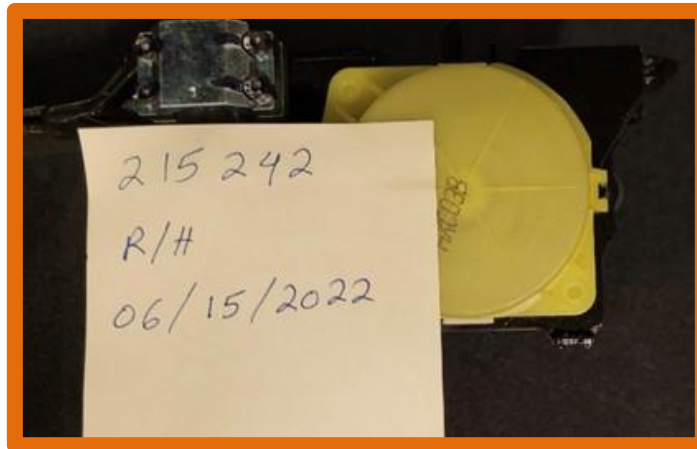
14. Mark all 4 bolts with paint after installing.

Using STUI, please take photos of the completed pretensioner assembly with the caps installed. Within the picture, include a piece of paper with the last 6 digits of the VIN, date of the repair, and Driver (LH) side or Passenger (RH) side.

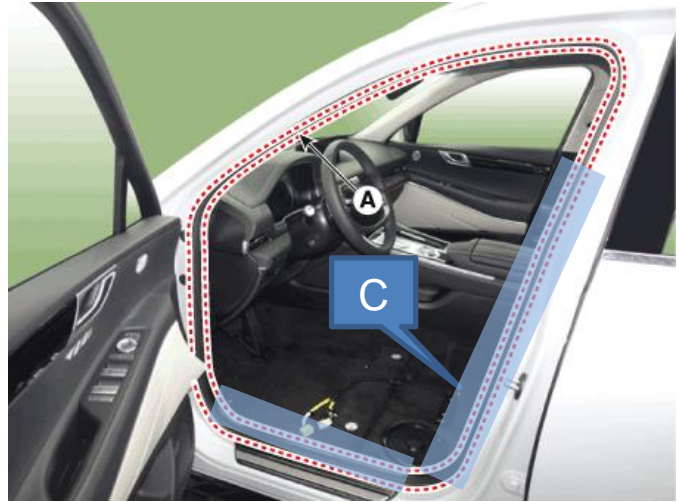
3. Partially remove the front door body side weather strip (C).

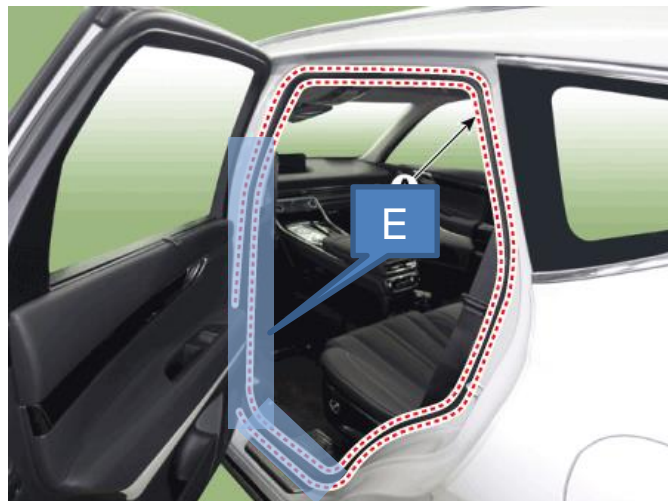
- Partially remove the rear door body side weather strip (E).

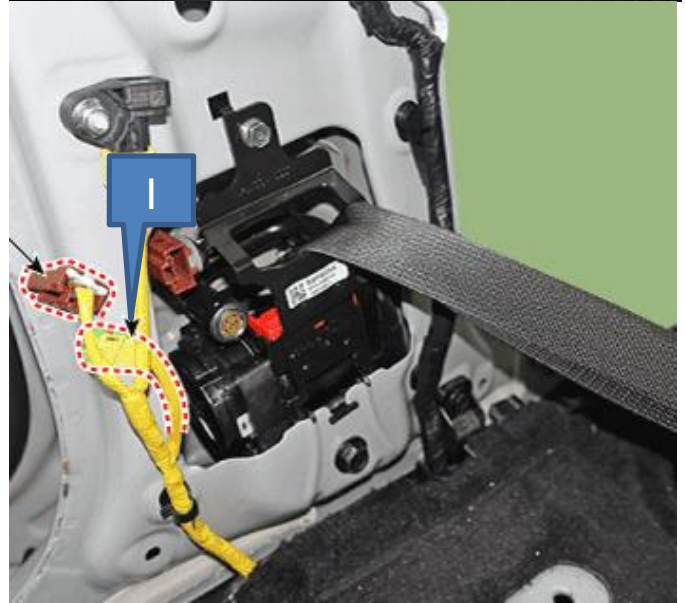
8. Press the lock pins (H) to disconnect the front seat belt pretensioner connector (I).

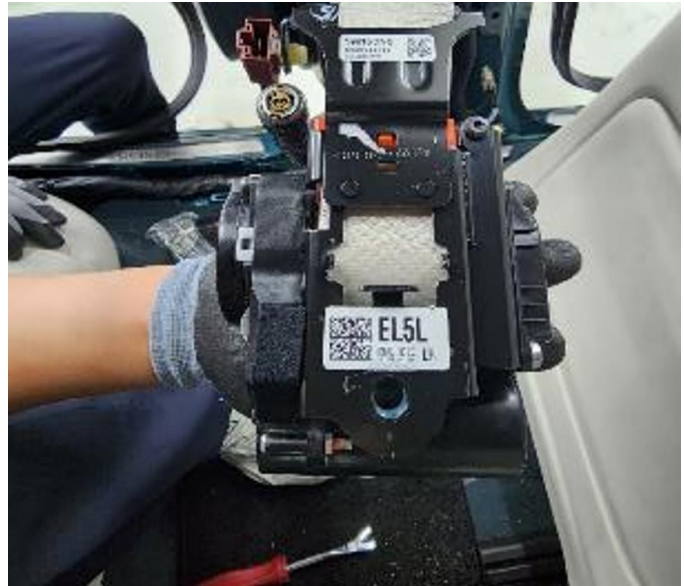
9. Loosen the mounting bolts (J & K) and remove the front seat belt pretensioner.

**Tightening Torque: bolt (J)**  
7.8 ~ 11.8 Nm (0.8 ~ 1.2 kgf.m, 5.8 ~ 8.7 lb-ft)

**Tightening Torque: bolt (K)**  
39.2 ~ 53.9 Nm (4.0 ~ 5.5 kgf.m, 28.9 ~ 39.8 lb-ft)

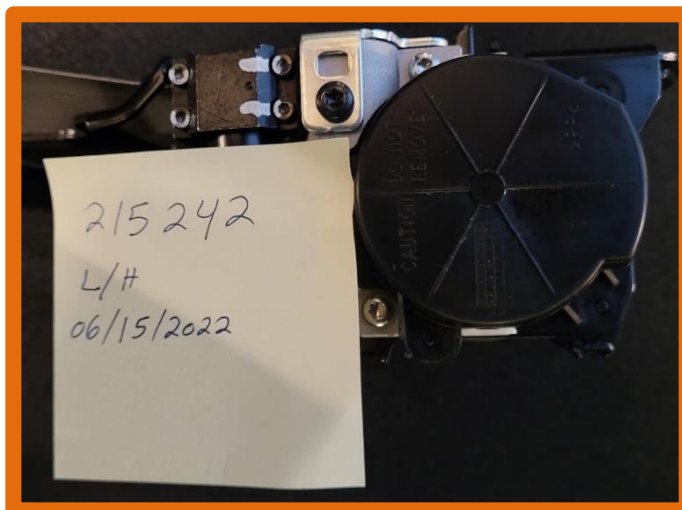
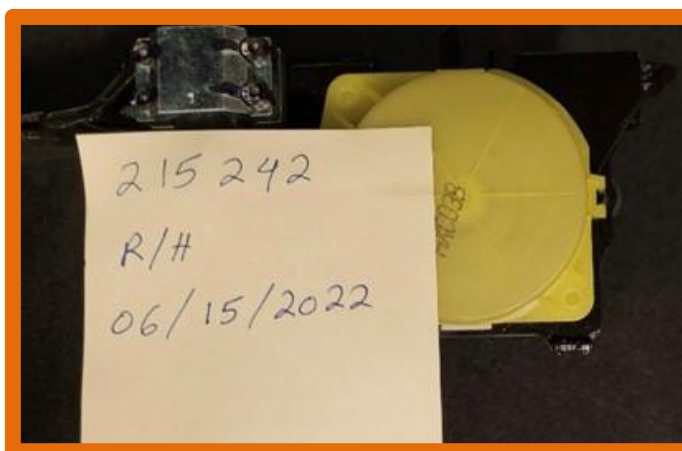
14. Mark all 4 bolts with paint after installing.

Using STUI, please take photos of the completed pretensioner assembly with the caps installed. Within the picture, include a piece of paper with the last 6 digits of the VIN, date of the repair, and Driver (LH) side or Passenger (RH) side.

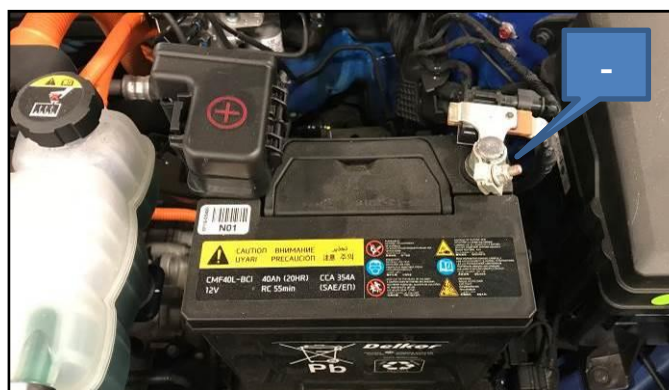
2. Disconnect the negative ( - ) battery terminal. Battery is located under luggage board.

**Negative Battery Terminal Tightening Torque:**  
**7.8 – 9.8 Nm (0.8 – 1.0 kgf.m, 5.8 – 7.2 lb-ft)**

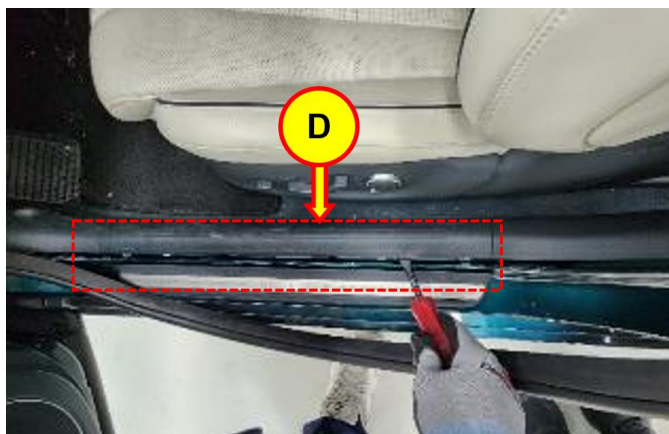
- 4. Remove the front door scuff trim (D) using the trim tool.

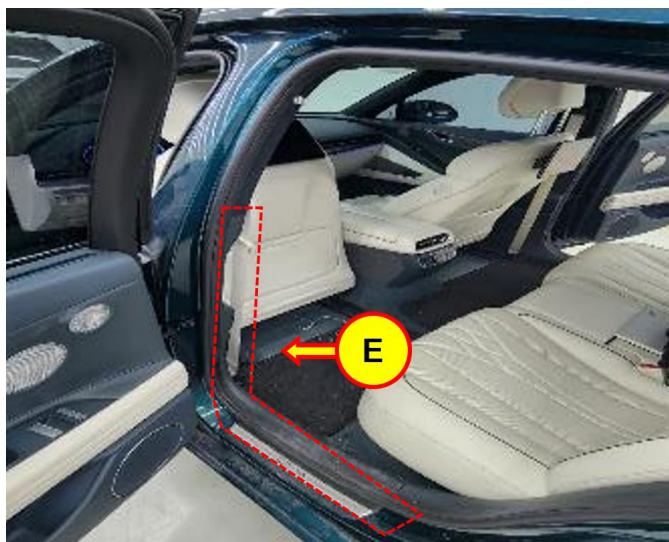
- 5. Partially remove the rear door body side weather strip (E).

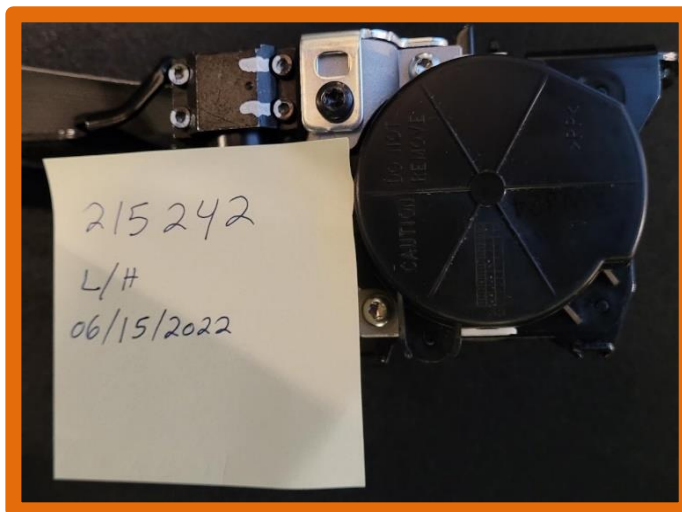
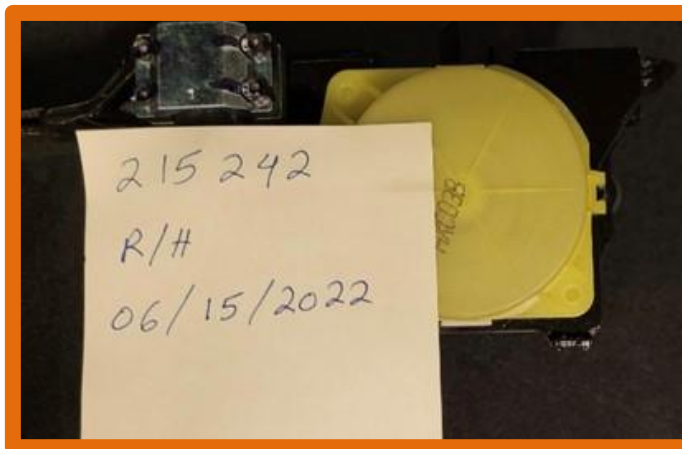
14. Mark all 4 bolts with paint after installing.

Using STUI, please take photos of the completed pretensioner assembly with the caps installed. Within the picture, include a piece of paper with the last 6 digits of the VIN, date of the repair, and Driver (LH) side or Passenger (RH) side.
