SAFETY RECALL

Manual Transmission Clutch

Reference: 19A / NHTSA 23V-116

FCA US LLC

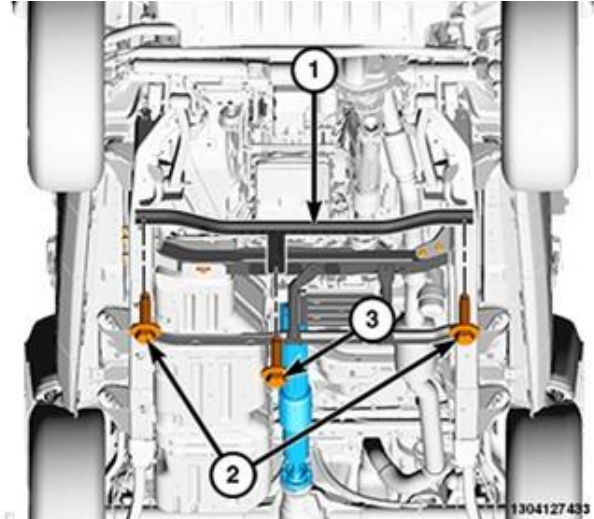
Figure 2 – Crossmember

5. Remove the front reinforcement crossmember bolt (Figure 2).

6. Remove the front reinforcement crossmember frame bolts and remove the crossmember (Figure 2).

- 1 - Front Reinforcement Crossmember
- 2 - Front Reinforcement Crossmember Frame Bolt
- 3 - Front Reinforcement Crossmember Bolt

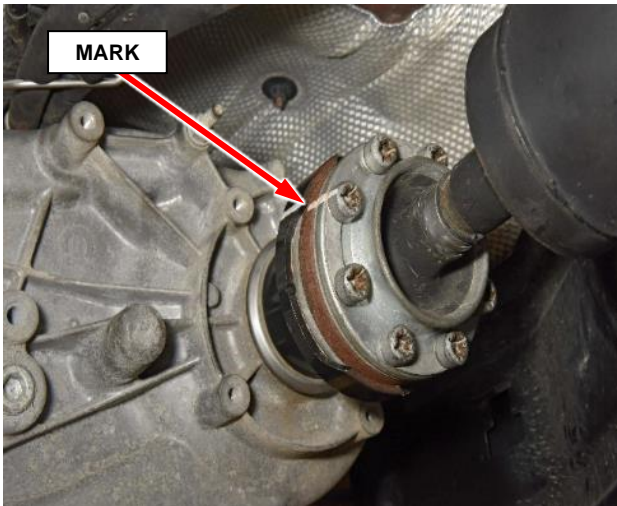
Figure 7 – Transfer Case Flange

18. Mark the transfer case rear flange and the propeller shaft for installation reference before removing the propeller shaft. Mark the transfer case front flange and the front propeller shaft before removing the propeller shaft (Figures 7 and 8).

19. Remove the rear drive shaft flange bolts at the transfer case and the bolts at the rear axle and remove propeller shaft and set aside (Figure 7).

77. Install the rear driveshaft with the reference marks aligned and tighten the **NEW** bolts to 39N·m (29ft. lbs.) (Figure 7).
78. JT Model: Align and Install **NEW** center bearing mount bolts and tighten to 62 N·m (46ft. lbs.).

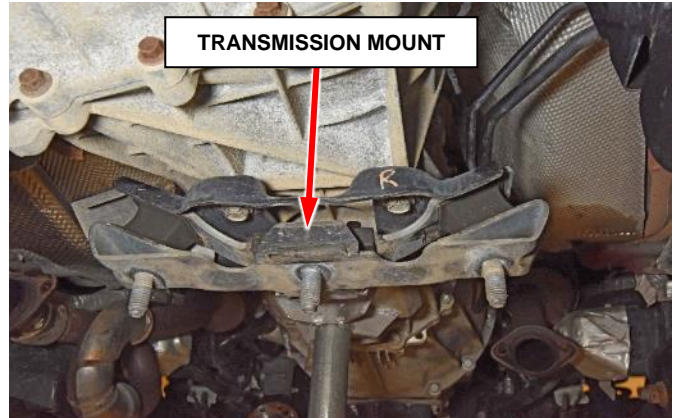
Figure 10 – Transmission Mount

24. Remove the transmission mount (Figure 10).

80. Install the transmission mount and tighten the bolts to 54N·m (40ft. lbs.) (Figure 10).
81. Install the transmission crossmember to the vehicle (Figure 6).
