GROUP	NUMBER	
RECALL	23-01-062H	
DATE	MODEL(S)	
JULY 2023	VELOSTER (FS)

REAR PARKING ASSIST SENSOR (RPAS) INSPECTION AND FUSE/SENSOR REPLACEMENT (RECALL 242)

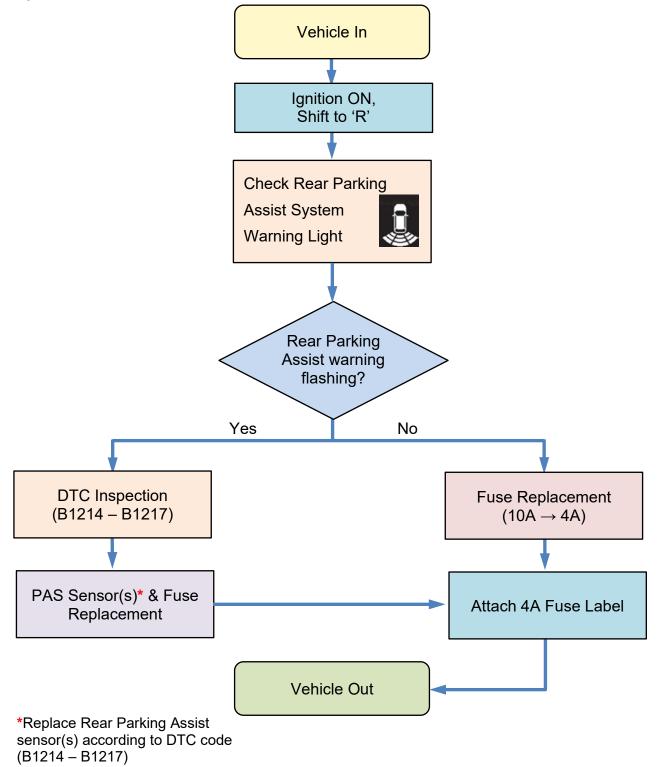
I. Inspection Procedure:

Turn the ignition ON and move the shift lever to 'R' and then check the cluster.

Case 1: Normal operation. When moving the shift lever to 'R', the parking assist warning light does not flash. If it does not flash, this is normal.

Case 2: Abnormal operation.

When moving the shift lever to 'R', the parking assist warning light flashes. This is not normal.

Inspect the DTC and replace the fuse, label, and PAS sensor(s) according to the DTC codes (B1214~1217) shown to the right.

Proceed to section III for sensor(s) replacement & then to section II for Fuse Replacement & Label Attachment.

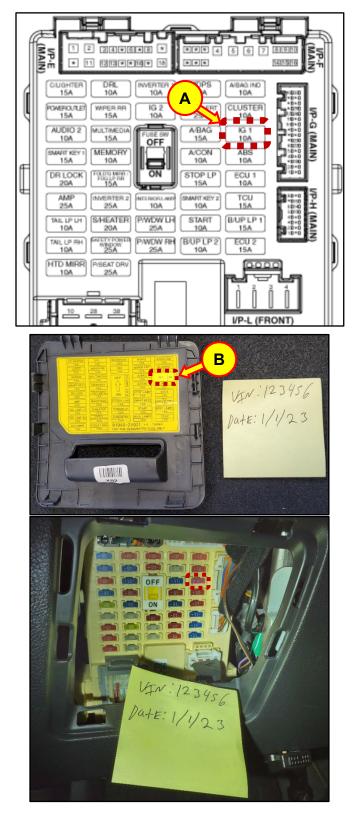
II. Fuse Replacement and Label Attachment (for all vehicles):

- 2. Remove the smart junction box cover.
- 3. Remove the IG1 10A fuse (A) and install the supplied 4A fuse.

4. Attach the supplied fuse label (B) sticker (4A) onto the cover.

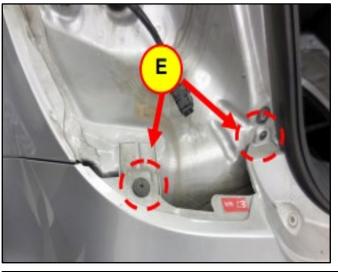
10. Loosen the rear bumper side mounting clips and screws (F) on both sides.

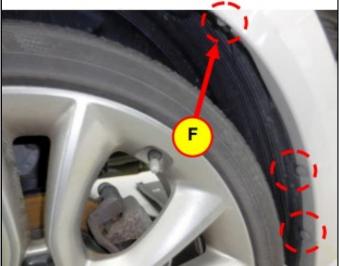
11. Loosen the rear bumper lower mounting fasteners (G).

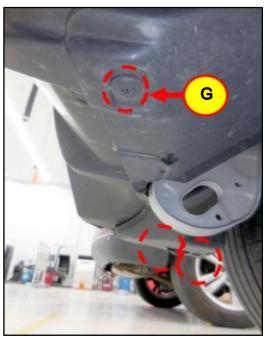
12. Remove the rear bumper (H) and locate the license plate lamp(s) and PAS sensors.

13. Disconnect the license plate lamp connector(s) and PAS sensor connectors (I), located on the inside of the rear bumper.

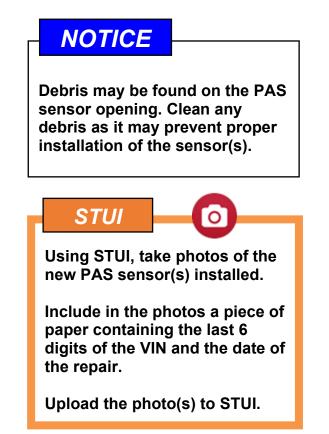
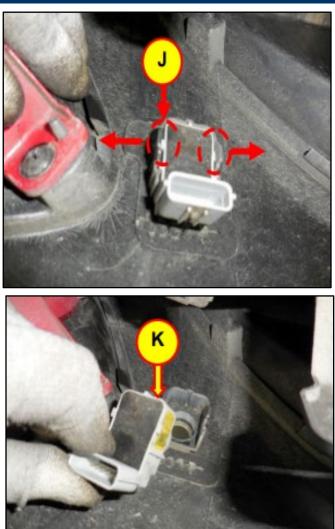
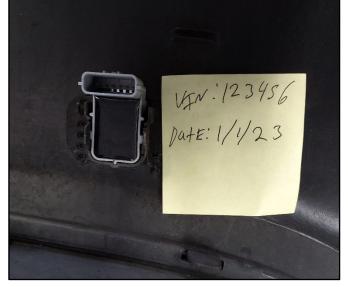
14. Remove the PAS sensor by pulling both sides of the attachment hooks (J) away from the sensor as shown.

15. Install the new PAS sensor (K).

Ensure the correct color sensor(s) are installed in the correct locations and that the rubber seal on the sensor is firmly installed without any damage.
