# RRC-72-23-002-1: Replace Side Curtain Airbag Fasteners

<b>Document Type</b>	Safety Recall Bulletin
<b>Date</b>	March 16, 2023
<b>Affected Region(s)</b>	USA, Canada
<b>Affected Model(s)</b>	R1S
<b>Model Year(s)</b>	2022 - 2023
<b>Approximate Build Dates</b>	October 2022 - January 2023

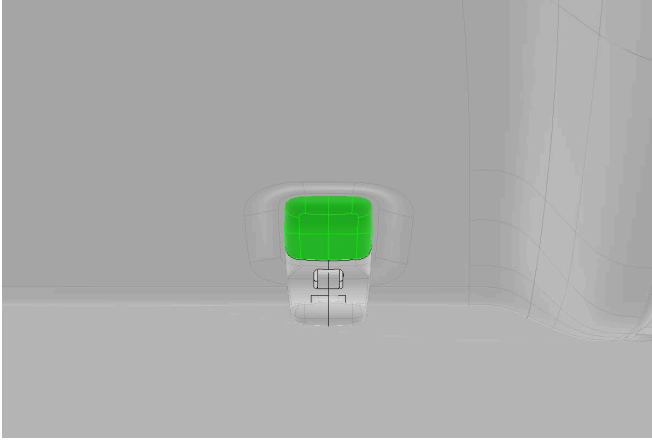
7. On both sides:

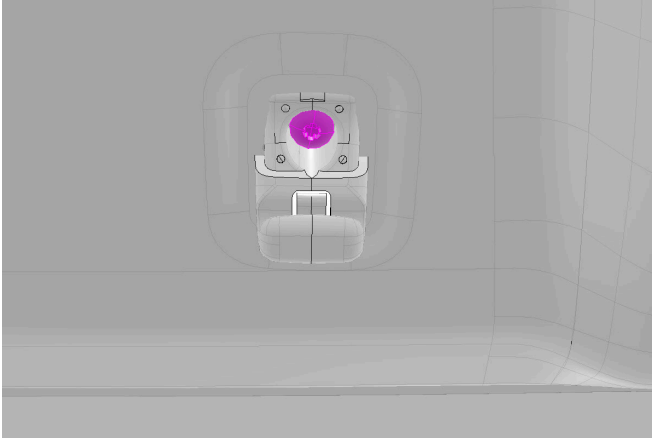
8. On both sides:

Step Number	Torque (Nm)
8	3.5
9	2.2
13	7.2

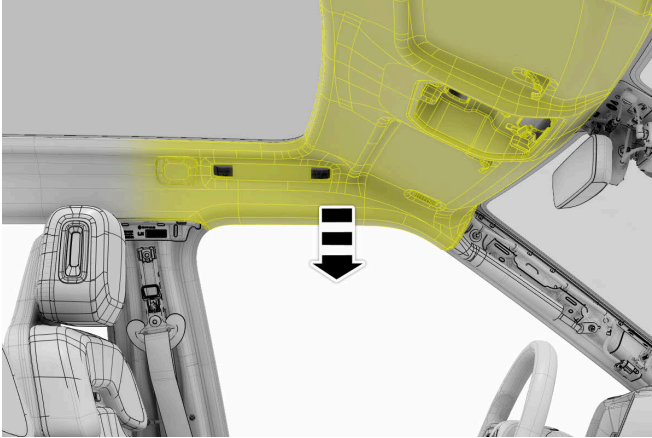
11. On both sides:

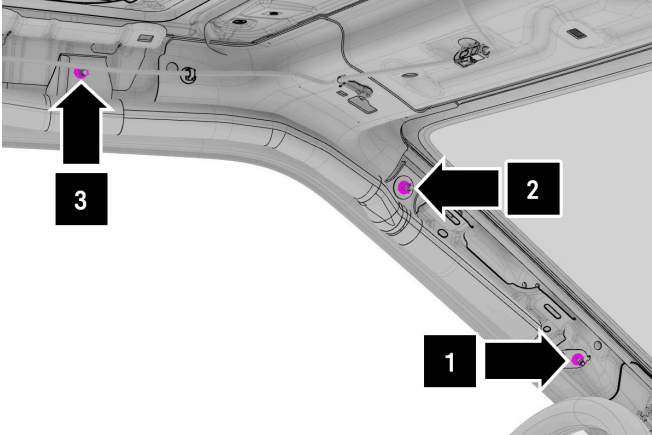
12. On both sides: Remove and discard:

**Note:** Shown with components removed for clarity.

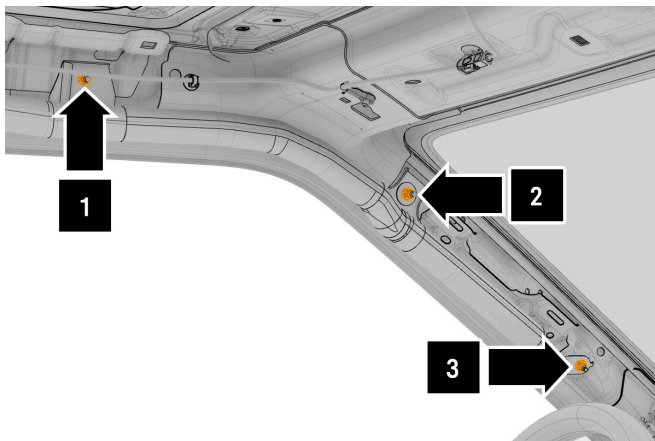
13. On both sides: Install:

**Important:** Use new fasteners.

**Note:** Shown with components removed for clarity.

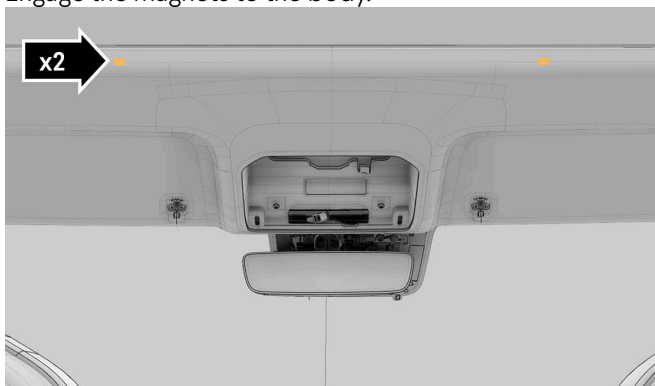
15. Engage the magnets to the body.
