July 26, 2024

Version 3

## Safety Recall: 2020–22 Multi-Model Door Mirror Glass

Supersedes 23-035, dated May 16, 2023, to revise the information.

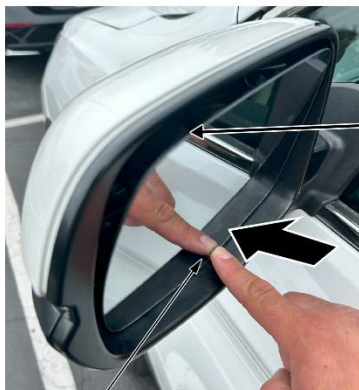
1. Carefully push on either the top or bottom of the mirror to create an opening at the outer corner between the mirror backing plate and the mirror housing.

Push on the mirror to create an opening.
