HYUNDAI Technical Service Bulletin	GROUP RECALL	NUMBER 23-01-027H-1
	DATE JUNE 2023	MODEL(S) SANTA CRUZ (NXT) SANTA FE (TM) SANTA FE HYBRID (TM HEV) SANTA FE PLUG-IN (TM PHEV)
SUBJECT:	TRAILER TOW HITCH HARNESS INSPECTION AND 4 PINS PIGTAIL HARNESS/FUSE REPLACEMENT (RECALL 244)

This TSB supersedes 23-01-027H to add remedy repair for Santa Fe, Santa Fe Hybrid, & Santa Fe Plug-in vehicles.

This bulletin provides the inspection procedure for vehicles NOT equipped with the trailer tow hitch and wire harness or only have the 7-PIN harness installed. For vehicles EQUIPPED with the 4-PIN wire harness, this bulletin provides the details for the 4-PIN extension/replacement, and the fuse replacement.

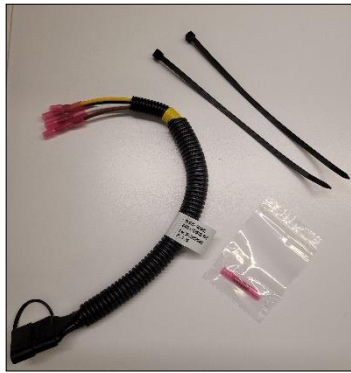
MODEL	PART NAME	PART NUMBER	IMAGE
SANTA FE (TM), SANTA FE HYBRID (TM HEV), SANTA FE PLUG-IN (TM PHEV)	EXTENSION WIRE KIT	S8F67-AC900-QQH

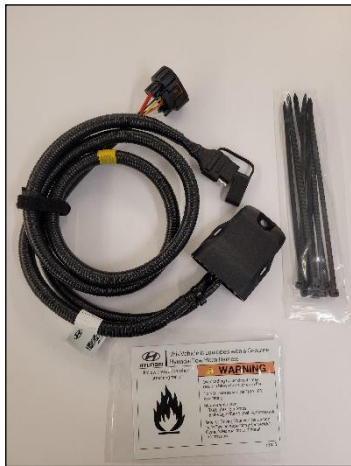
EXTENSION HARNESS ASSY KIT	S2F67-AC700

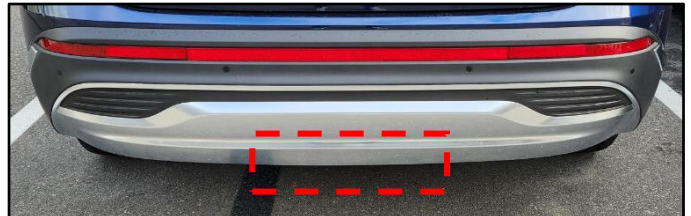
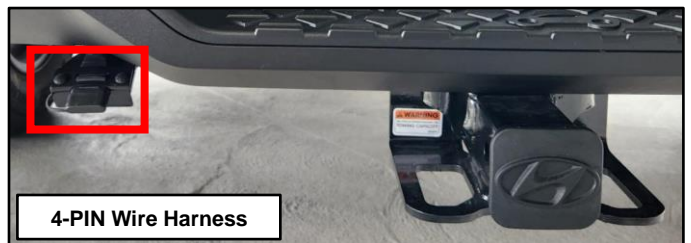
1. Visually inspect the center rear lower bumper for the following:
 - Genuine Hyundai Accessory trailer tow hitch and **4-PIN** wire harness installed.
 - Genuine Hyundai Accessory trailer tow hitch and **7-PIN** wire harness installed.
 - Genuine Hyundai Accessory trailer tow hitch installed, but no visible harness connection installed.
 - No trailer tow hitch installed
- 1A. If the vehicle is equipped with a Genuine Hyundai Accessory trailer tow hitch and **4-PIN** wire harness, please proceed to [page 10](#) and continue this Service Bulletin.

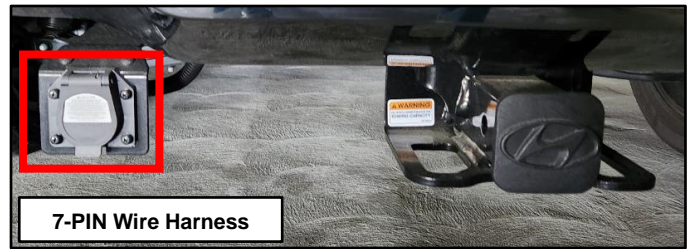
1B. If the vehicle is equipped with a Genuine Hyundai Accessory trailer tow hitch and **7-PIN** wire harness, proceed to **step 2 to complete the procedure.**

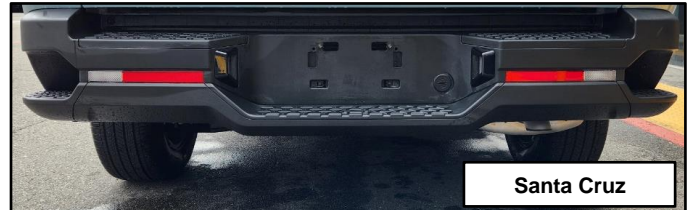
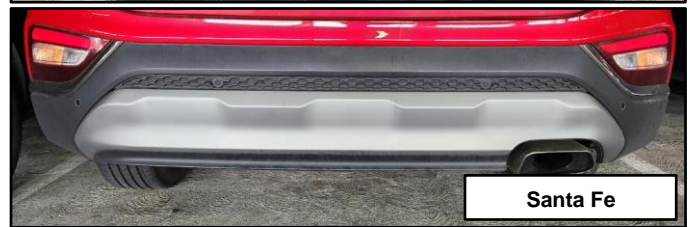
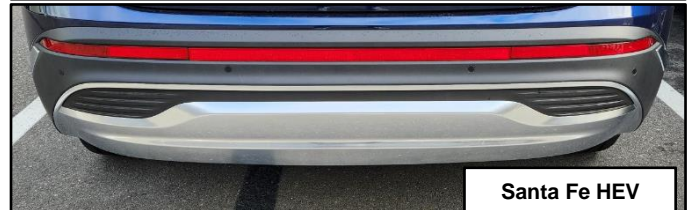
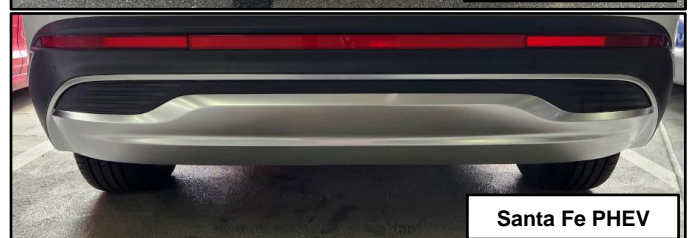
1C. If the vehicle is not equipped with a Genuine Hyundai Accessory trailer tow hitch, then proceed to **step 2 to complete the procedure.**

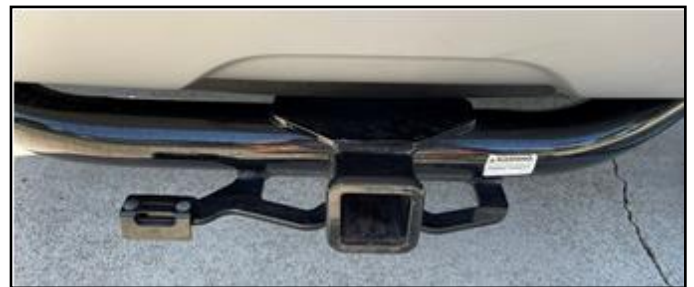
1D. If the vehicle is equipped with a Genuine Hyundai Accessory trailer tow hitch, but there is no visible wire harness installed, then proceed **to step 2 to complete the procedure.**

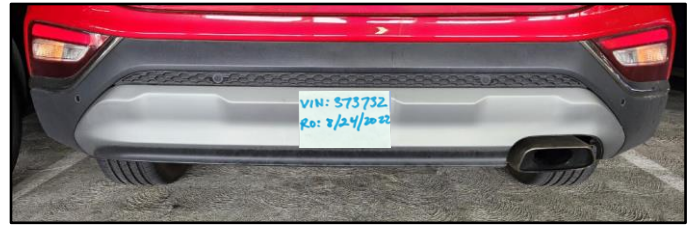
Example to the right is a picture of a vehicle not equipped with the Genuine Hyundai Accessory trailer tow hitch.

Using STUI, take a picture of the rear center lower bumper with the last six digits of the VIN and date of the inspection included. Upload the photo to STUI.

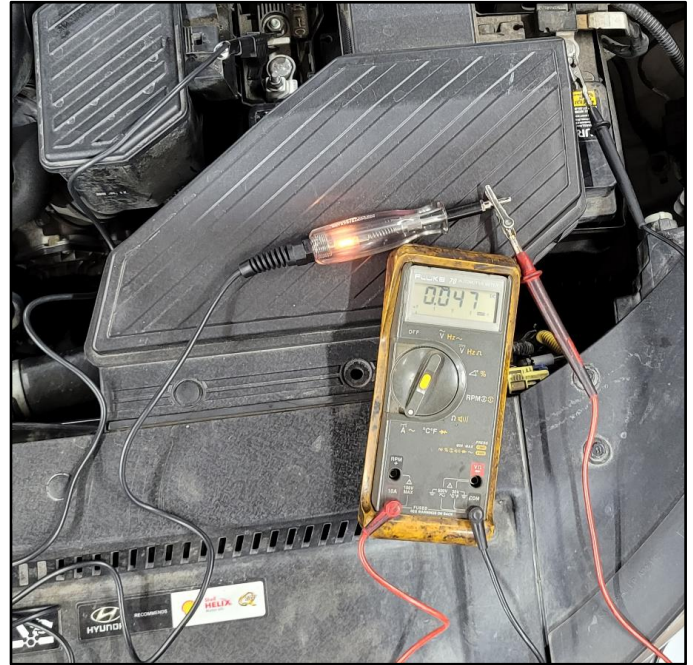
Utilizing the multimeter test tool, connect the black probe to the battery's black terminal, and red probe to tester light as shown in example photo.

2. If electrical reading is 47mA, and the test light is on, the multimeter is ready for use, and proceed to the next step.

If electrical reading is anything other than 47mA, consider checking the fuse.

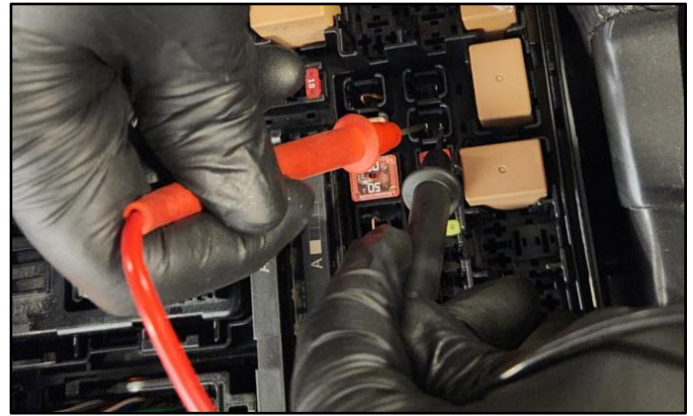
3. Measure both terminals where the fuse was with a multimeter probe.

Vehicle should be OFF, with key removed.

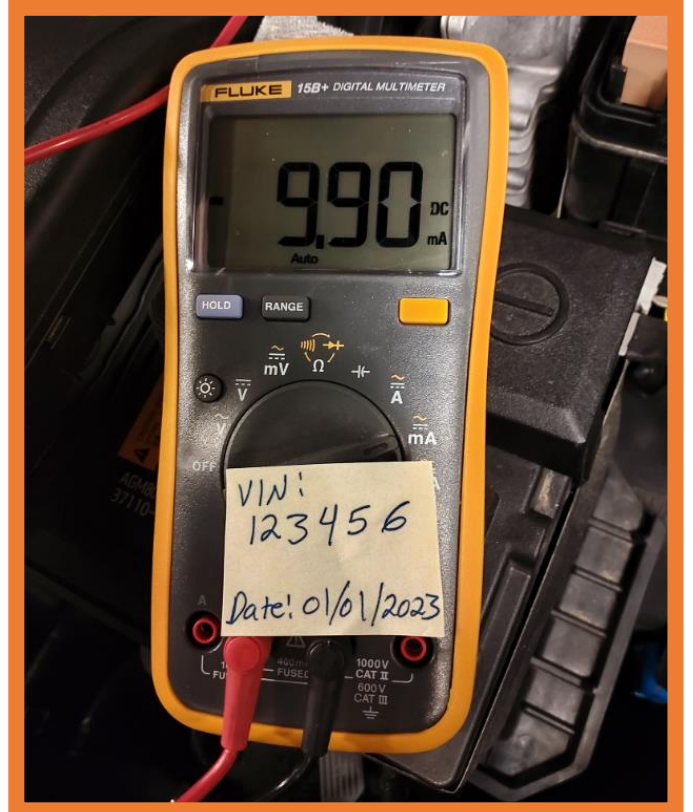
4. Check whether the multimeter is reading above, equal to, or below 13mA. Take a picture of the results.

If reading is **below 13mA**, proceed to step 5 to perform wire harness repair with extension wire kit, install an updated fuse, and fuse label.

If reading is **equal to or above 13mA**, the accessory harness assembly must be removed and replaced. An updated fuse must also be installed with a new fuse label. Proceed to [page 25](#) for harness assembly removal and replacement procedure.

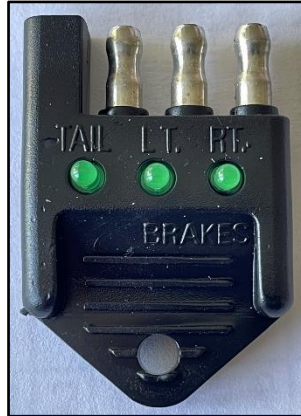
4 Pins Mini-Tester Light Validation

NOTE: The three lights are TAIL, LT, and RT

Activate From Vehicle	Light Output From Mini-Tester	
	Engine Off	Engine On
Right Turn Signal ON	No light	RT light flashes
Left Turn Signal ON	No light	LT light flashes
Hazard On	LT and RT light flashes	LT and RT light flashes
Brake Depressed	LT and RT light constantly ON	LT and RT light constantly ON
Turn Light Switch to ON position	TAIL light constantly ON	TAIL light constantly ON
Turn Light Switch to ON position and Hazard ON	TAIL light constantly ON and LT and RT light flashes	TAIL light constantly ON and LT and RT light flashes
Turn Light Switch to ON position and Brake Depressed	TAIL light constantly ON and LT and RT light constantly ON	TAIL light constantly ON and LT and RT light constantly ON
