Service Bulletin

NVA110B #1
March, 2023

SAFETY RECALL

2022 NVA110B Speedometer Cable Replacement

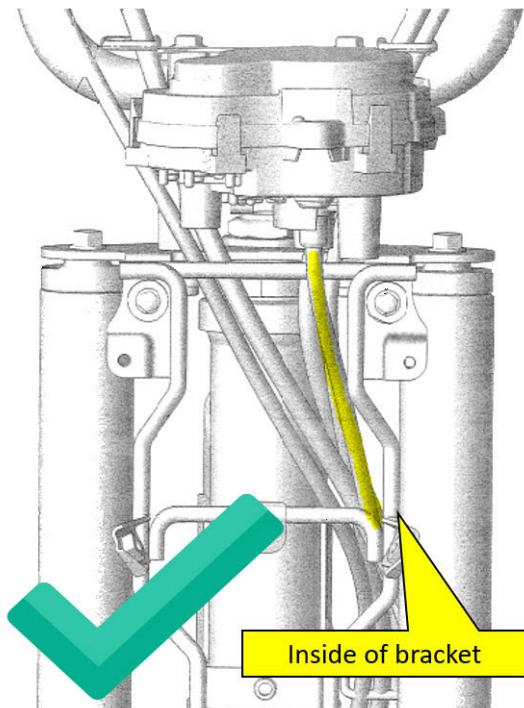
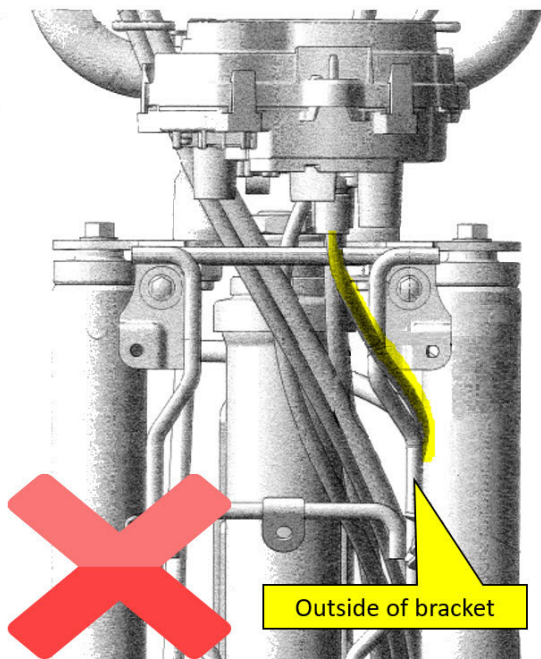
Honda is launching a **SAFETY RECALL** on **CERTAIN 2022 NVA110B** motorcycles to replace the speedometer cable. An improperly routed speedometer cable may result in a speedometer malfunction which can affect the rider's judgment to ride safely, increasing the risk of a crash or injury.

6. Install the new speedometer cable in reverse order of removal. Follow the routing instructions shown below.
