Service Bulletin

NVA110B #1
Revised December 2023

SAFETY RECALL

2022 NVA110B Speedometer Cable Replacement

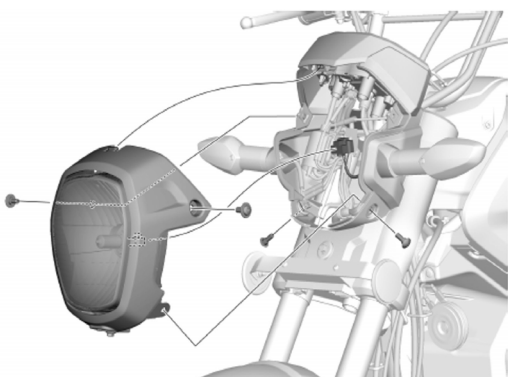
1. Remove the headlight assembly and disconnect the headlight bulb.

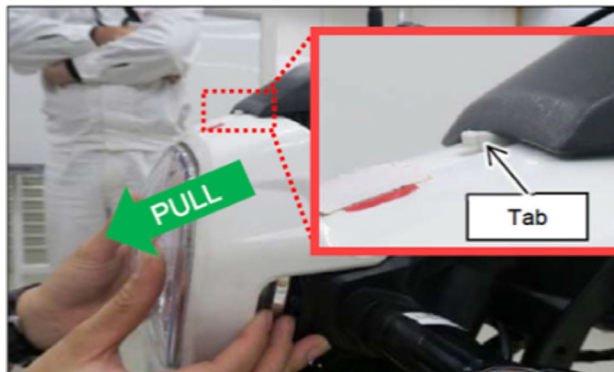
1. **Note:** Be careful to pull the lower part of the headlight outward slightly, then release the tab that secures the meter cover to the headlight assembly and pull the assembly straight out.

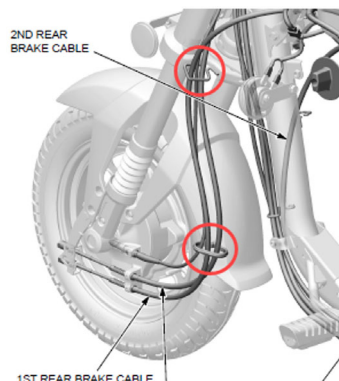
2. Disconnect the speedometer cable by unscrewing the knurled nut that attaches the speedometer cable to the underside of the meter.
3. Pull the speedometer cable through the cable guides.

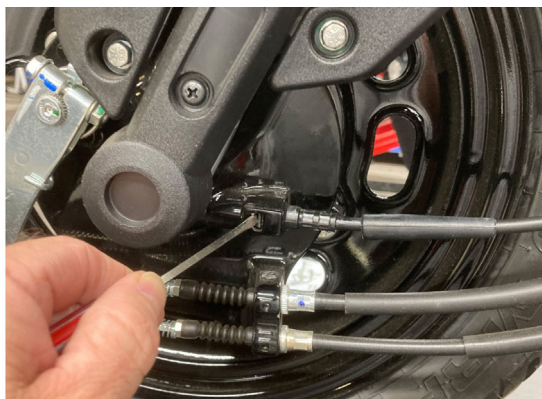
4. At the front wheel hub, release the tab securing the other end of the speedometer cable to the brake panel.
