Recall Campaign Bulletin

Campaign No. 2023040009, April 2023

SUBJECT: **Model S-Class (223 platform)**
Model Year 2021

Rework the Primary Bulkhead Sealing

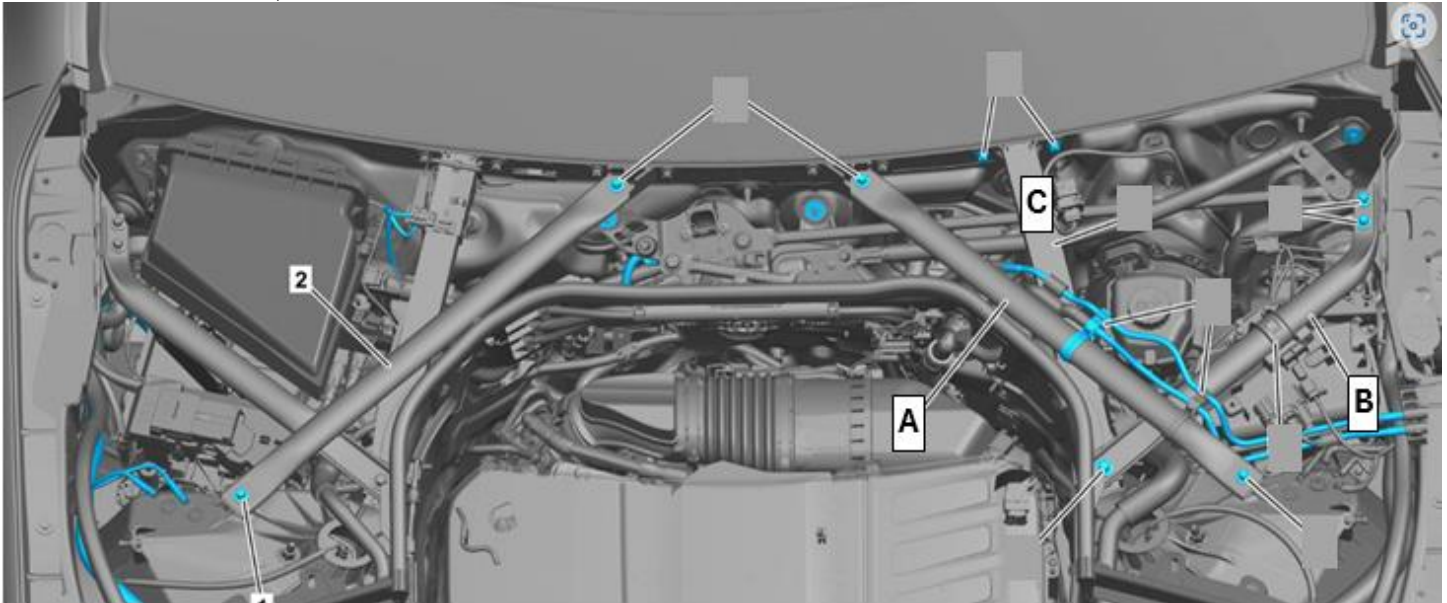
Figure 1

1. Remove left and right wiper arms.
i For basic data, see AR82.30-P-6100S
2. Remove air/water duct under windshield and struts (A, B and C, Figure 1).
i For basic data, see AR82.30-P-0001S

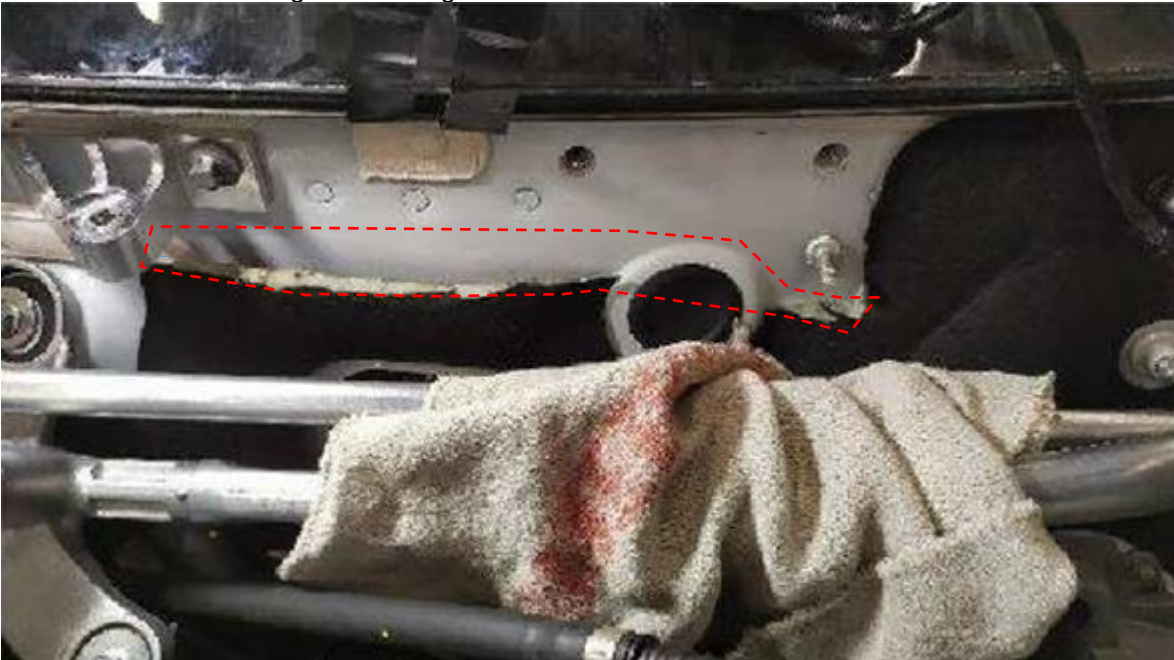
Figure 3

5. Cut off an approx. 2 cm wide section of insulating mat as shown (Figure 4).

i Cut off insulating mat below ground bolt.

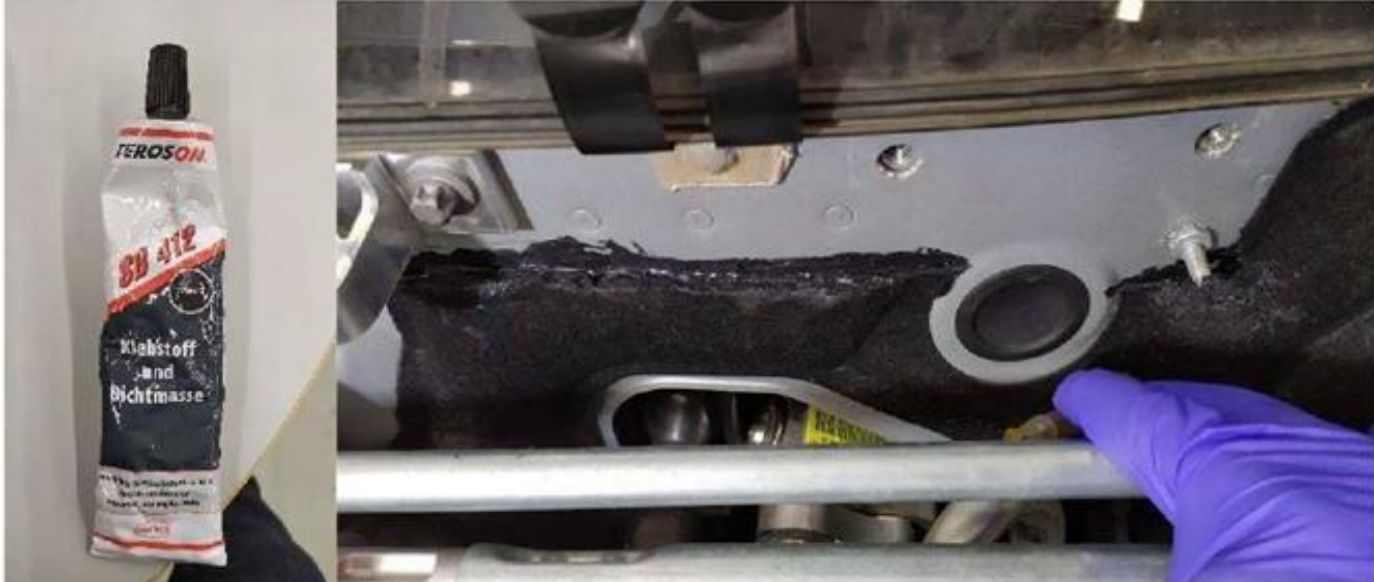
Figure 4, adhesive application example

6. Bond insulating mat at cut edge to firewall using Teroson adhesive and also coat cut edge with Teroson adhesive (Figure 5, 6).

i Apply adhesive with a disposable glove.

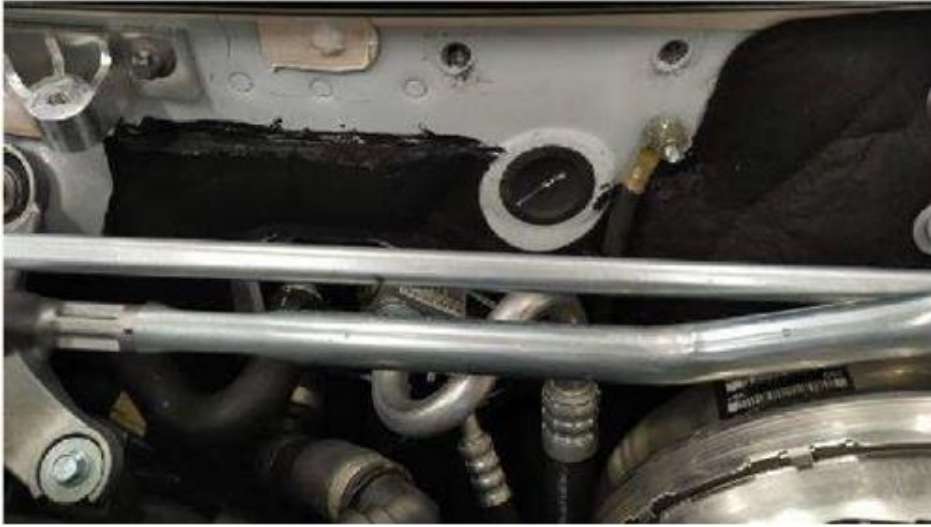
Figure 6

7. Screw ground line onto firewall again (Figure 7).

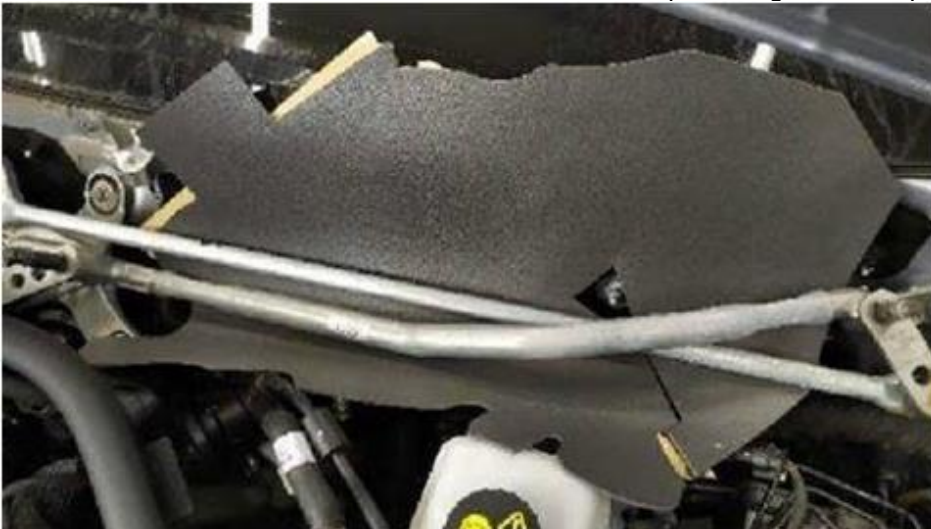
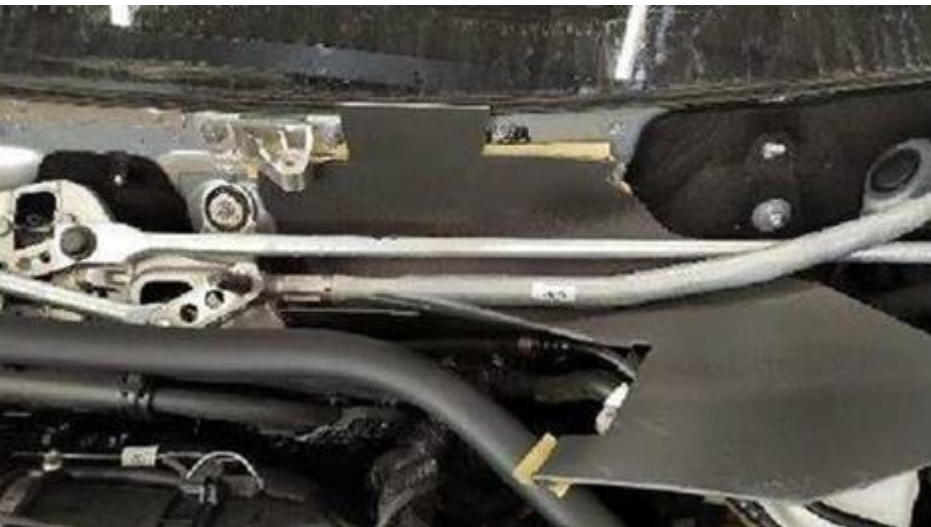
8. From the firewall side, feed water deflector under wiper linkage until it is positioned as shown (Figure 8, 9).

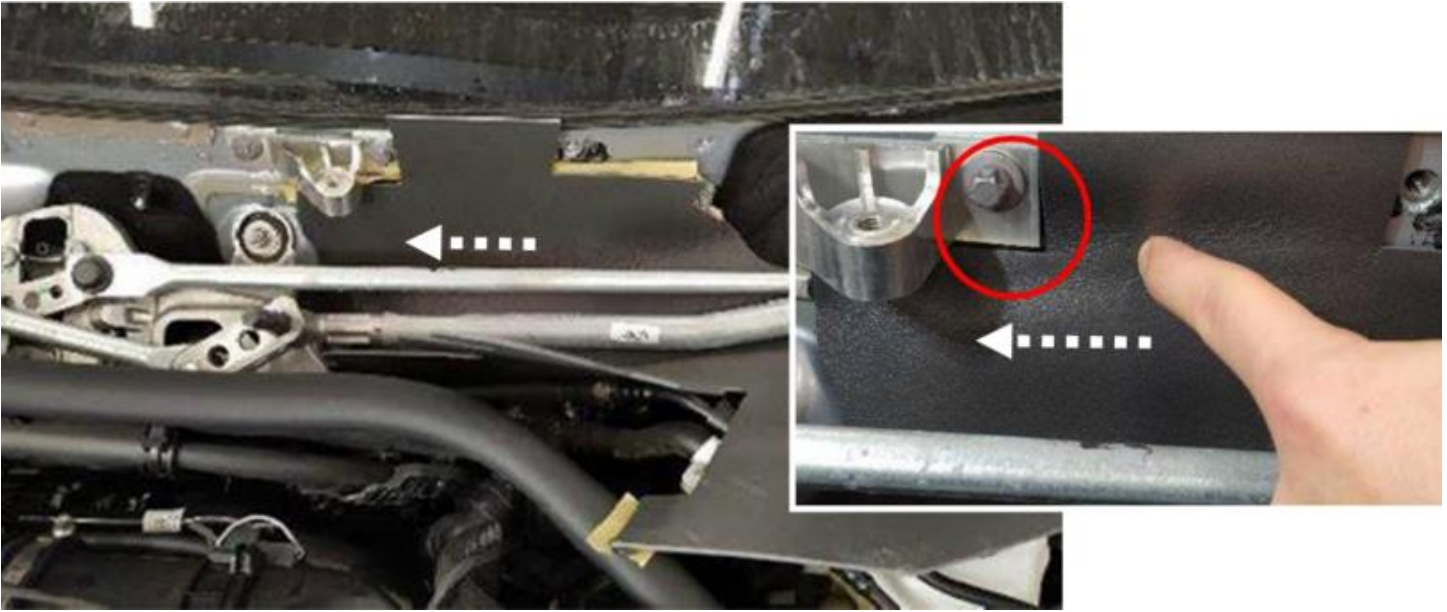
**Figure 8**

9. Water deflector is moved under wiper linkage towards vehicle center (Figure 10) until corner of water deflector is in contact with mounting support of strut.

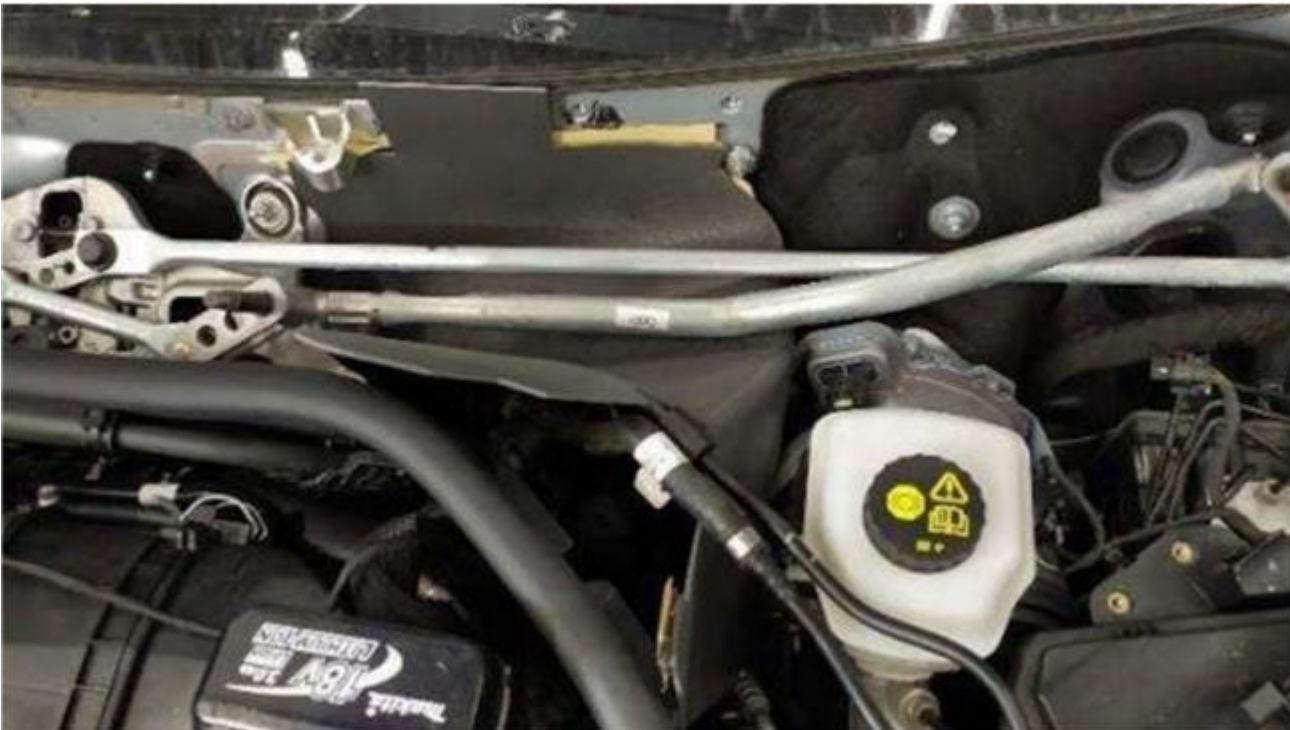
**Figure 9**

10. On the driver's side, the water deflector is folded in directly behind the end of the butyl tape so that the fold is in contact with the brake booster (Figure 11).

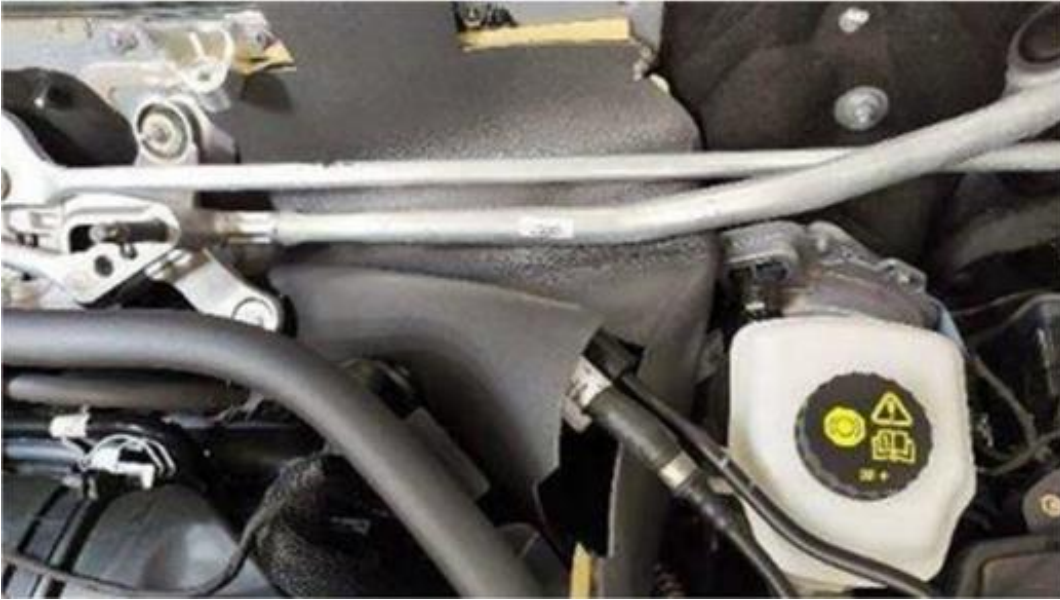
Figure 10

11. Fold water deflector at front side as shown so that hoses are covered (Figure 12).

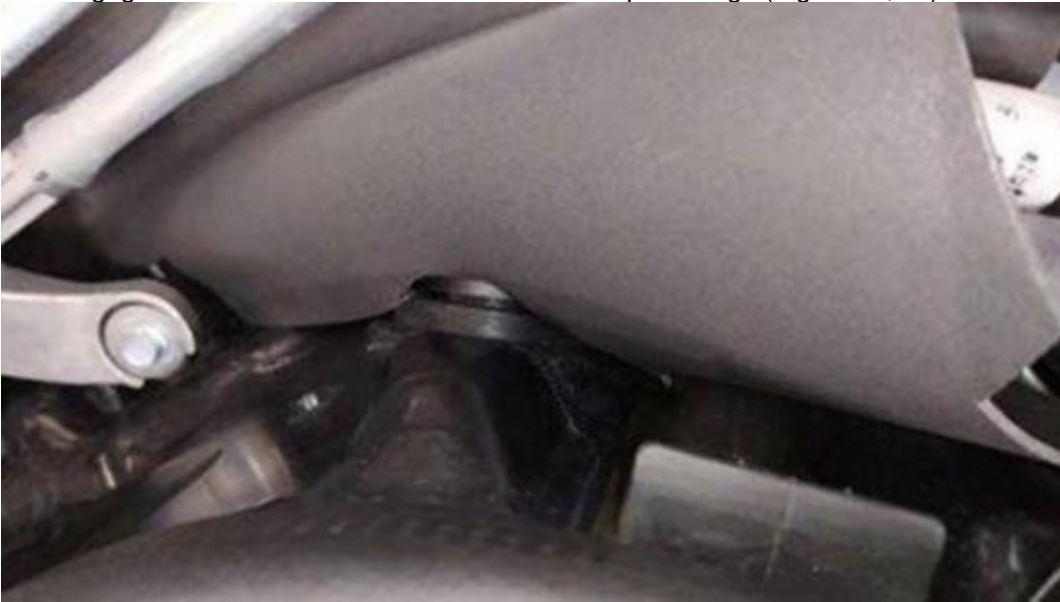
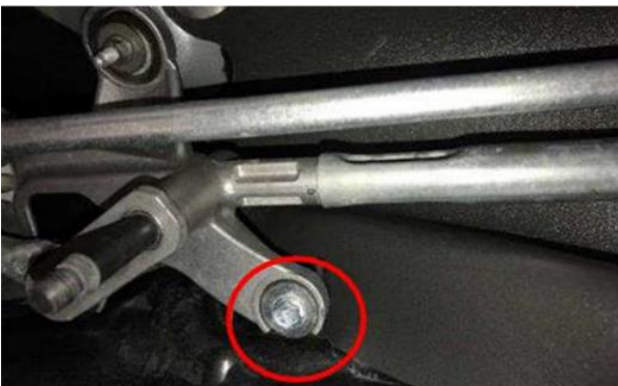
12. Engage water deflector as shown at mount of wiper linkage (Figure 13, 14).

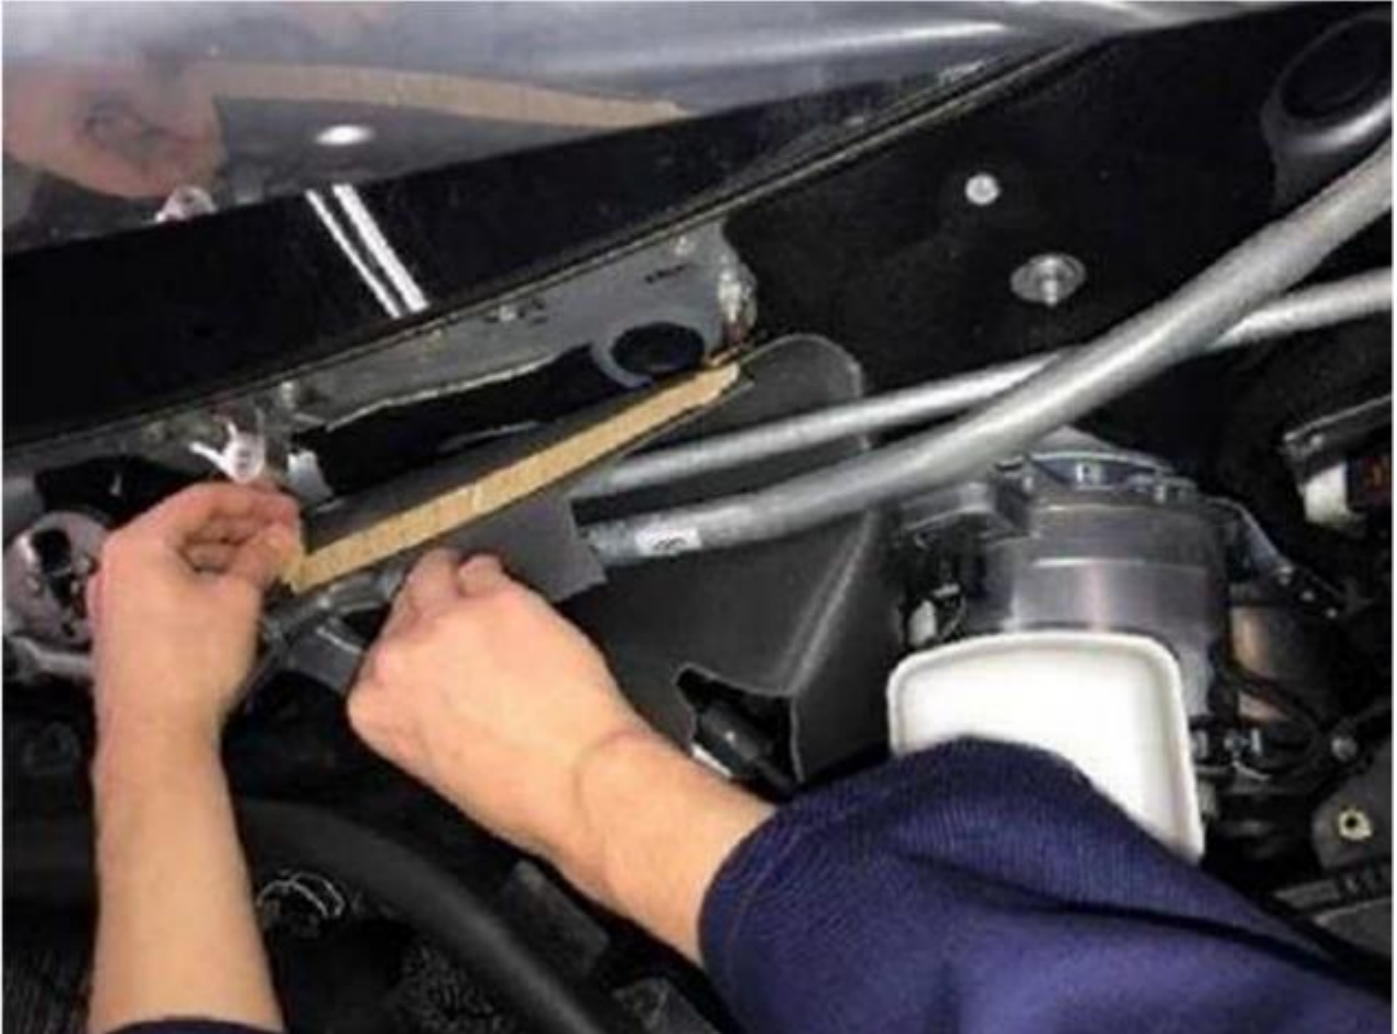
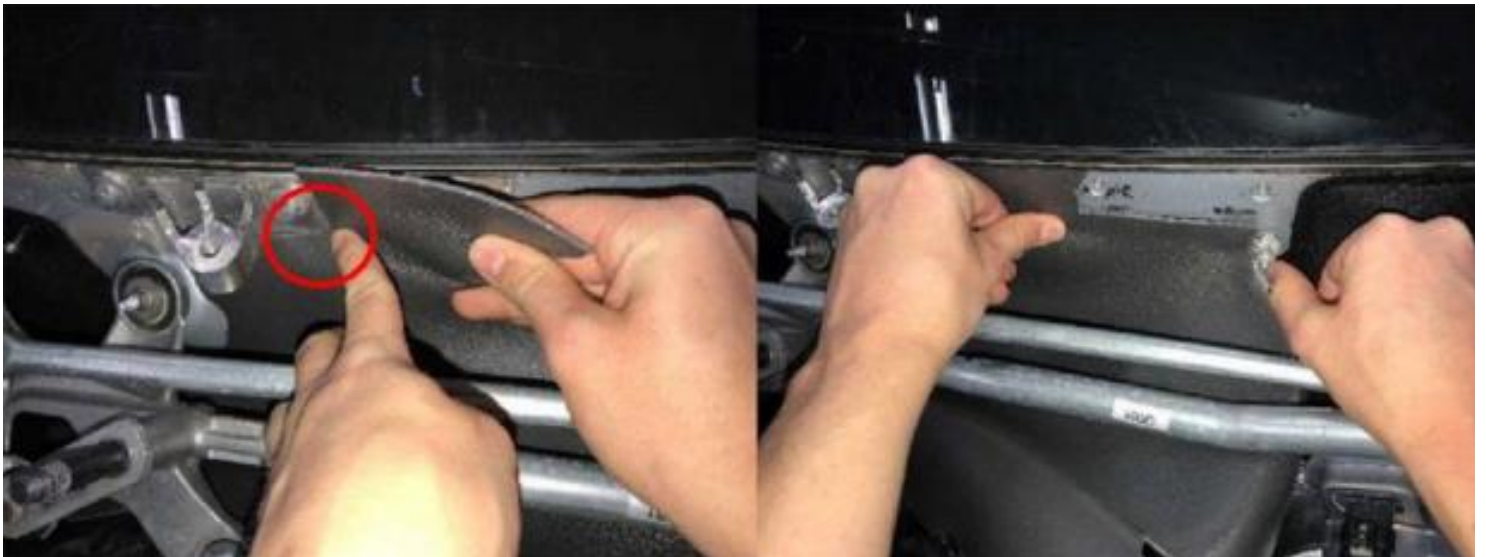
13. Remove wax paper from butyl tape and bond water deflector to firewall (Figure 15).

i Firmly press on water deflector.

i First position corner of water deflector (Figure 16) and press onto firewall.

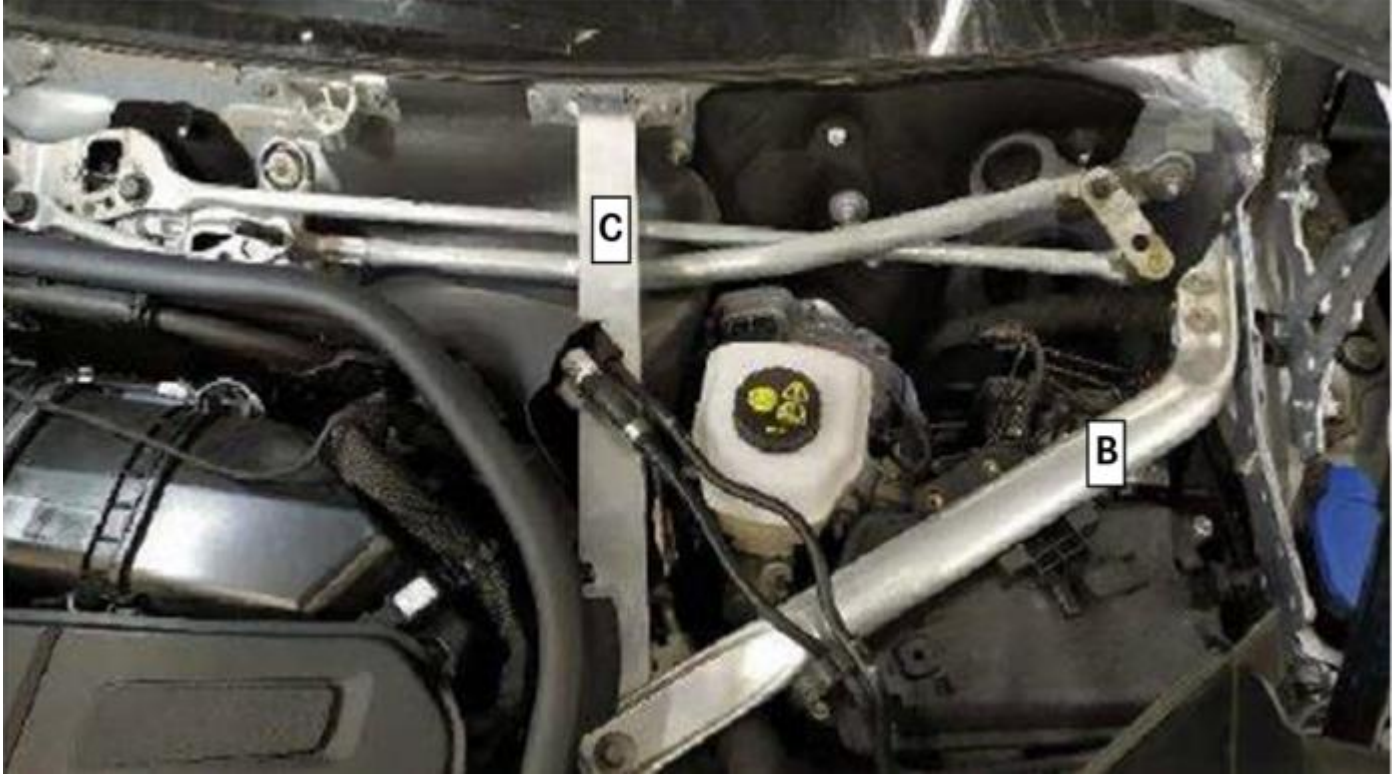
Figure 15

14. Install struts (B and C, Figure 17).

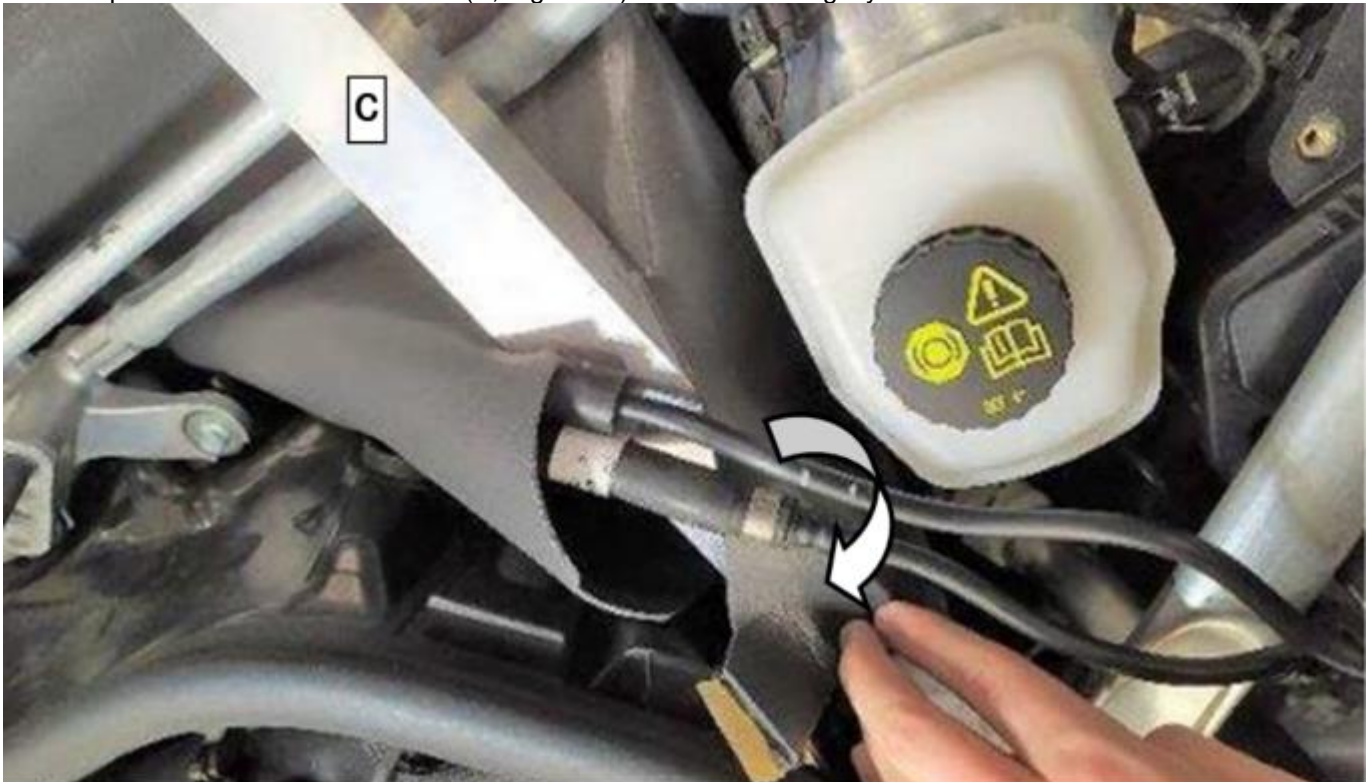
Figure 16

15. Wrap water deflector around strut (C, Figure 18) so that strut is tightly enclosed.

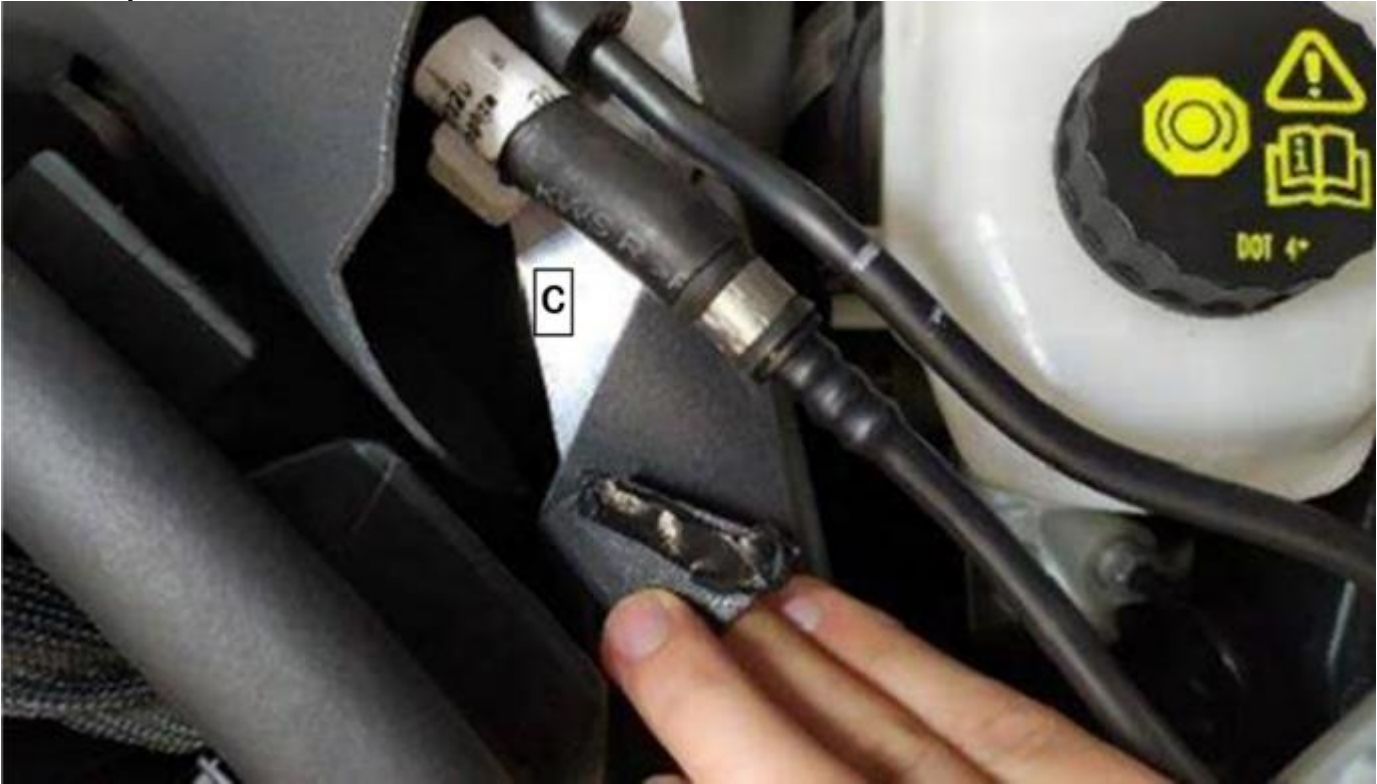
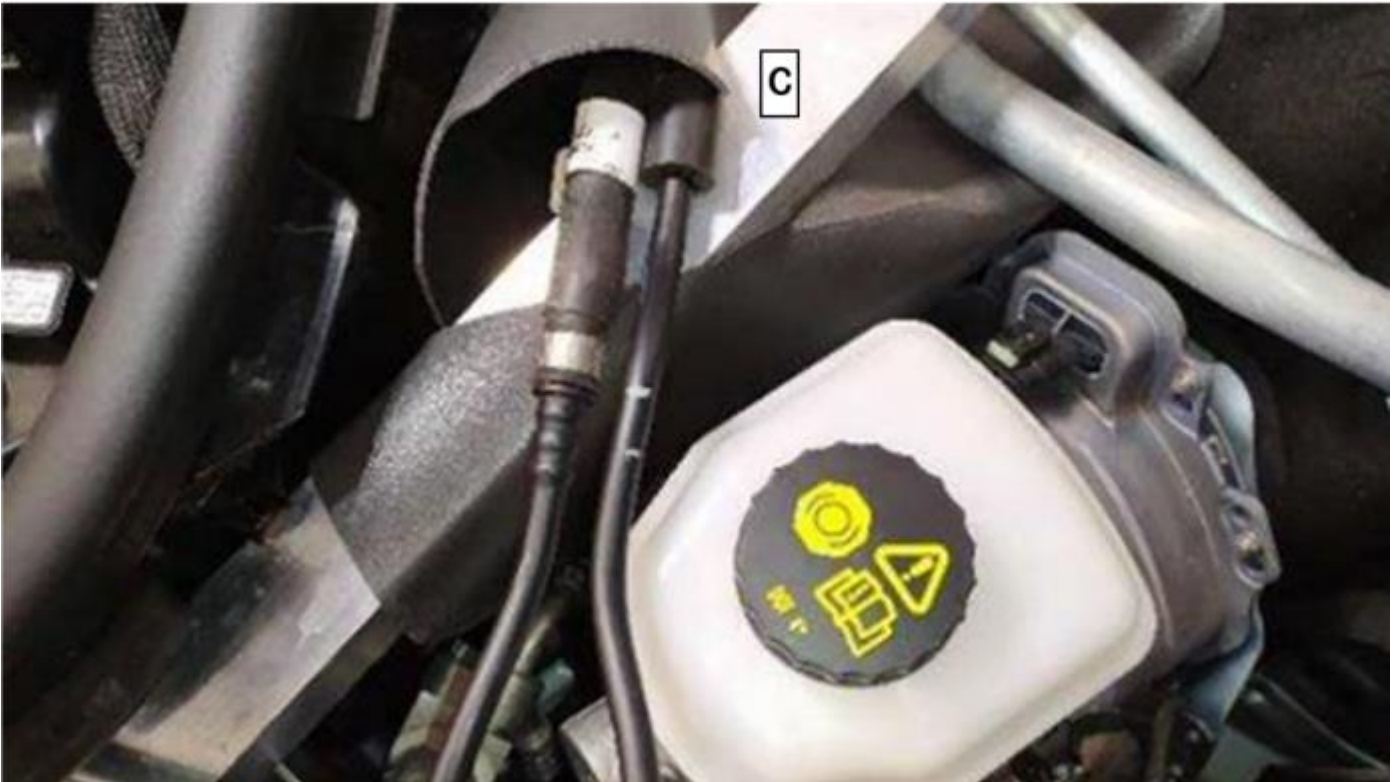
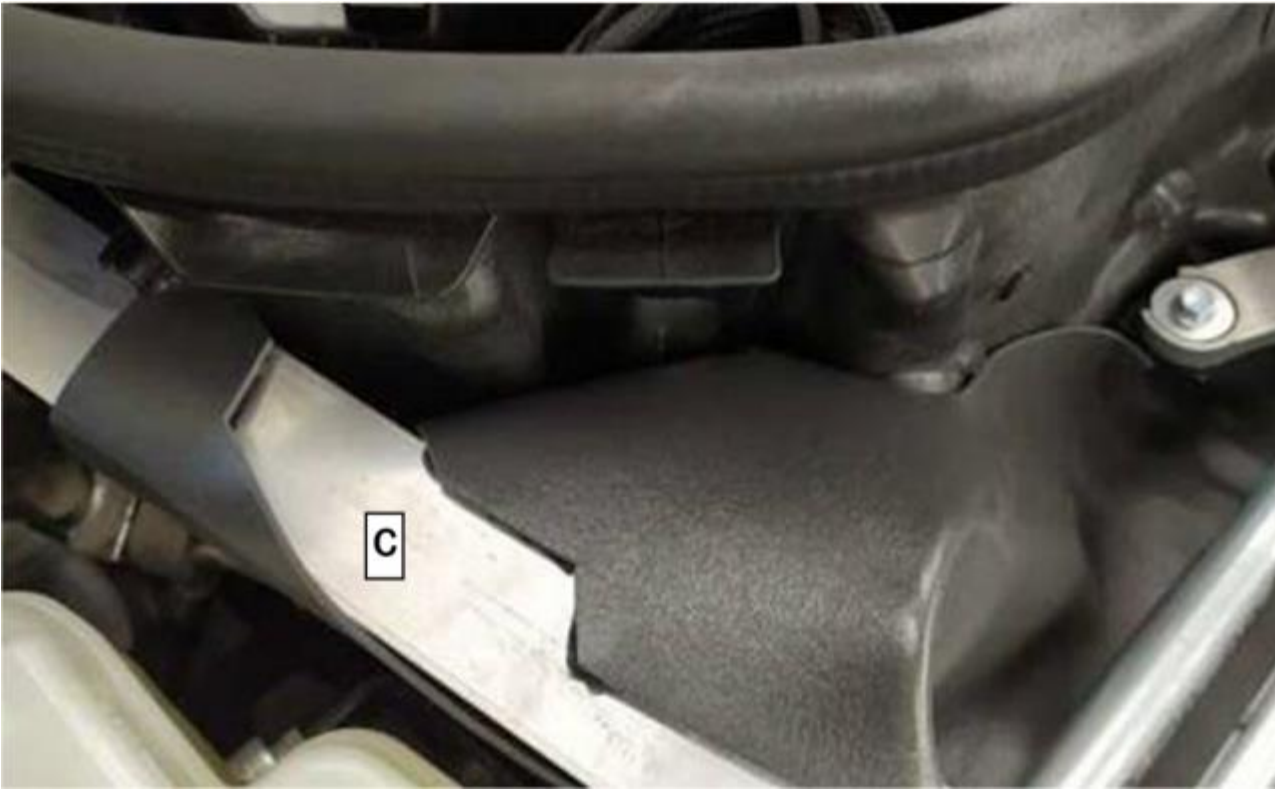
16. Remove butyl tape and bond tongue of water deflector under tension to strut (C, Figure 19, 20 and 21) so that it fits closely with strut.

Figure 17, with heated washer fluid reservoir

Figure 18, with heated washer fluid reservoir

Figure 19, without heated washer fluid reservoir

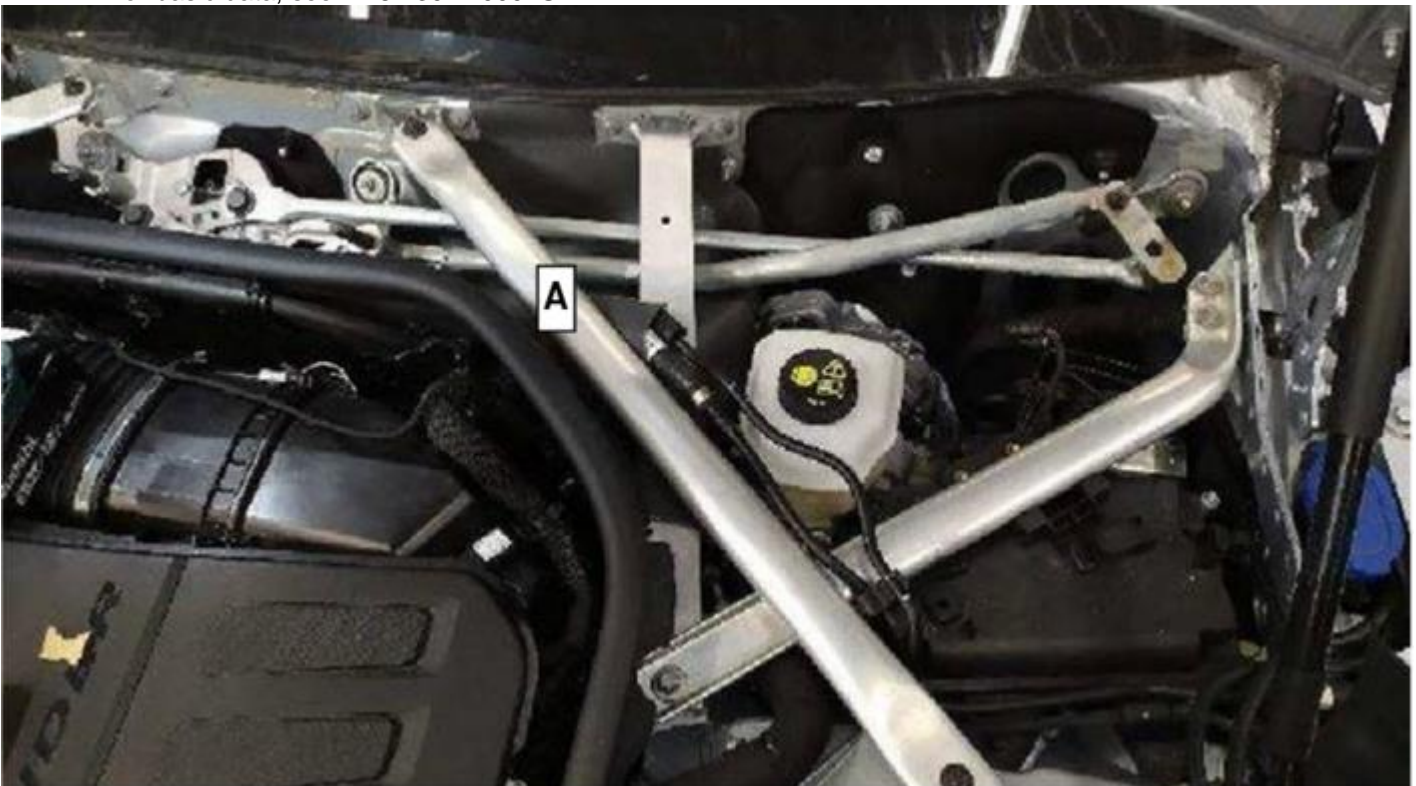
Figure 22

17. Install strut (A, Figure 22).

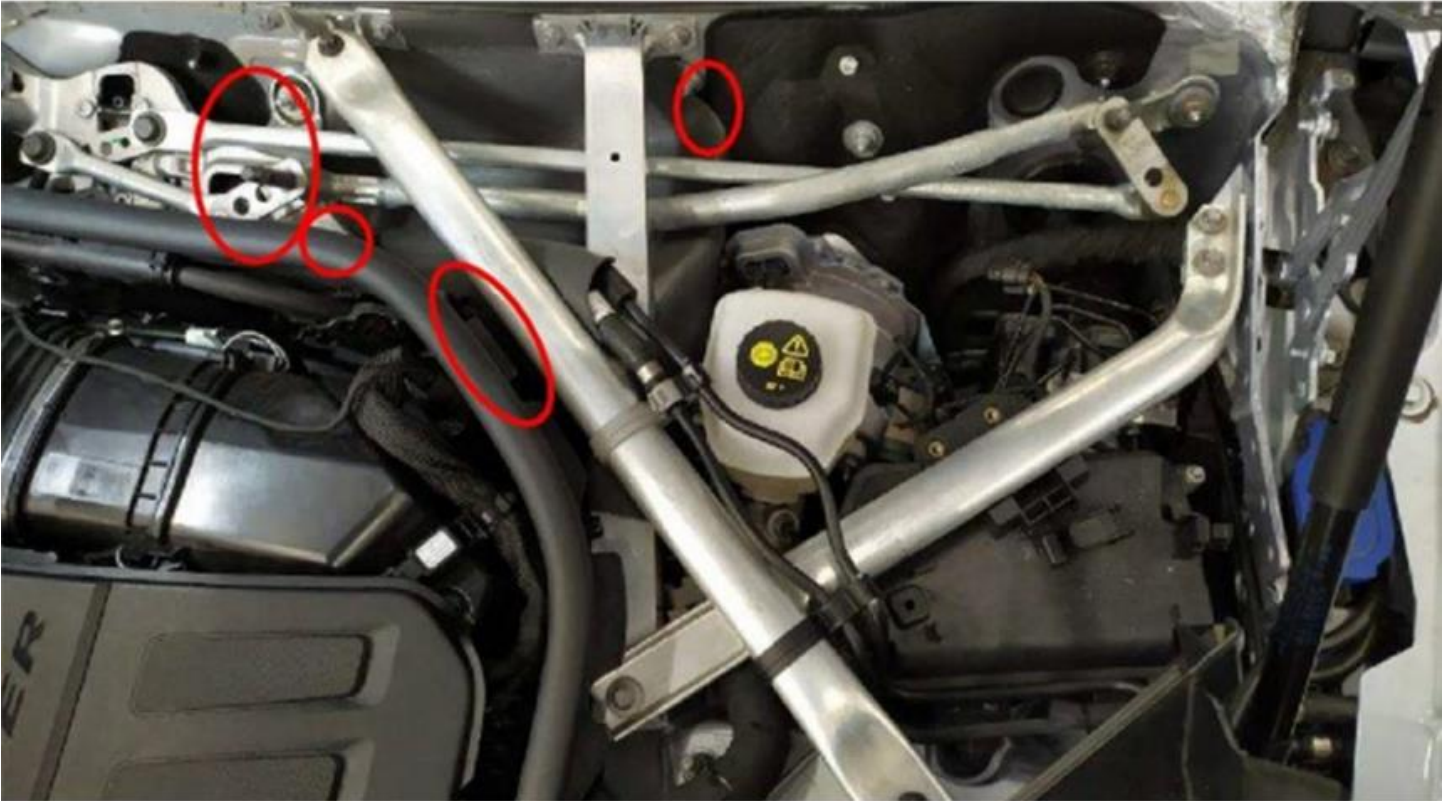
Figure 20

18. Check whether water deflector is in contact at relevant locations (Figure 23), and correct if necessary.

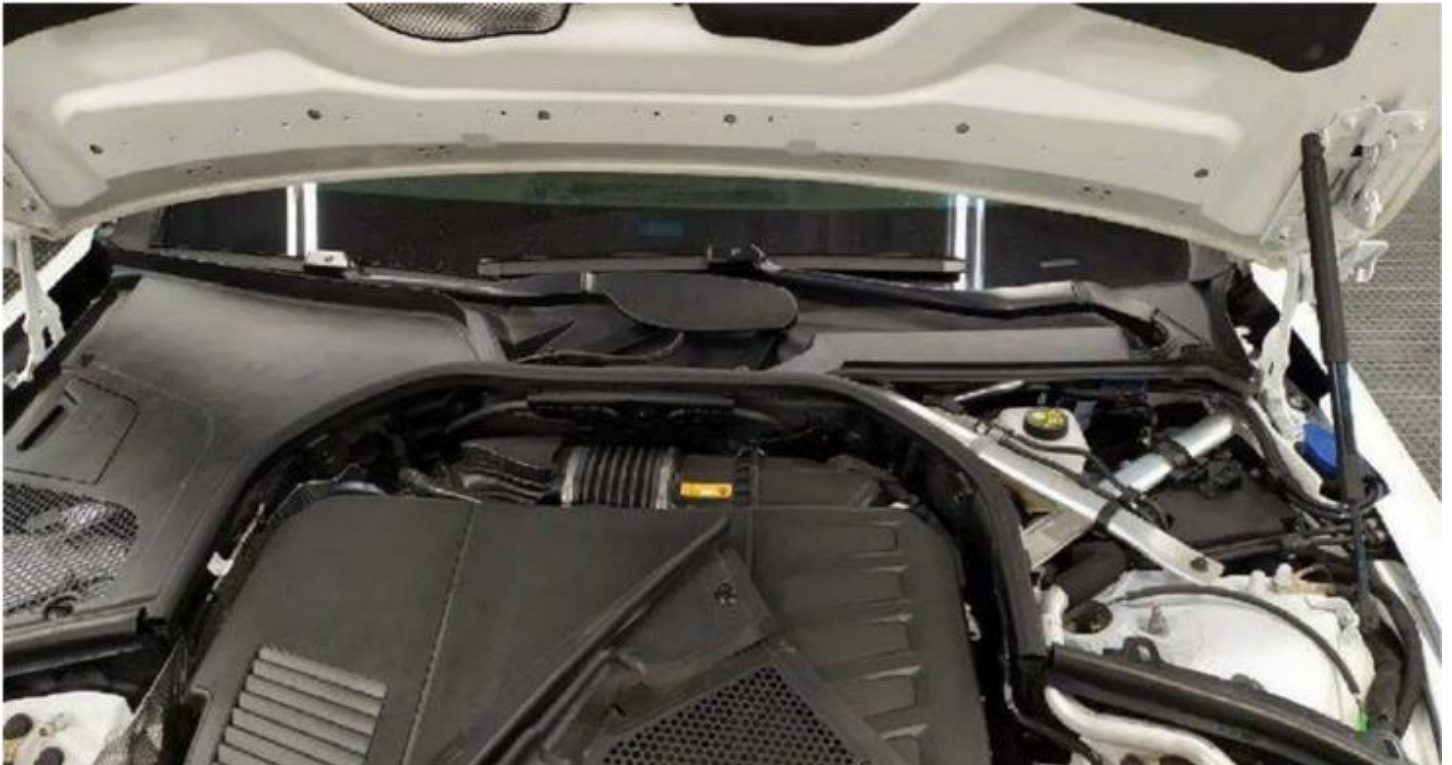
Figure 21

18. Install air/water duct and wiper arms (Figure 24).
