Technical Service Bulletin

23-01-047G

G90 (RS4)

FRONT AND REAR SEAT BELT PRETENSIONER
PROTECTION CAP INSTALLATION (RECALL 013G)

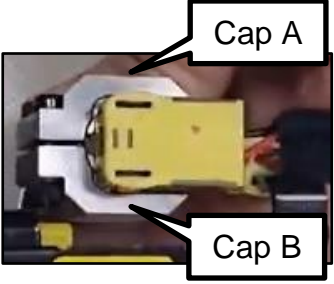
Cap B does not have a marking groove.
	Cap A

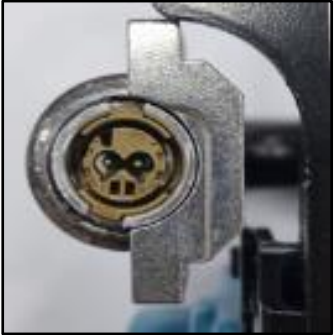
Cap A does not have a marking groove.
	CAP B
