Safety Recall Code: 57J4

Door Handles

May 17, 2023

The affected vehicles may have been built with door handles that do not meet the factory specifications for protection against water ingress. Water ingress at the printed circuit board assembly of the door handle may cause a situation where a vehicle door could open unexpectedly when the vehicle is subject to high lateral forces at speeds below 9 mph/15 kmh. An open door on a moving vehicle puts occupants at risk of injury, and can cause damage to objects and people who may be outside of the vehicle.

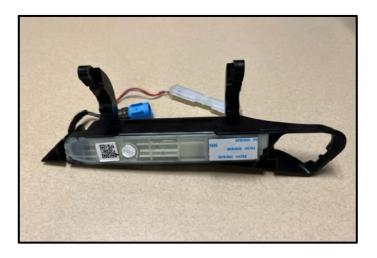
Repair Overview

- Inspect door handle assemblies and replace handle, if necessary.
- Update door control module software via SVM.

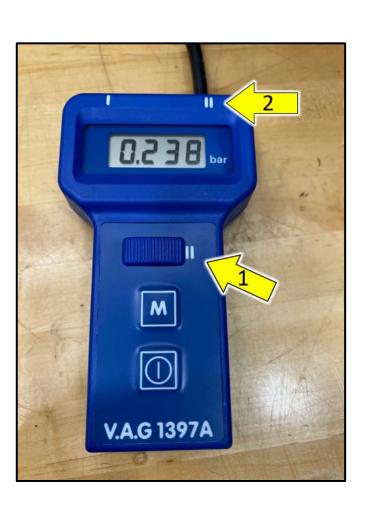
! NOTE

If using VAG1397B, the reading can be changed from bar to psi as follows:

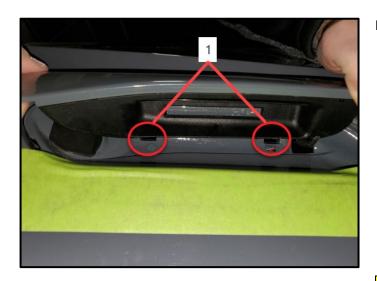
- All four door handles must be inspected.
- Apply masking tape as needed to protect painted surfaces.
- Lift the door handle to the position shown.
- Locate the cutouts <1> in the door handle assembly.

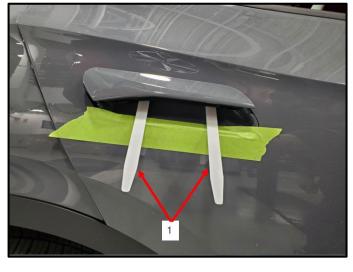
Do not insert plastic wedges into cut outs that have wires visible.

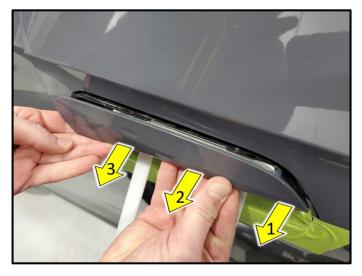
- Unclip the door handle cover at the front (in direction of travel) <arrow 1> first.
- Then continue unclipping at the bottom <arrows 2 and 3>.

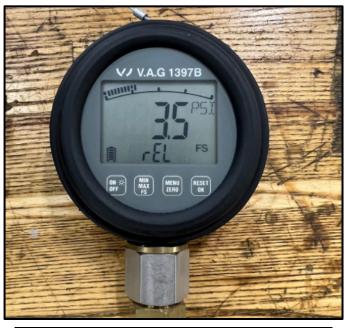
Unnecessary damage to the door handle will occur if the specified pressures are exceeded.

If immediate pressure loss is noted, be sure that the test adapter is fully seated in the test port and a good seal is present.

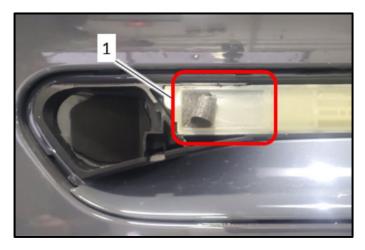
- Remove the old foam tape from the area indicated <1>.
- Clean the area where the new foam pad will be applied using isopropyl alcohol and a lint free cloth.
- Allow the cleaner to dry completely.

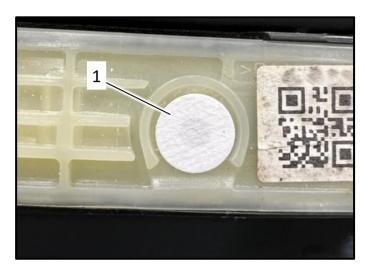
- Apply new membrane <1> to the door handle.
- Ensure the membrane is placed precisely in the center of the recessed area.
- Press evenly so the entire membrane is adhered to the door handle.
- Ensure there are no air pockets.

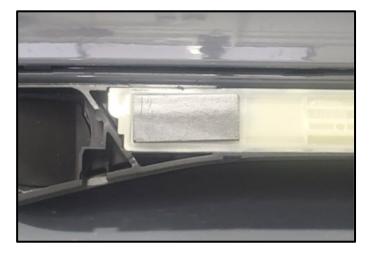
- Peel the backing off ONE side of the foam pad.
- Apply new foam pad <1> to the door handle.
- Ensure the foam pad is placed precisely in the center of the recessed area.
- Press evenly so the entire foam pad is adhered to the door handle.
- Ensure there are no air pockets.

• Remove the adhesive backing from the exposed side of the foam pad.

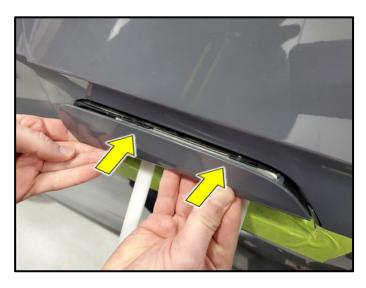
- Install the door handle cover.
- Attach the bottom first, then clip in the top in the direction of <arrows>.

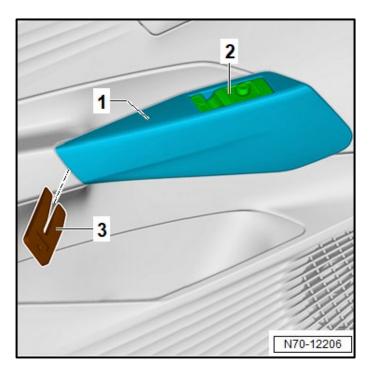
- Unclip the button trim <1> with controls <2> using the Wedge -T10383- <3>.
- Disconnect the connectors.
- Replace the button trim if damaged.

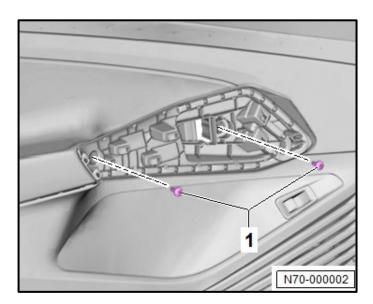
Remove the bolts <1>.

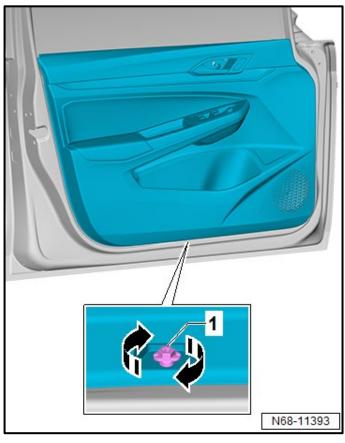
Turn the rotating clip <1> 90° in the direction of <arrow> and release it.

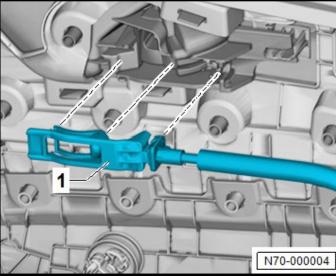
- Disengage the release cable <1>.
- Set the door panel off to the side.

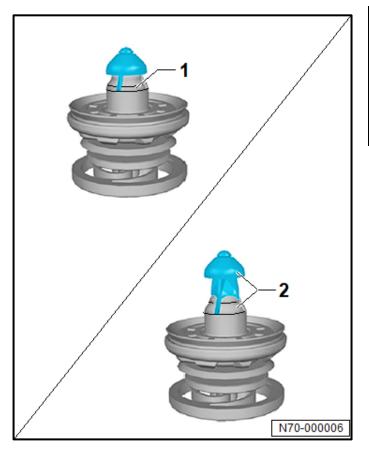
- Always turn the locking mechanism from position <2> to position <1>.
- The door trim panel can only be installed when the locking mechanism is in position

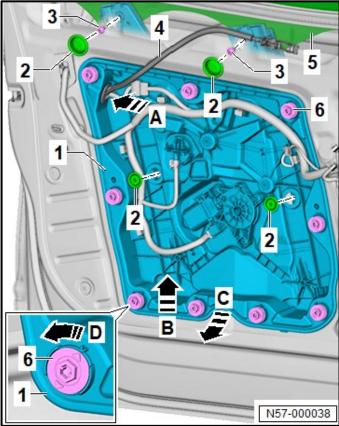
Pry off/remove the caps/adhesive tape <2> from the support <1> using a commercially available plastic wedge.

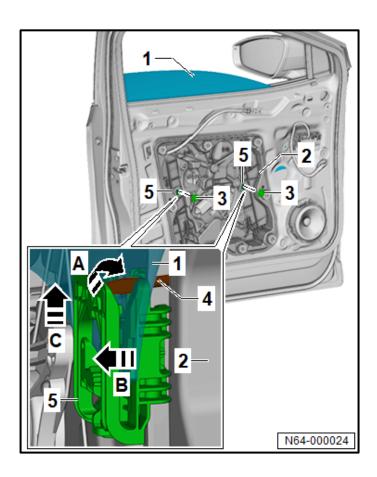
- Reconnect window switch temporarily.
- Lower the front door window <1> until the clamping brackets on the sub-frame <5> are accessible through the opening in the subframe <2>.
- Guide a suitable screwdriver <4> through the openings in the sub-frame <2> and the front door window <1> toward the sub-frame clamping bracket <5>.
- Turn the screwdriver <4> 90° in the direction of <arrow A> and press in the direction of the <arrow B> in the hook on the sub-frame clamping brackets <5> until they disengage.
- Slightly lift the front door window <1> in the direction of <arrow C> so that it does not fall back into the hook.

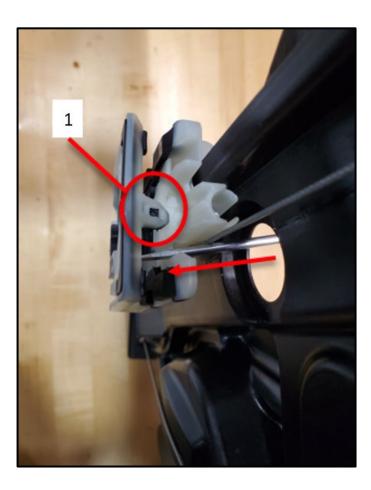
Clamping bracket <1> shown with sub-frame removed. Screwdriver pressed in the direction indicated <arrow> to disengage the clamp from the window glass panel.

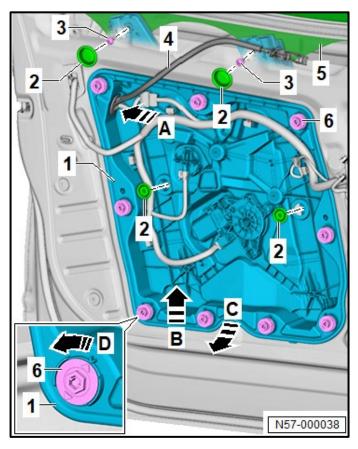
- Push the front door window <5> upward and secure it from falling using commercially available adhesive tape.
- Disconnect the connectors on the sub-frame components.
- Unclip the wires.
- Remove the bolts <3>.
- Turn the clips <6> in the direction of <arrow D> 90° and remove it slightly.
- Guide the release cable with the grommet <4>
 in the direction of <arrow A> out of the support
 <1>.
- Push the support <1> slightly in the direction of <arrow B>.
- Remove the support <1> in the direction of <arrow C> out of the door.

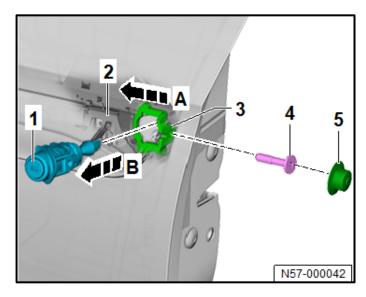
- Pry out the cap <5>.
- Remove the bolt <4> all the way.
- Press the bolt <4> with locking mechanism
 <3> in the direction of <arrow A> until the lock
 cylinder <1> is released.
- Remove the lock cylinder <1> in the direction of <arrow B> out of the mounting bracket <2>.

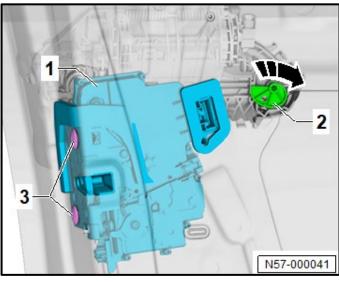
- Disconnect the connector from the door lock unit <1>.
- Remove the bolts <3> and lower the door lock unit <1> downward.

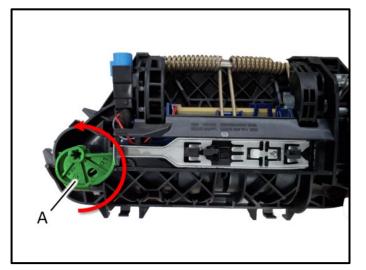
- Rotate the eccentric cam <A> 270° using a T30 Torx screwdriver.
 - Clockwise for driver side.
 - Counter clockwise for passenger side.

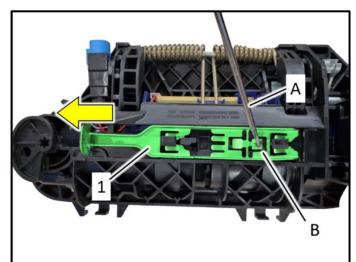
- Press on the locking tab with a screwdriver <A>.
- While holding the locking tab , slide the lock plate <1> in the direction of <arrow>.

A small amount of silicone spray can be used on the plate <1> if movement of the plate is stiff.

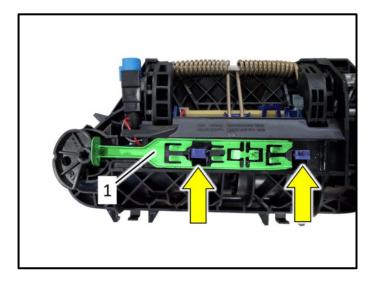
Once the locking plate <1> is in the unlocked position (as shown), the pins <arrows> on the door handle will be released and the door handle assembly can be removed from the door.

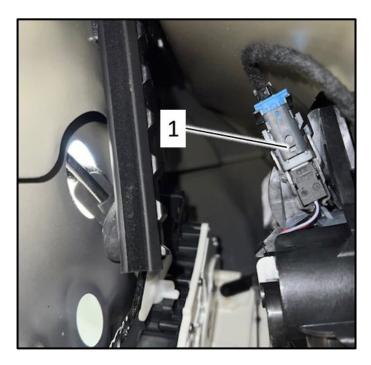
Disconnect the connector <1> from the door handle assembly.

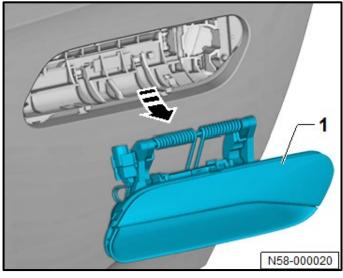
Pivot out the door handle assembly <1> in the direction of <arrow> and remove.

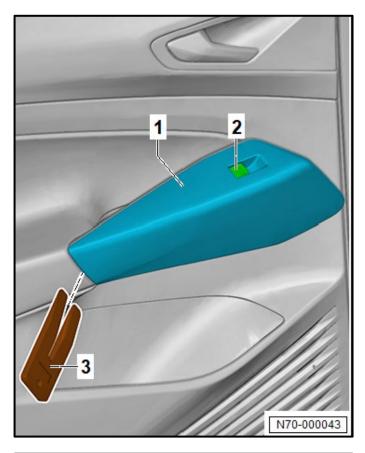
- Unclip the button trim <1> with controls <2> using the Wedge T10383- <3>.
- Disconnect the connectors.
- Replace the button trim if damaged.

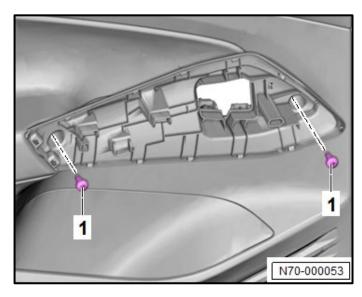
Remove the bolts <1>.

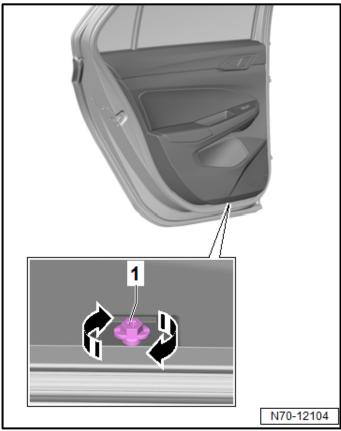
Turn the rotating clip <1> 90° in the direction of <arrow> and release it.

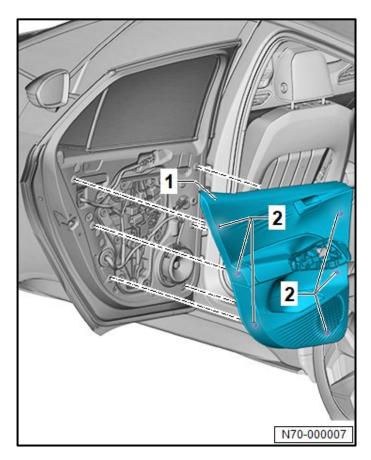
- Loosen the clips <2> for the rear door trim panel <1> using the Wedge Set -T10383-.
- Pull the rear door trim panel <1> upward out of the inner window shaft strip.
- Disconnect any connectors present.

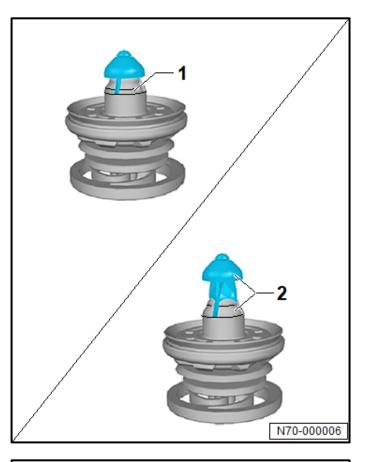
- Always turn the locking mechanism from position <2> to position <1>.
- The door trim panel can only be installed when the locking mechanism is in position <1>

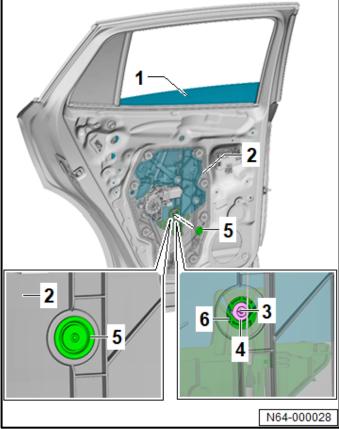
- Pry the cap <5> out of the subframe <2> using a commercially available plastic wedge.
- Temporarily install the window switch and lower the rear door window <1> until the expanding pin <3> and spreader plug <4> are accessible through the opening in the subframe <2>.
- Remove the expanding pin <3> from the spreader plug <4> using the Release Tool -T10615-.
- Remove the spreader plug <4> from the window regulator guide <6> using the Release Tool - T10615-.
- Push the rear door window upward and secure it from falling using adhesive tape.

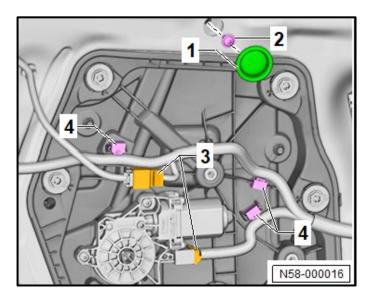
- Pry out the plugs <1>.
- Remove the bolt <2>.
- Disconnect the connectors <3>.
- Loosen the clips <4> and move the wires to the side.

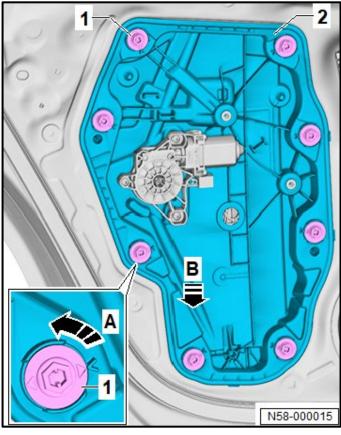
- Turn the clips <1> 90° in the direction of <arrow A> and pull them out slightly.
- Remove the door components carrier <2> in the direction of <arrow B> out of the door.

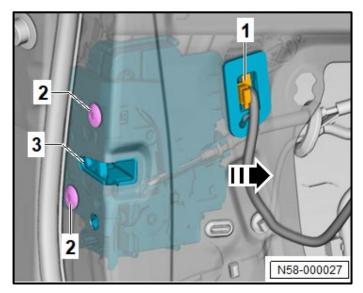
- Disconnect the connector <1>.
- Remove the bolts <2> and lower the rear Door Lock Unit <3> downward.

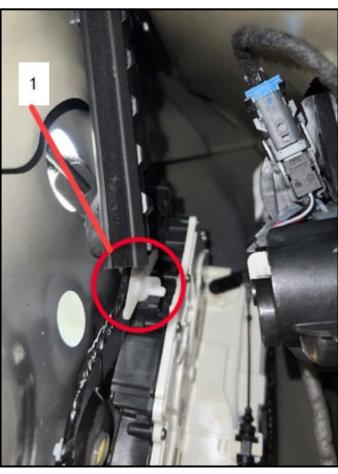
The door cable connection <1> can be unlocked to aid in lowering the door lock. The cable does not have to be completely removed, only unlocked so it can move freely.

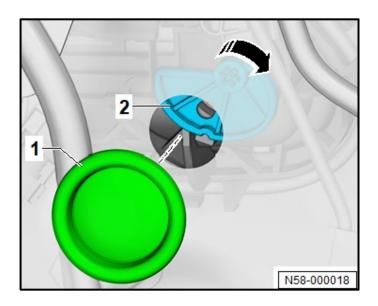
• Pry out the plug <1>.

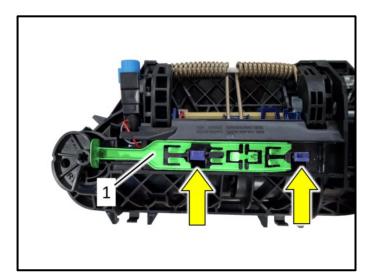
Once the locking plate <1> is in the unlocked position (as shown), the pins <arrows> on the door handle will be released.

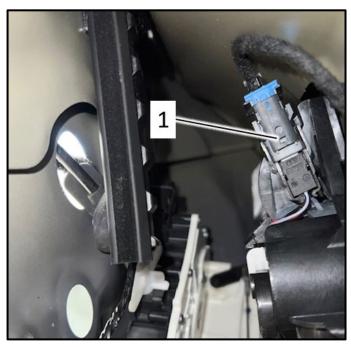
Disconnect the connector <1> from the door handle assembly.

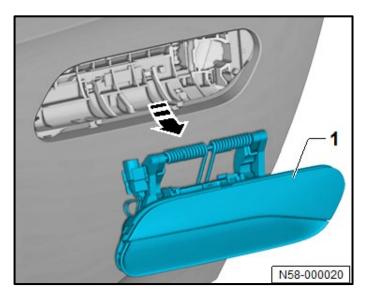
• Pivot out the door handle assembly <1> in the direction of <arrow> and remove.

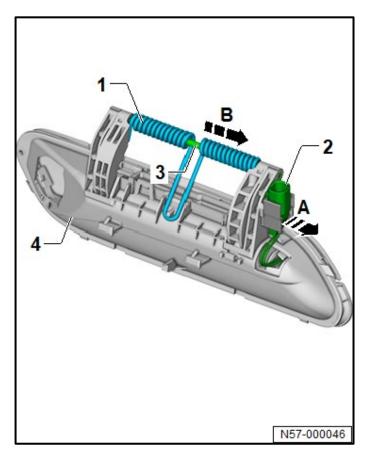
- Disengage the connector for the exterior door handle illumination and exterior door handle touch sensor <2> in the direction of <arrow A>.
- Note the installation position of the spring.
- Drive out the pin <3> in the direction of <arrow
 B> using a Drift Punch and remove the pin.
- Remove the spring <1> from the door handle <4>.

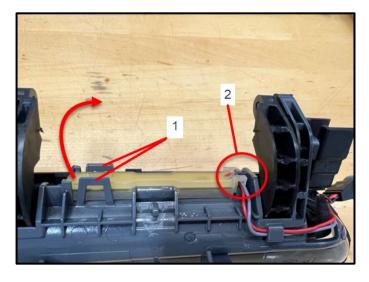
Once the tabs <1> have been released, rotate the lamp out of the retaining tab <2> in the direction indicated <arrow>.

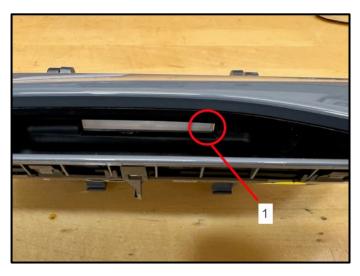
To aid in removal of the lamp, once the tabs have been released, using a few fingers, push on the lamp from inside the handle in the area shown <1>.

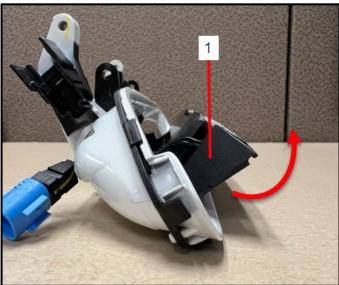
- Carefully rotate the door handle <1> out in the direction indicated <arrow>.
- Feed the lamp and connector housing out of the carrier.

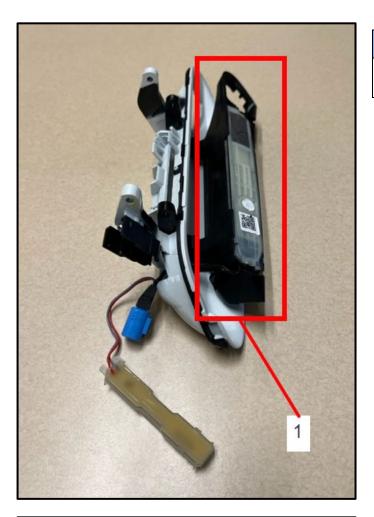
Door handle <1> shown from a different angle for clarity.

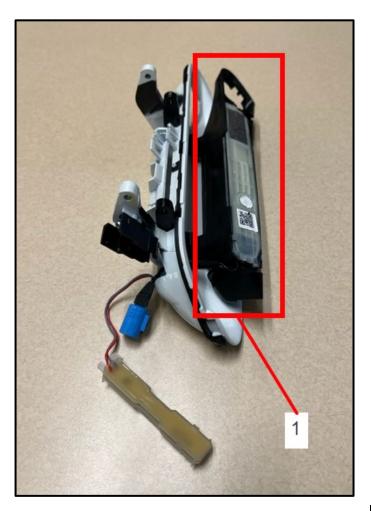
- Insert the new door handle <1> into the carrier in the reverse order of removal.
- Install the connector and lamp back into their retainers in the carrier.

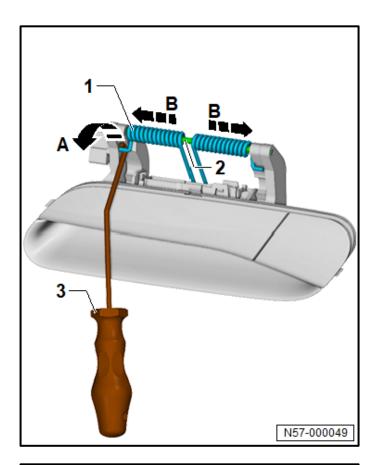
- Turn the spring <1> 90° in direction of <arrow
 A> using the Assembly Tool -T10118- <3>,
 until the hook engages in the mount.
- Push apart the spring <1> in the center area
 2> in the direction of <arrow B>.

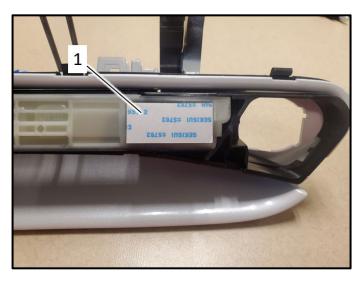
- Using isopropyl alcohol and a lint free cloth, clean the area <1> where the foam tape was.
- Ensure no residue remains.
- Allow the cleaner to dry completely.

<u>Front door handles only</u>: Remove the adhesive backing from the foam pad <1>.

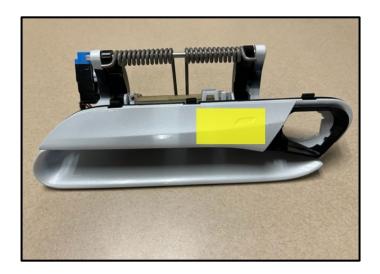
- Reinstall the door handle cover.
- Ensure it's fully clipped into place.
- <u>Front door handles only:</u> Press firmly in the area shown to adhere the foam pad to door handle cover.
