**September 29, 2023**

Version 4

## Safety Recall: 2007–11 CR-V Rear Frame Brace

Supersedes 23-032, dated May 16, 2023, to revise the information highlighted in yellow

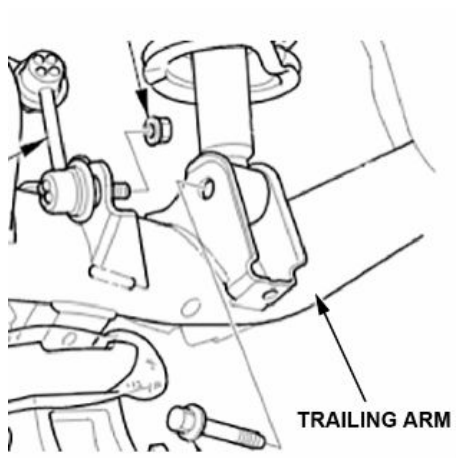
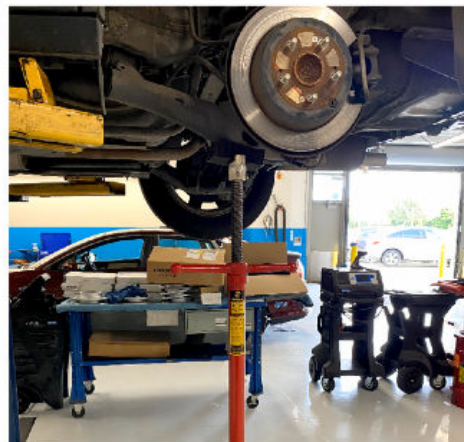
7. Using an impact gun, attempt to remove the trailing arm front mounting bolt.

YES - If successfully able to remove the trailing arm front mounting bolt, reinstall and torque the trailing arm bolt to **115 N·m (84.6 lb-ft)** and continue to the repair procedure.

NO - If the trailing arm front mounting bolt spins freely without being removed or the bolt does not loosen, re-install the wheels and inform your Service Manager and/or Shop Foreman. The vehicle is not eligible for repair and the Trailing Arm Holder kit cannot be installed on the vehicle.

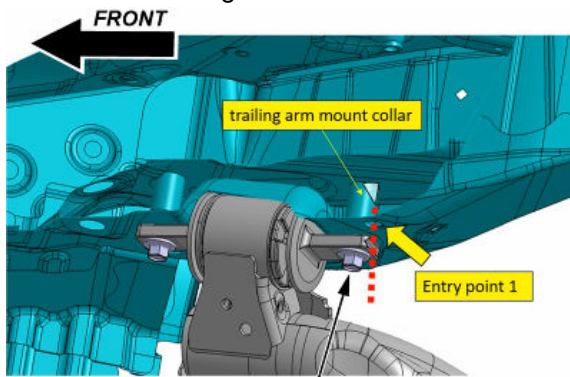
**REAR BOLT AND COLLAR**

Photo of the trailing arm mount collar.

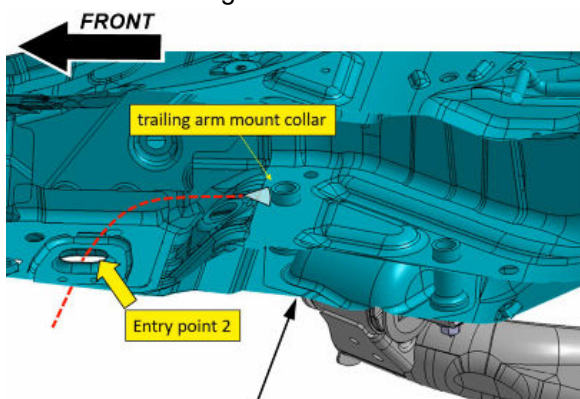
**FRONT BOLT AND COLLAR**

Photo of the trailing arm mount nut.

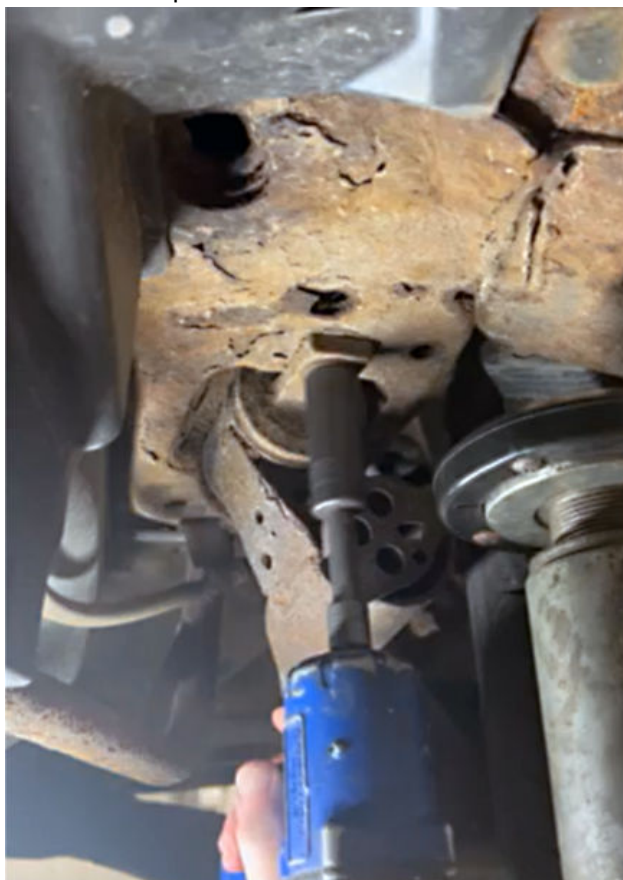
**EXAMPLE OF TRAILING ARM COLLAR FRONT MOUNT**

For trailing arm front bolts that spin, take a 3 second video clip showing the trailing arm front bolt spinning. Video should be 720p resolution and under 20Mb in size.

NOTE: Video clip, VIN and odometer photos will need to be emailed to [techline@ahm.honda.com](mailto:techline@ahm.honda.com), and include "23-032 and VIN XXXX" in the subject line to provide the VIN number of the vehicle.

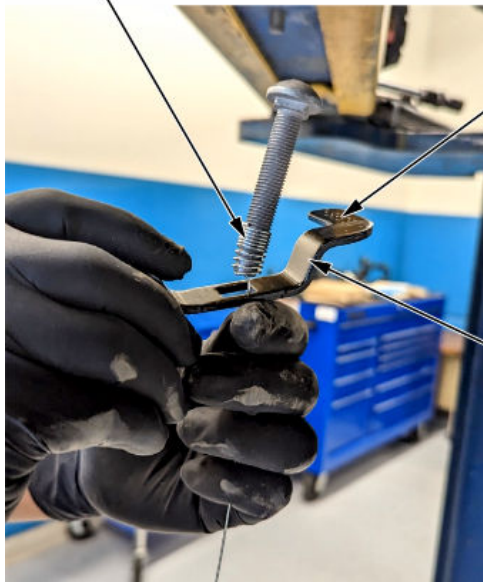
**BOLT GUIDE WIRE**

1. From the trailing arm holder kit, install the bolt guide wire around the threads of the 10x62 bolt. Then, insert into the frame insert washer.

NOTE: Make sure the engraving THIS SIDE UP on the washer is facing up.

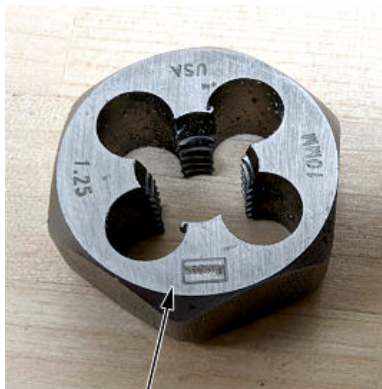
**10mm x 1.25  
MACHINE THREAD DIE**

NOTE: Due to an excessive layer of protected zinc (galvanized bolt), the **10mm** nut is difficult to hand tighten. Before installing the guide wire clean the bolt threads. Use a **10mm x 1.25mm** machine thread die or, if a tool is not available, use a socket or wrench to move the **10mm** nut up and down the bolt (10x62) until the bolt and nut can be hand-tightened.

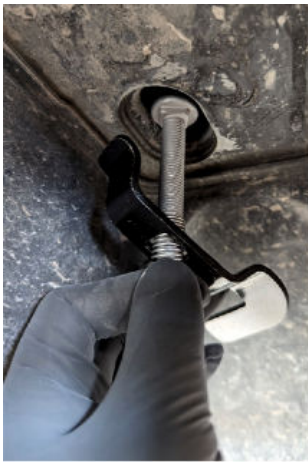
2. Insert the assembled bolt with guide wire and frame insert washer into the underbody opening.

Insert the head of the bolt through the drain hole.

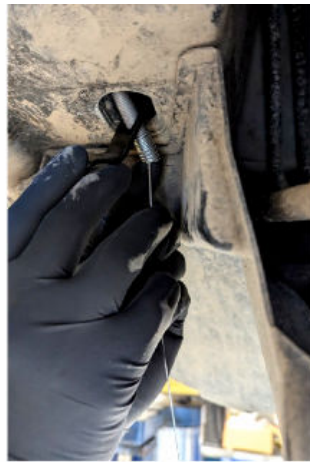
Keep one hand on the guide wire while using the other hand to push the frame insert washer through the drain hole.

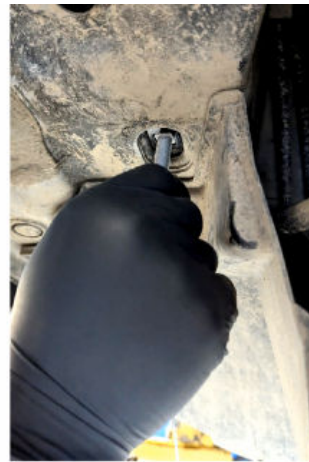
Align the squares of the bolt and the frame insert washer. (Keep bolt guide connected to the bolt.)

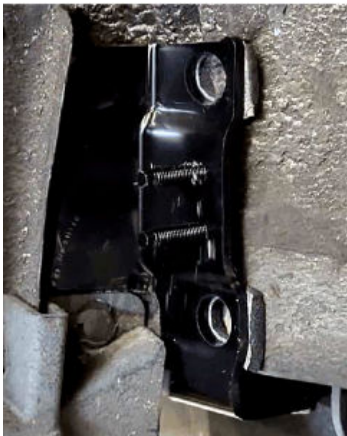
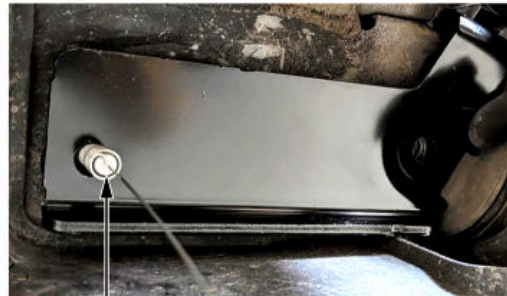
**WHEEL WELL VIEW**

3. Line up the brace.

Bolt guide wire and bolt will be seen here.

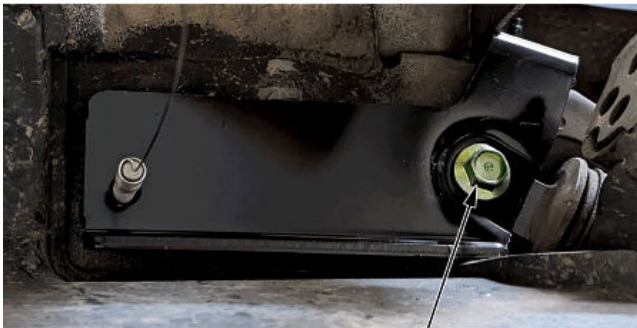
4. Loosely install the rear trailing arm front mounting bolt (do not torque to spec).

**REAR TRAILING ARM  
FRONT MOUNTING BOLT**  
Do not torque to specification.

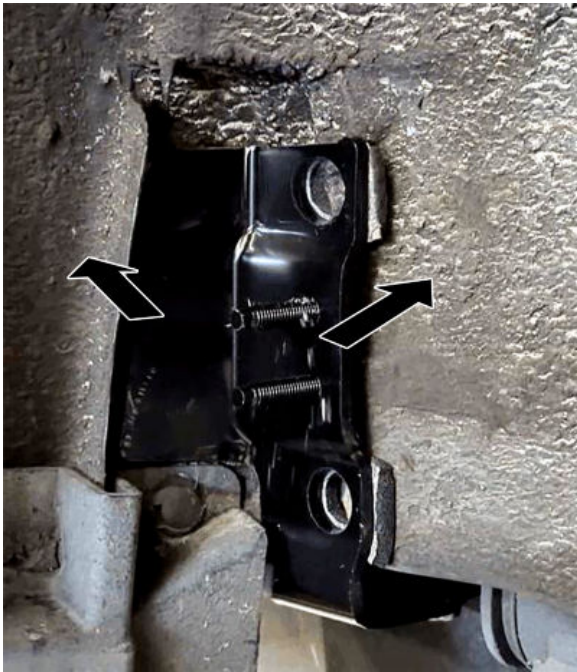
6. Before tightening the underbody bolts, make sure that the brace is sitting flush against the wheel well in both directions as shown below.

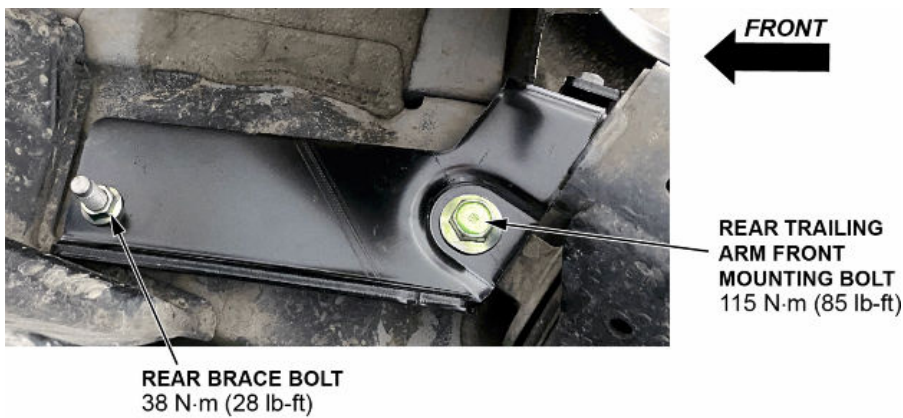
7. Once the brace is positioned against the wheel well, torque the rear trailing arm front mounting bolt to **115 N·m (85 lb-ft)** first, then torque the rear brace bolt to **38 N·m (28 lb-ft)**.

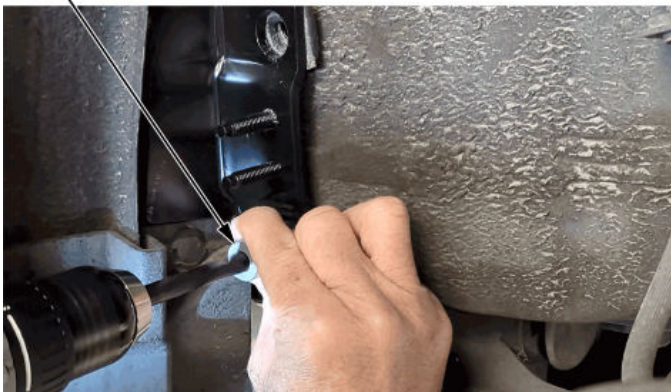
**DRILL GUIDE**

8. From the wheel well side, place the drill guide into one of the brace openings and use the **3/8 bit** to drill into the wheel-well body. Drill both holes.
  - Use a vacuum to remove any metal shavings.
  - Apply touch-up paint around both drilled holes to prevent any new corrosion to the body.

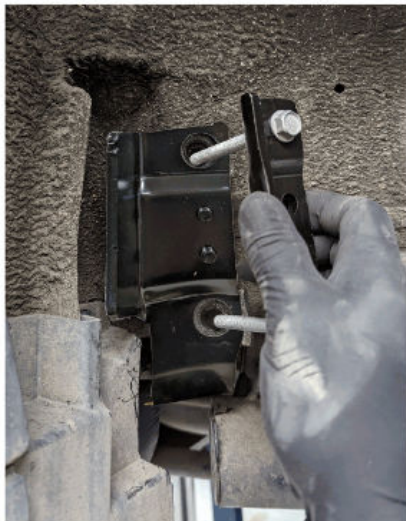
9. Align the support bracket with the two bolts from the brace and place into the body. Then install the two **8mm nuts**, and torque them to **21 N.m (15.5 lb-ft)**.

Align bracket with flange facing towards the front of the vehicle, over the two brace studs, then install the two bracket bolts.
