Safety Recall: 2023 Civic Type R Driver's Seat Cushion Frame

Supersedes 23-030, dated March 31, 2023.

During manufacturing, the driver seat cushion frame assembly may have been improperly welded. An improperly welded seat frame may not hold the seat in position. In the event of a collision, the seat may not properly restrain the occupant, increasing the risk of injury.

Replace the driver's seat cushion frame.

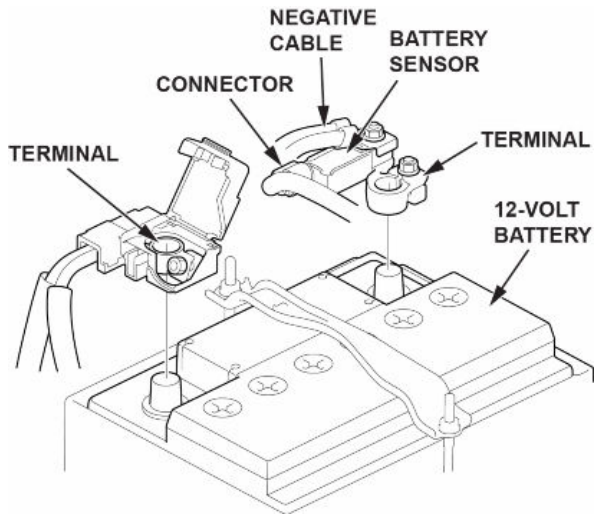
1. Raise the driver's lower seat cushion to highest position.
2. Disconnect 12-volt battery negative terminal.

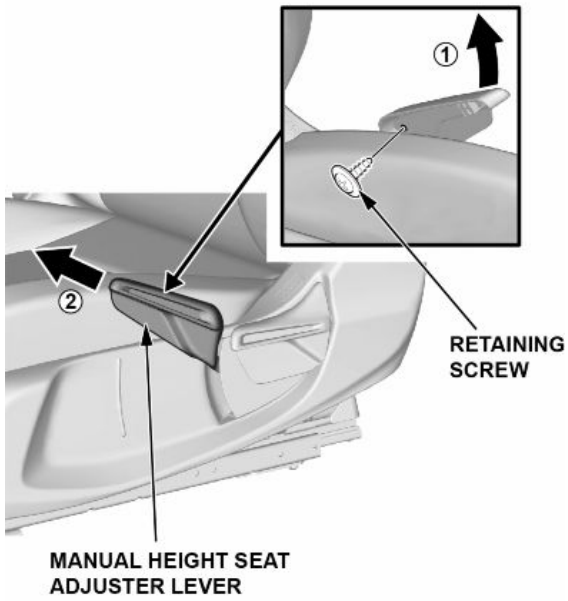
3. Remove the retaining screw for the manual height adjuster lever.

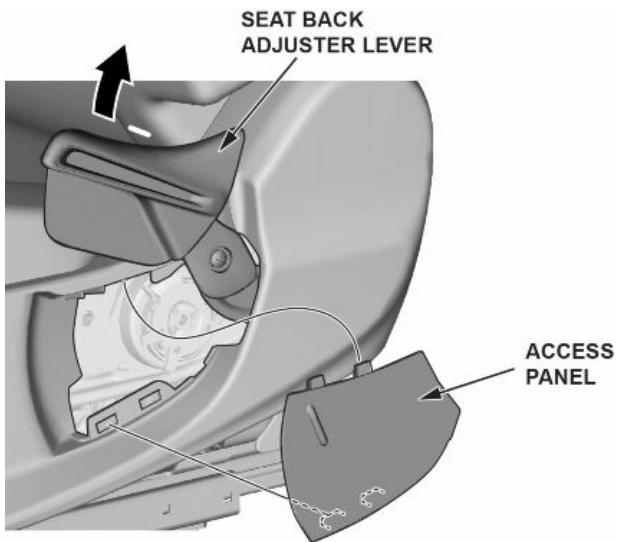
4. With the seat back adjuster lever raised, remove the access panel and pull the front and rear cover to disconnect the clips and locking tabs.

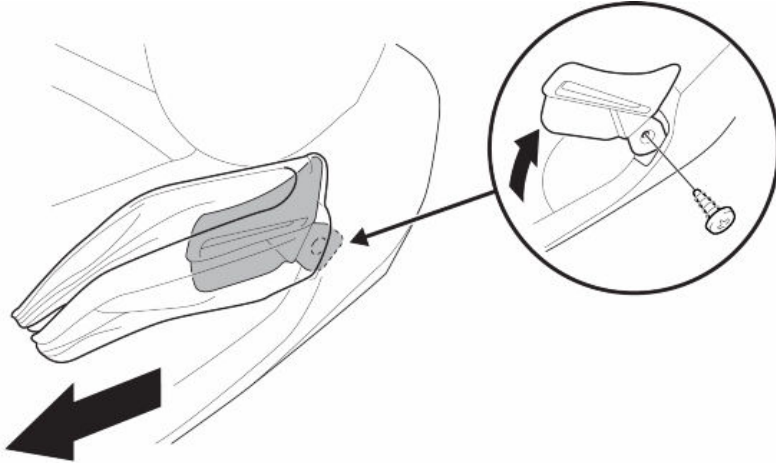
5. Remove the seat back adjuster lever.

NOTE: Using a shop towel wrapped around the lever, grab each end of the towel and pull the towel hard to remove the lever cover.

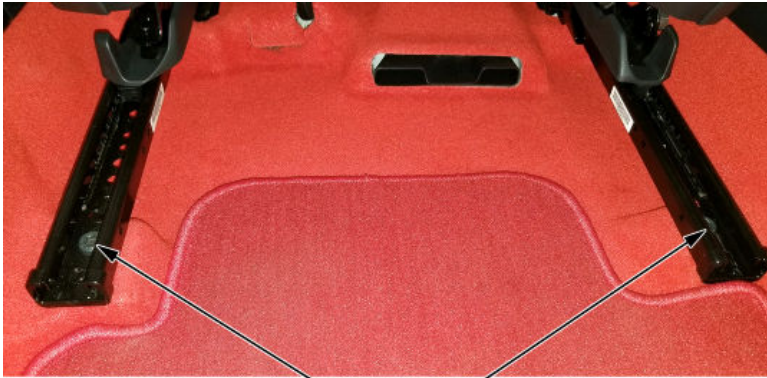
RAIL BOLTS

6. Adjust the front driver's seat to the most forward position until the rail bolts are fully visible, then remove the bolts. Use TORX Plus Socket Driver 50IP.

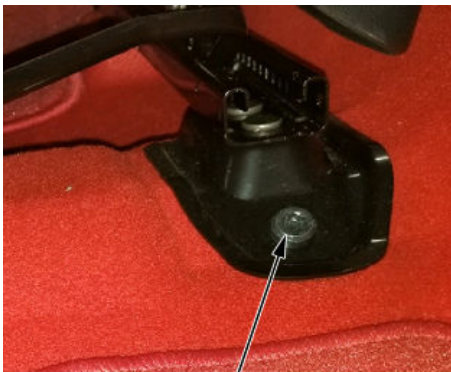
RAIL BOLTS

7. Adjust the front driver's seat to the most rearward position until the rail bolts are fully visible, then remove the bolts. Use TORX Plus Socket Driver 50IP.

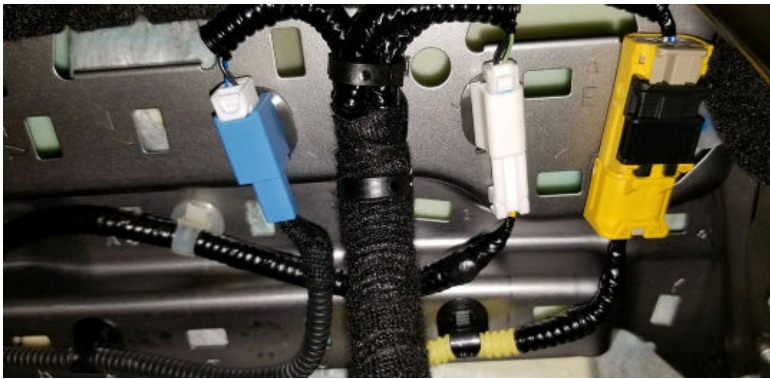
8. Carefully and slowly tilt back the seat assembly to expose the harness and connectors.

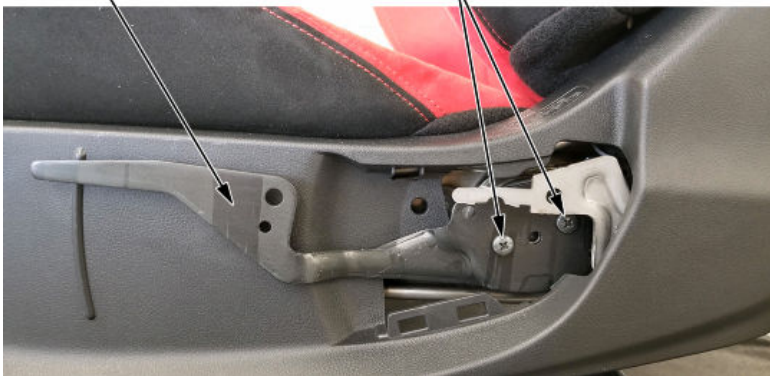
**HEIGHT
ADJUSTMENT
LEVER**

11. Remove the two screws and remove the height adjuster lever.

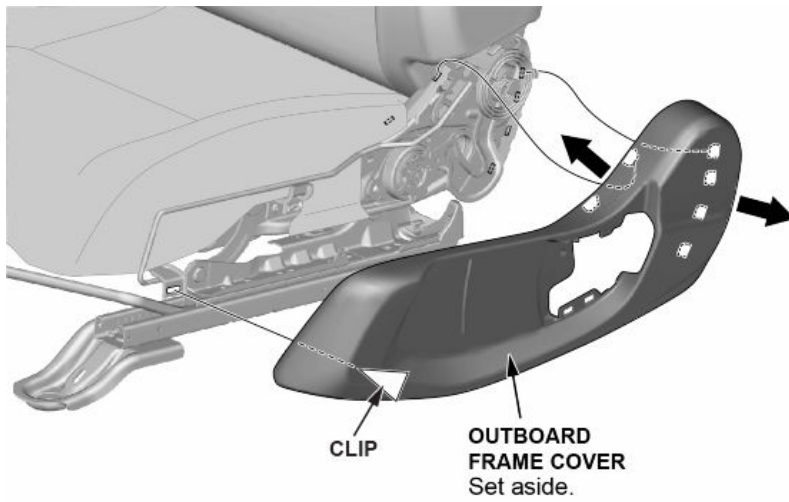
12. Remove the outboard frame cover.

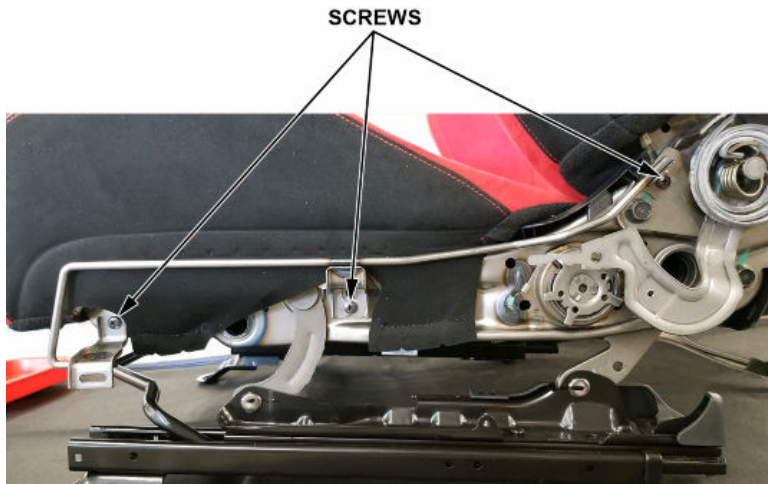
13. Remove the three 5x10 screws holding the driver's seat anchor wire to the seat frame.

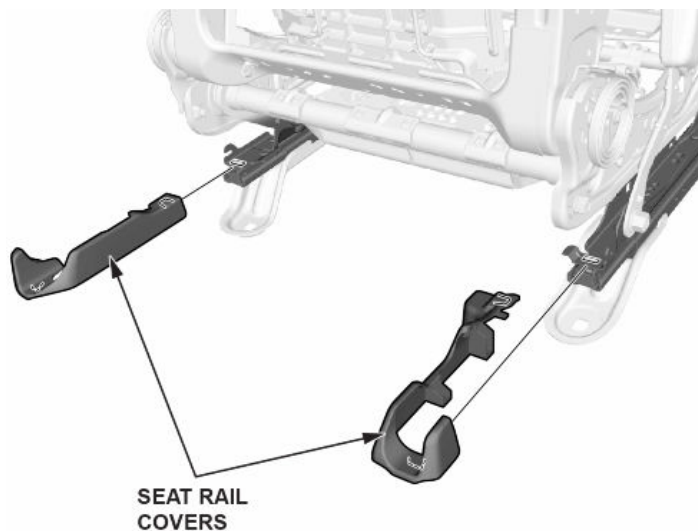
15. Remove the inner and outer seat rail covers.

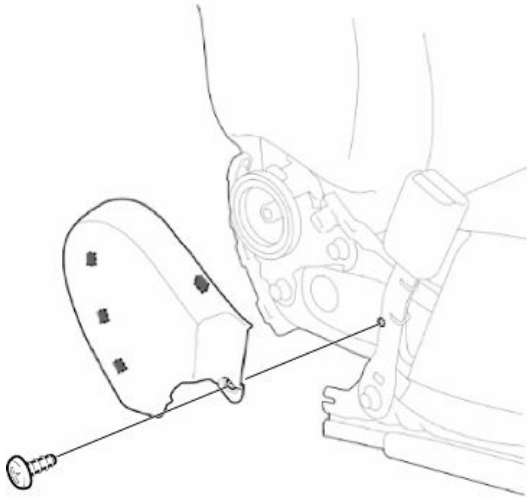
16. Remove the inboard seat recline cover.

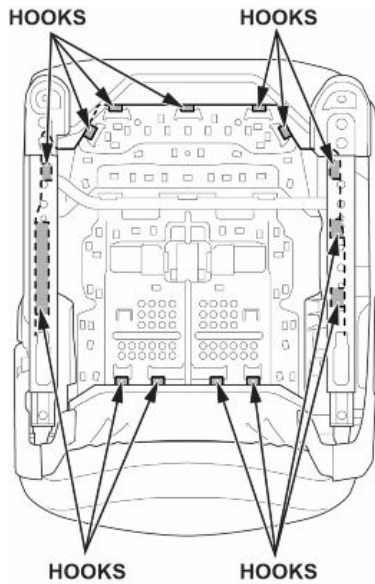
18. Release the hooks securing the pad and seat cover to the lower seat frame, remove and set aside.

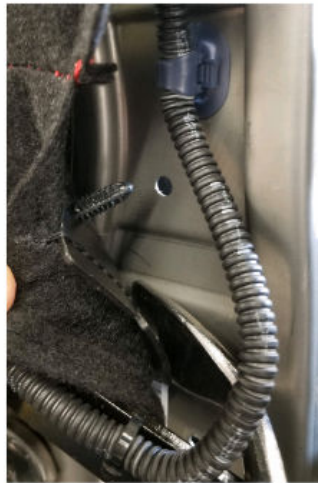
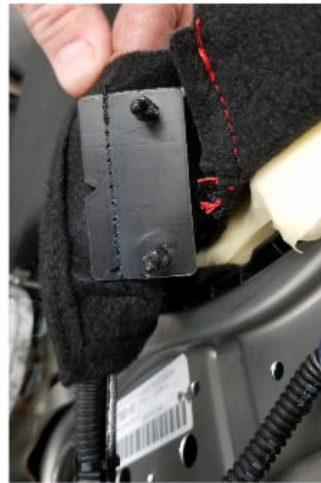
Additional seat trim fastening location.

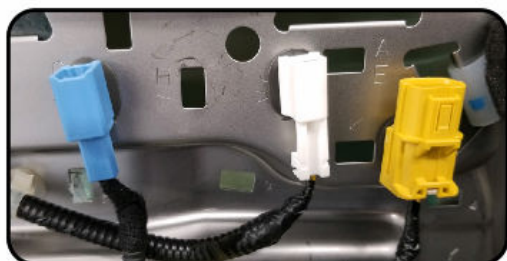
19. With the pad and cover released from the frame, work from the top side and push out the clips holding the harness to the seat pan, making note of their location and routing orientation.

NOTE: Pushing the clips from the top of the pan while squeezing them will reduce damage.

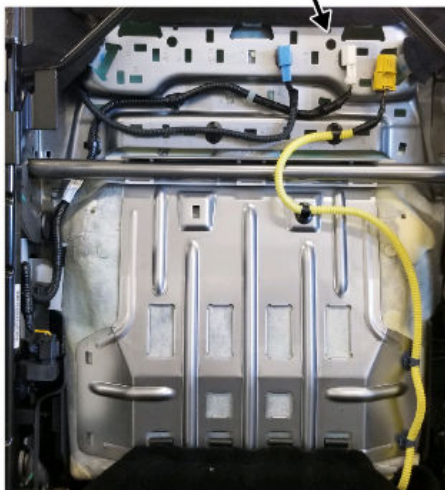
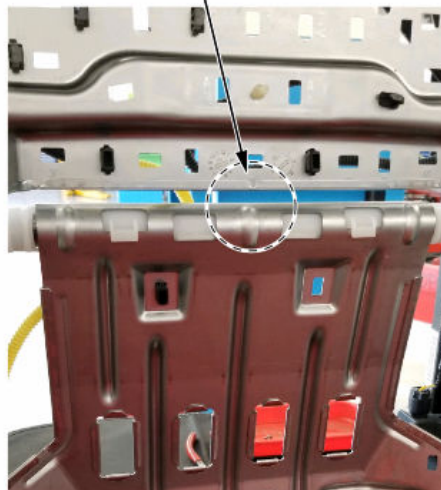
During reinstallation, make note of alignment markings.

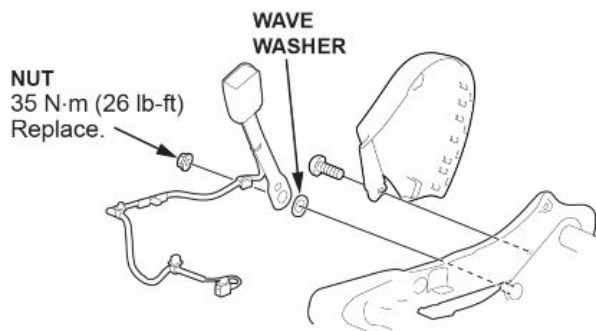
20. Remove the front seat belt buckle and make note of the wave washer location.

NOTE: Upon replacement of the buckle, replace the 7/16" flange nut and torque to 35 N·m (26 lb-ft).

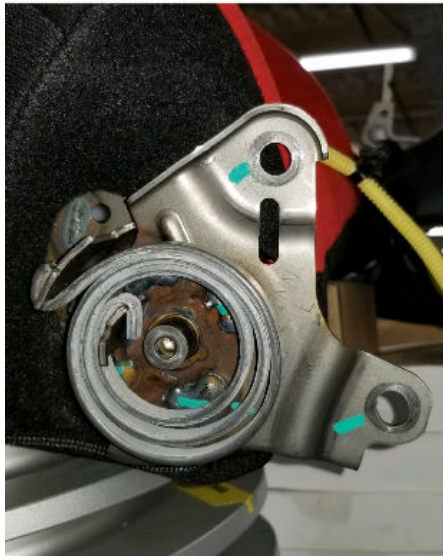
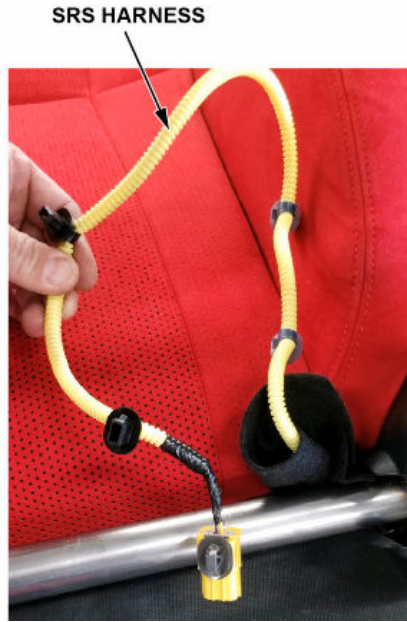
21. Remove the four 10x16 flange bolts to separate the lower frame from the seat back frame. When reassembling torque bolts to **47 N·m (35 lb-ft)**. After releasing the SRS (yellow) harness from the lower pan, carefully move the harness away from the lower seat frame.

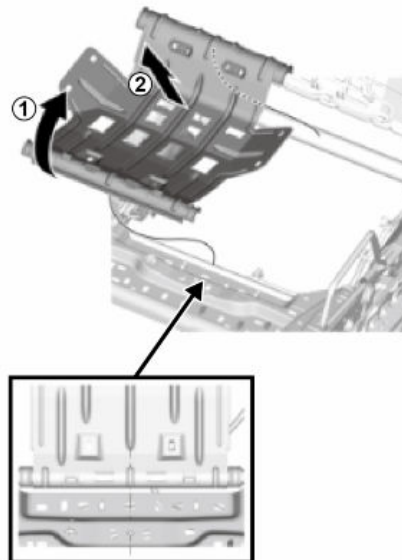
22. Remove the seat cushion spring and reinstall to the new frame.
NOTE: Take care while performing this task as many sharp exposed edges exist.

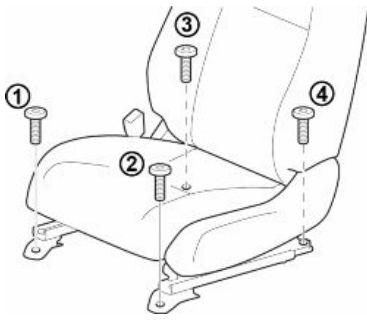
24. Torque the front and rear seat mounting bolts in sequence to **43 N·m (32 lb-ft)**.

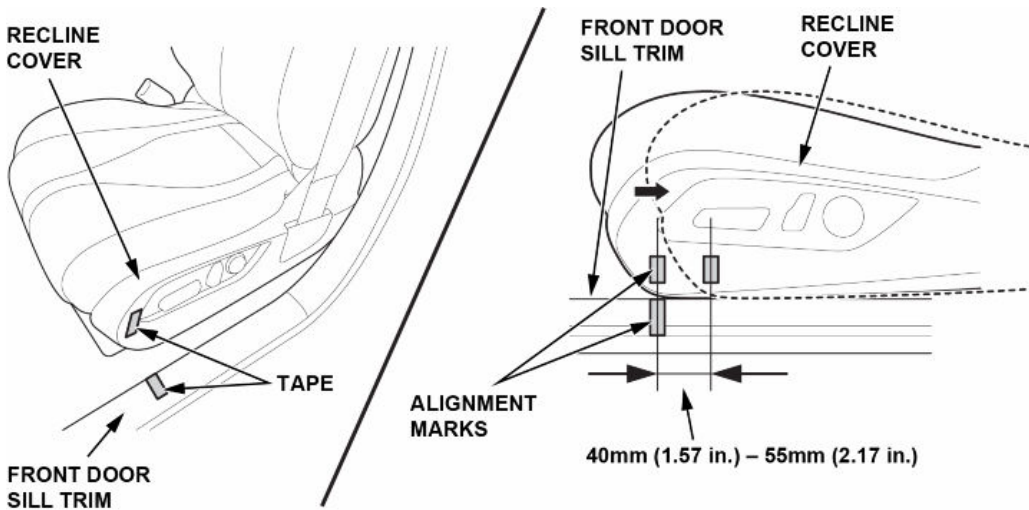
26.3. Using two pieces of tape, make alignment marks on the recline cover and the front door sill trim as shown. The driver's seat position sensor should read **NEAR** on the HDS.

26.4. Move the seat back in small increments (**about 5mm (0.20 in)**) until the driver's seat position sensor reads **NOT-NEAR** on the HDS. The measurement should be about **55mm (2.017 in)** from the full forward position.

NOTE: It takes a few seconds for the HDS to change display, so wait for about **5 seconds** between each movement. If the driver's seat position sensor data does not work as described above, check the driver's seat position sensor for damage and replace parts as needed.
