# VOLUNTARY RECALL CAMPAIGN

Classification: BT23-004	Reference: NTB23-033	Date: April 13, 2023
-----------------------------	-------------------------	-------------------------

## VOLUNTARY SAFETY RECALL CAMPAIGN 2023 PATHFINDER AND 2023 ROGUE; DRIVER'S SEAT RAIL INSPECTION

**CAMPAIGN ID #:** PC966  
**APPLIED VEHICLES:** 2023 Pathfinder (R53)  
2023 Rogue (T33)

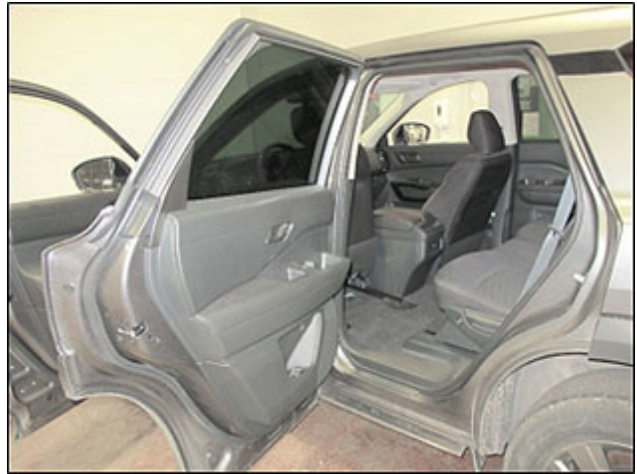
Figure 4

4. Open the driver (LH) rear door.
