Safety Recall 5823D – 2022-2023 CX-30 and 2023 CX-50 Brake Pedal Travel May Increase

A. VEHICLE INSPECTION PROCEDURE – AND PREPARE FOR REPAIR

C. REPAIR PROCEDURE – CX-30 ONLY

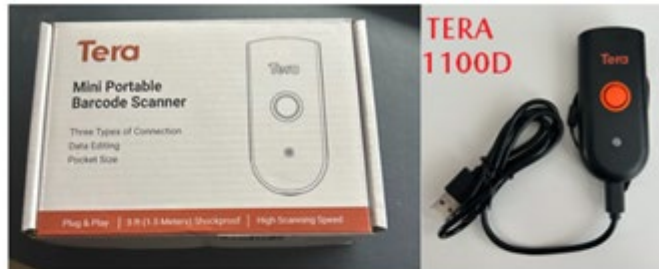
Use the Scan Tool with the black cable only, please do not use the “Bluetooth” dongle in the SST Scan Tool box as it does not work (red X in the box photo).

EY-015P. ONLY USE THE USB CABLE. DO NOT USE THE USB DONGLE TO SCAN

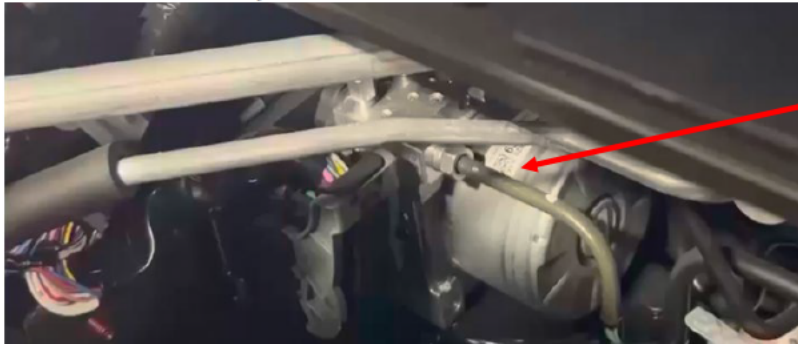
- With the hood raised, place the Laptop on the Engine Cover with the USB Scan Tool Connected. Locate the ABS Unit (DSC HCU) under the rear LH side engine bay. You will need to scan the QR Code on the ABS Unit.

- Place the cursor in the "ABS HCU SERIAL NUMBER" Field. Using the Barcode Scanner, Press and Hold the Orange button and scan the QR Code on the ABS Unit (DSC HCU). [Click Here to see a VIDEO on how to scan the QR Code "Video to Scan QR Code. This VIDEO is also available in MGSS under the 5823D Documents.](#)
