Technical Service Bulletin	GROUP	NUMBER
	RECALL	23-01-053G-1
	DATE	MODEL(S)
	JULY 2023	GV60 (JW1)
SUBJECT:	REAR INTEGRATED DRIVE AXLE (IDA) SHAFT REPLACEMENT (RECALL CAMPAIGN 014G)

Description: Certain GV60 (JW1) vehicles are equipped with all-wheel drive powertrain systems containing rear driveshafts that could potentially fracture due to abnormal stress incurred by improper jig alignment during manufacturing. A fractured driveshaft could result in a sudden reduction of motive power, increasing the risk of a crash. This bulletin describes the procedure to replace the rear driveshafts with a revised part.

**SUBJECT: REAR INTEGRATED DRIVE AXLE (IDA) SHAFT REPLACEMENT
(RECALL CAMPAIGN 014G)**

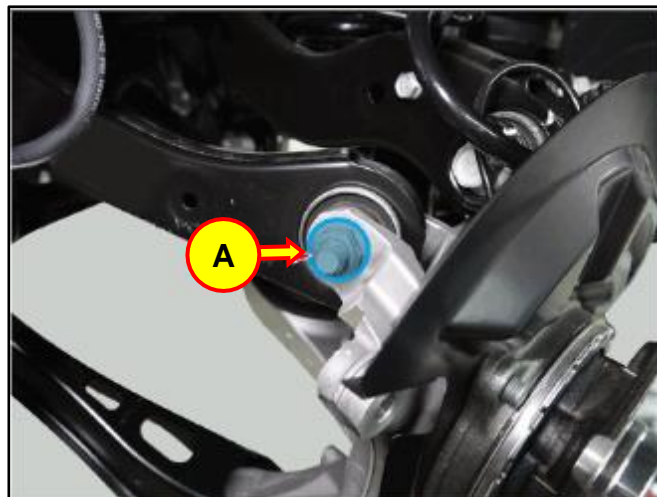
3. Separate the rear upper arm front from the rear carrier after removing the bolt and nut (A) on both sides of the vehicle.

Rear Arm to Carrier Tightening Torque

lb-ft	123
N.m	167

- Use a transmission jack to lift the rear carrier to prevent the bolt and nut from damage when removing and installing.
- Ensure the bolts are reinstalled without binding to properly torque the nut.

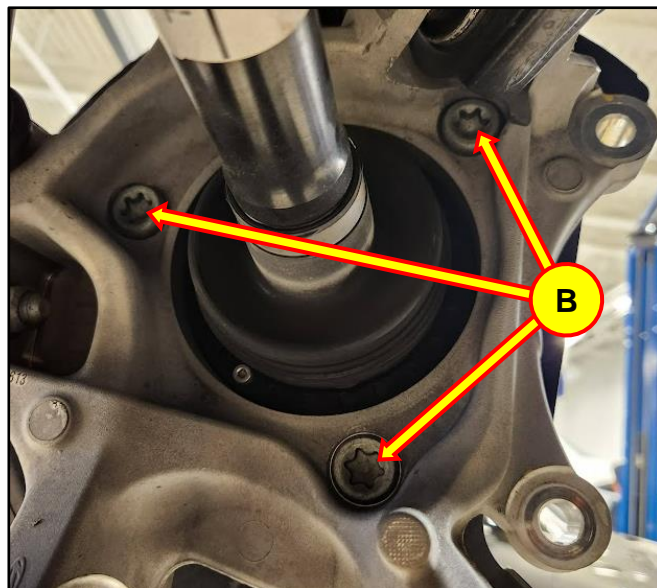
4. Remove the rear carrier mounting bolts (B) on both sides of the vehicle.

Rear Carrier Tightening Torque

lb-ft	102
N.m	138

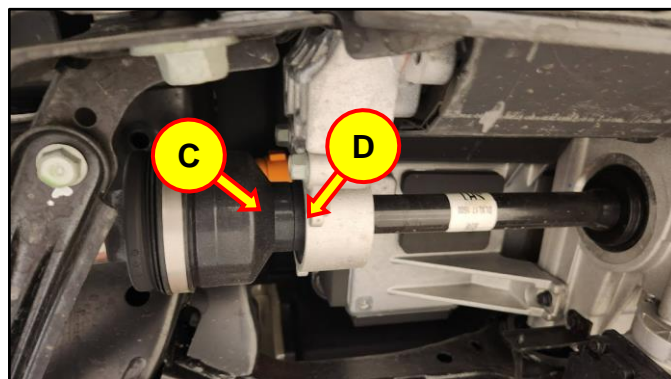
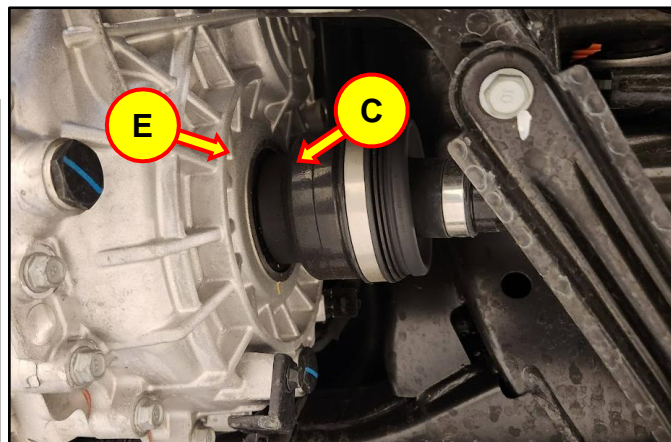
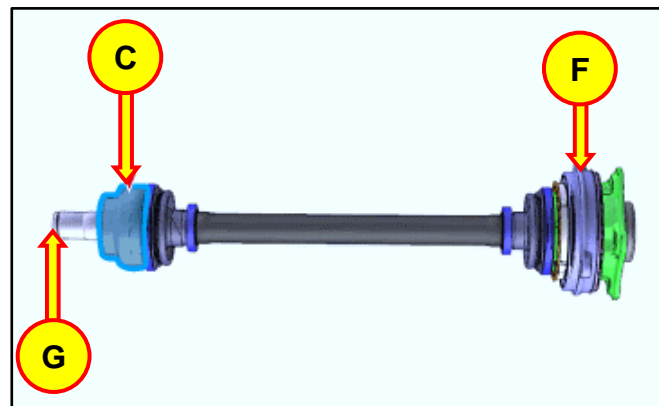
5. Remove both IDAs and place on a work bench.

Left Side IDA

Insert a pry bar between the IDA inner joint cup (C) and the bearing support bracket (D), then carefully pry the joint cup to separate it from the bearing.

Right Side IDA

Insert a pry bar between the IDA inner joint cup (C) and the reduction gear case (E), then carefully pry the joint cup to separate it from the reduction gear.

- Do not pull the wheel side axle joint (F), or shaft when removing IDA. Damage to the inside of the reduction gear or IDA joint may occur.
- Pull from the inner joint cup (C) to remove it from the bearing or reduction gear case.
- When carrying the IDA, hold the shaft or both joints.
- Do not insert the pry bar too deep, as this may damage the oil seal.
- Do not use excessive force to remove the IDA.
- After removing the IDA, cover the hole of the reduction gear to prevent contamination.
- Remove the circlip (G) on the inner side spline of the right IDA. Use the new circlip provided in the kit during reassembly.

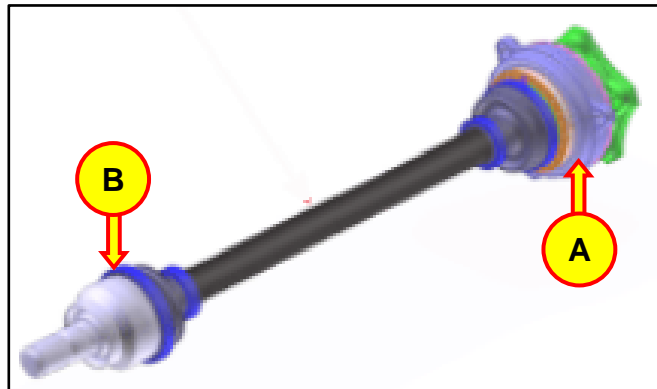
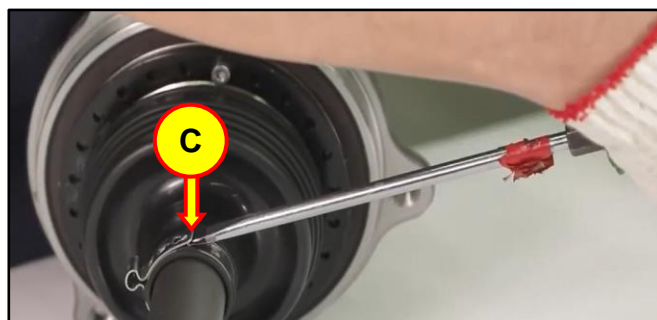
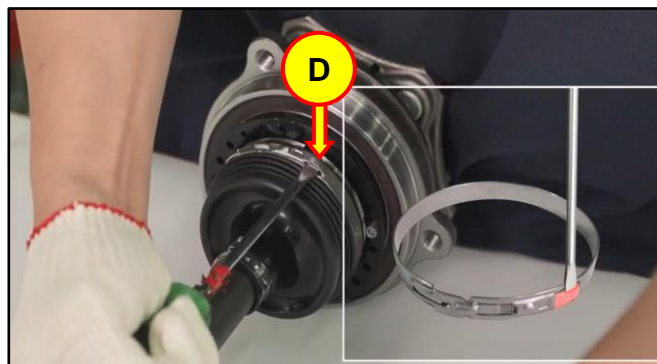
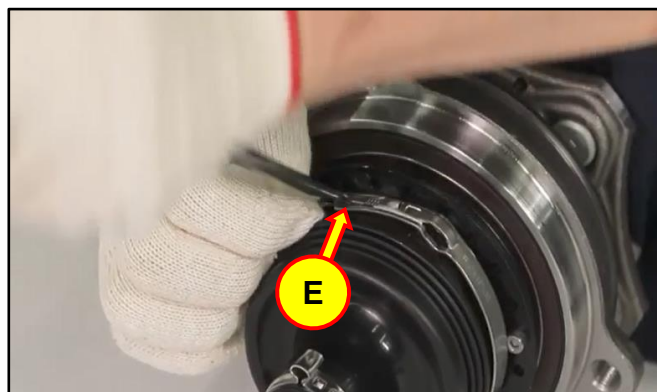
2. Starting from either end of the IDA, remove the small and large boot bands by using a flat-blade screwdriver and pry the bands at the locations shown (C), (D), and (E).

To help pry the bands apart, insert the flat-blade screwdriver into the band as shown and then hit the handle end of the driver with a mallet.

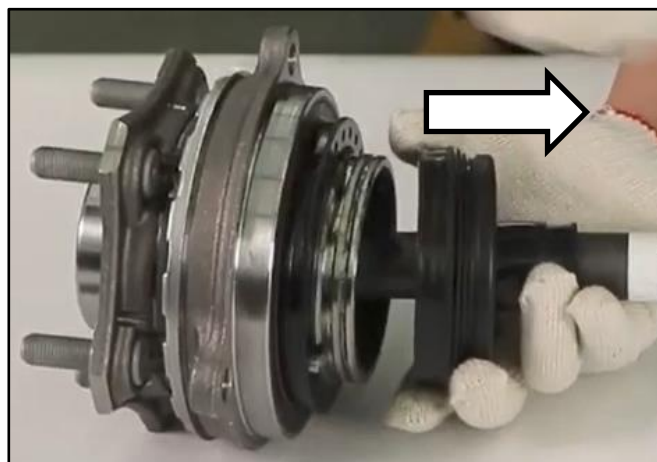
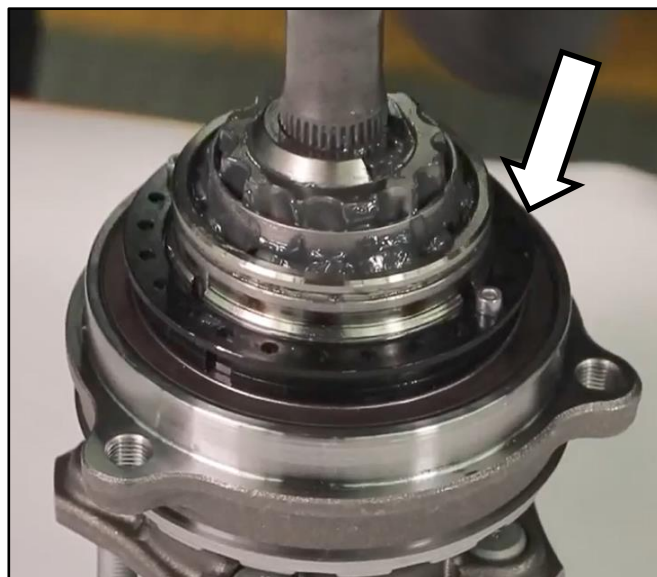
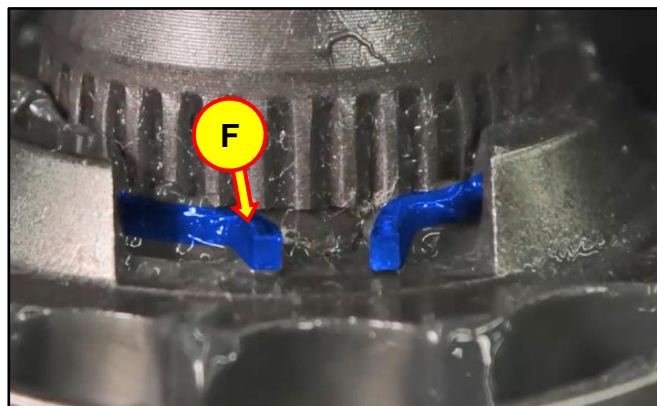
3. Slide the boot off of the joint and down the shaft.
4. Then use a clean cloth to remove as much grease as possible from within the joint to locate and remove the snap ring.
5. Using a rubber mallet, gently tap the joint downward to place the snap ring (F) against the groove.

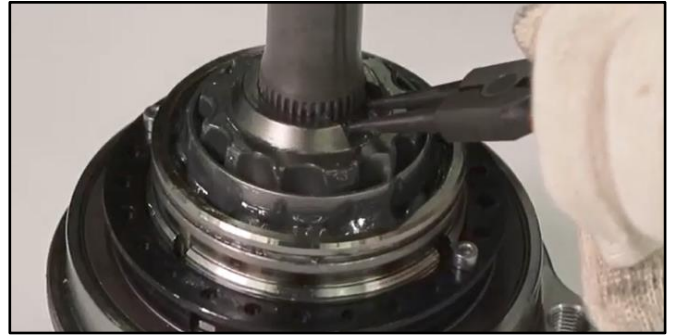
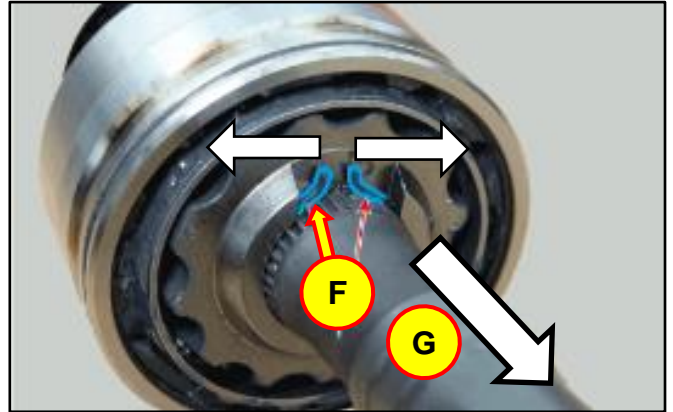
6. Use snap ring pliers to open the snap ring (F). If the snap ring is in position in the groove, the snap ring will stay open. Then pull or gently tap the joint until the shaft (G) is out of the joint.

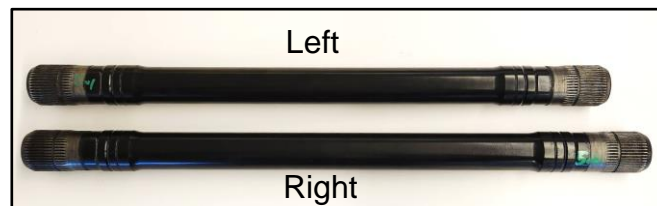
**Information****Shaft Length**

Left: 20.1in (51.1cm)

Right: 21.4in (54.3cm)

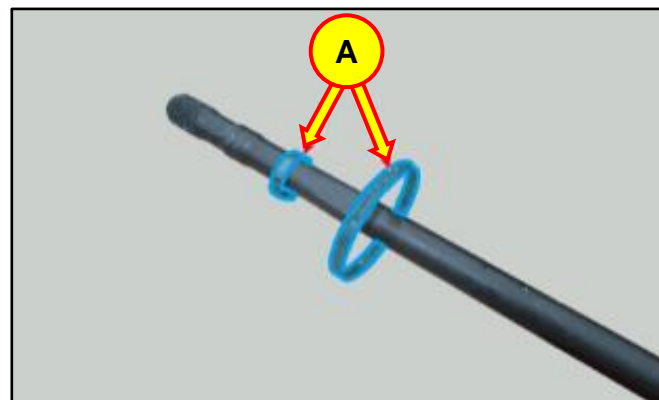
2. Slide the new small and large diameter boot bands (A) on the new shaft.

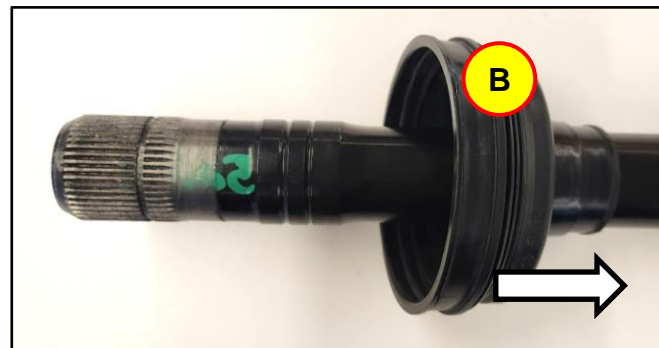
3. Slide a new boot (B) on the shaft.
Keep the interior of the boot clean.

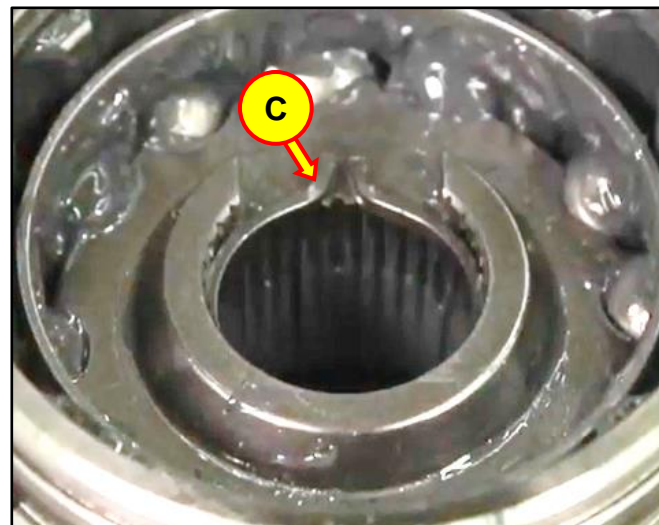
4. Place a new snap ring (C) inside the joint.

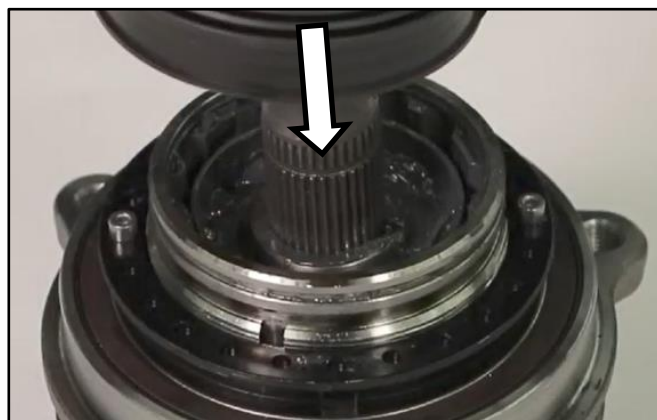
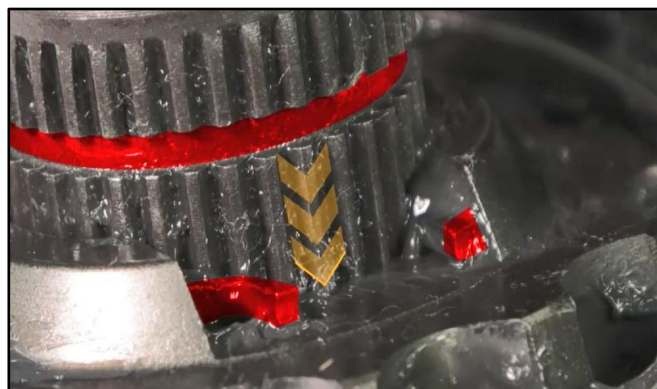
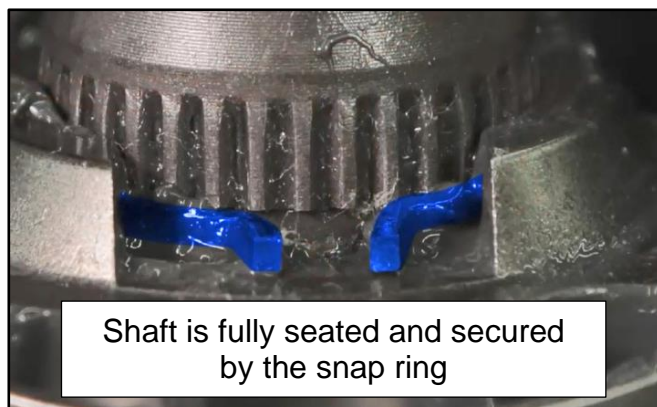
5. Insert the axle splines into the joint until the shaft is secured by the snap ring.

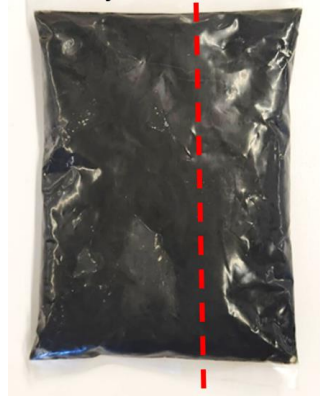
6. Use one grease packet for each joint/boot.

The IDA requires the use of the supplied grease. Do not add or use any other type of grease.

2/3rds for the joint 1/3rd for the boot

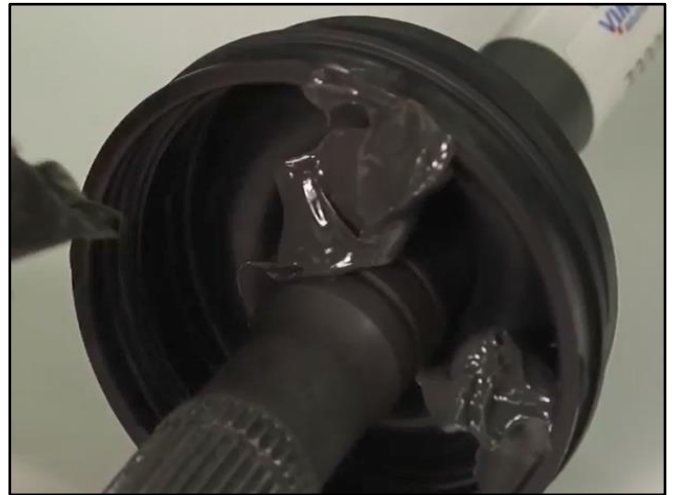
7. Apply approximately one-third of the grease inside the boot.

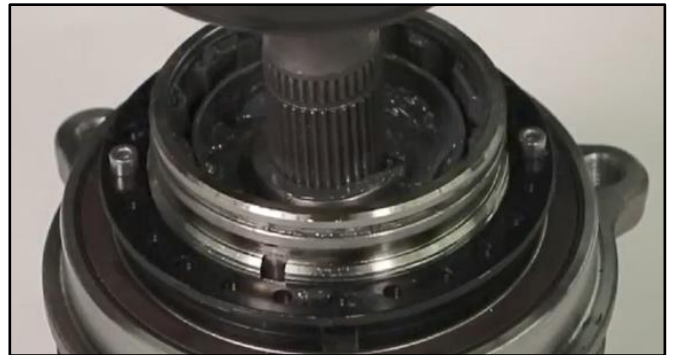
8. Apply the remaining two-thirds of the grease in the joint.

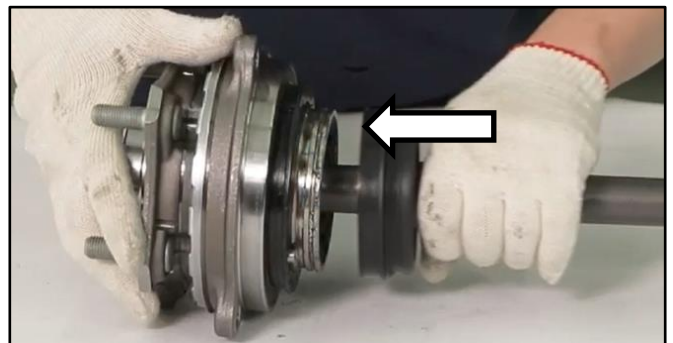
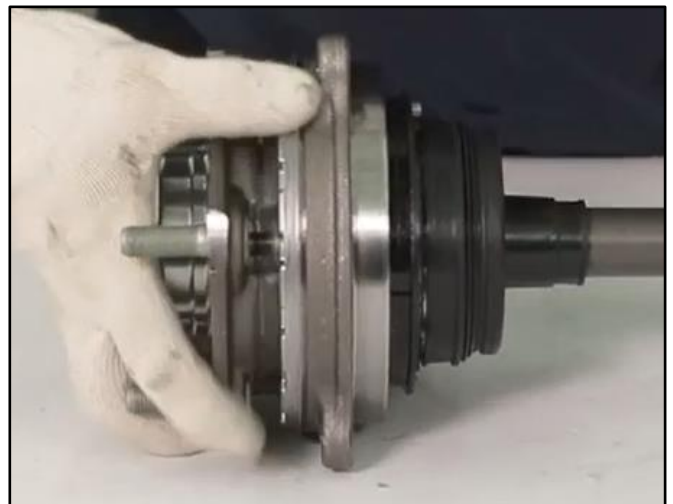
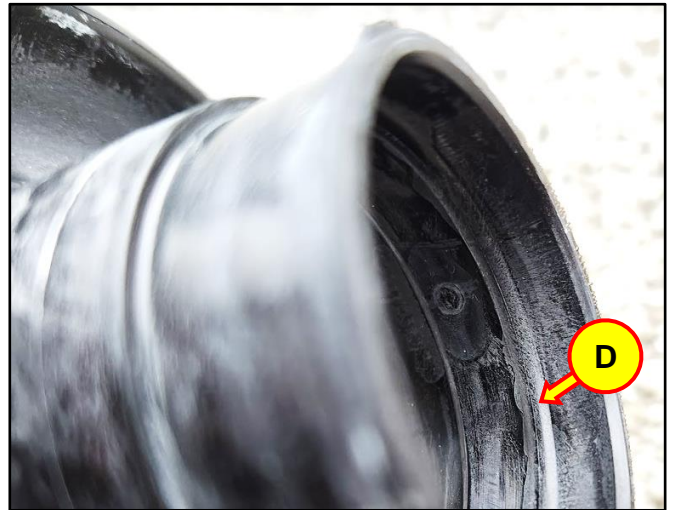
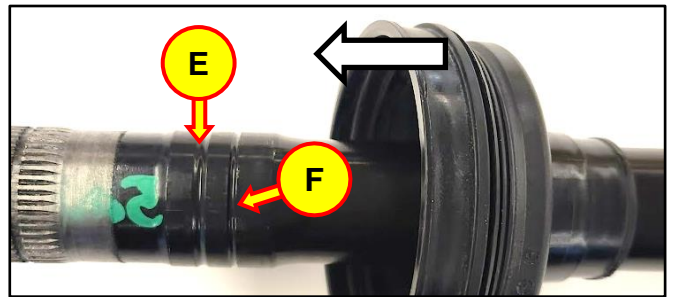
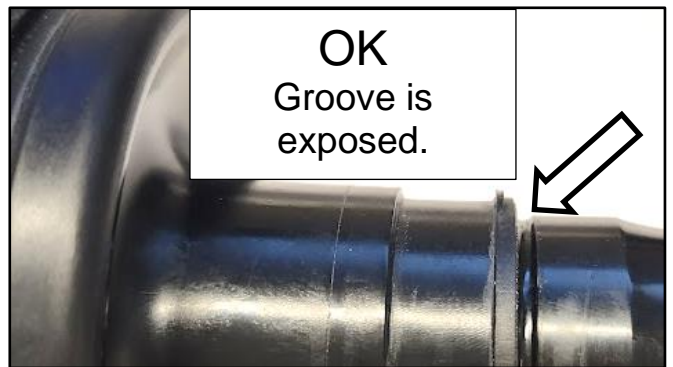
9. Install the boot onto the joint.

10. Ensure the molded ridge (D) in small end of the boot slides on to the groove that is closest to the spline end (E) when installing the boot onto the joint.

If the boot is installed correctly, the other groove (F) will be visible.

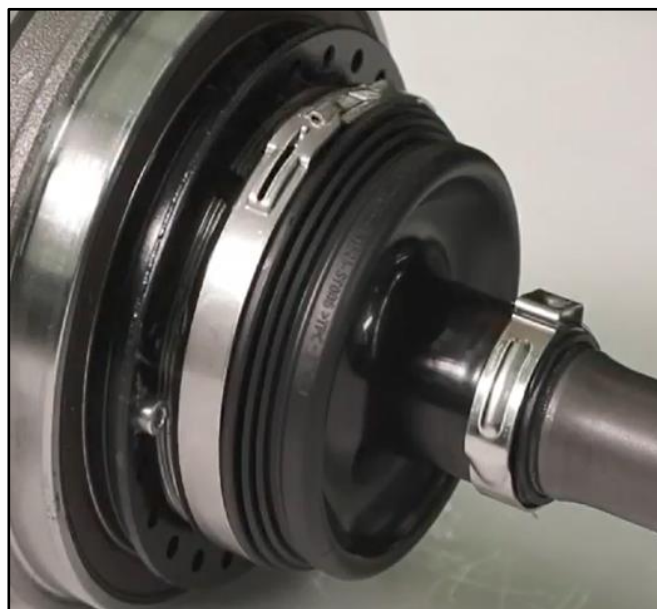
11. Clean the excess grease from the shaft and boots.
12. Place the small and large diameter bands into their respective positions.

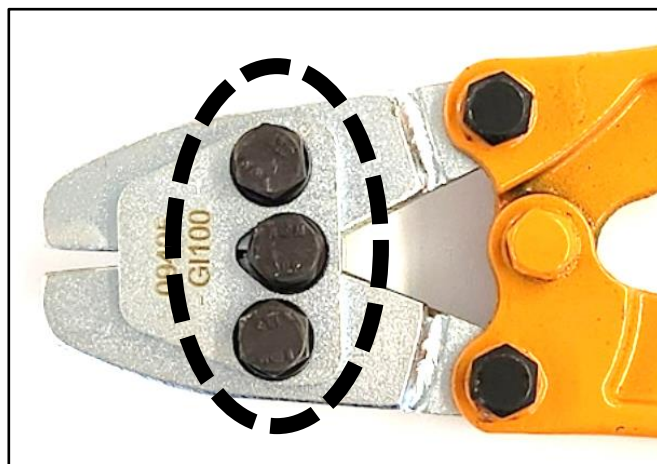
If it is difficult to open and close the tool smoothly, loosen the three bolts that are circled.

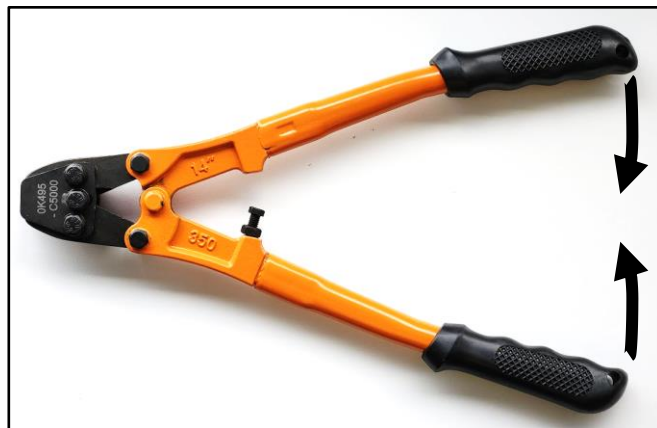
- Do not close the tool handles all the way in one motion to clamp the bands on the boot.
- Close the handles slowly and in small increments.
- Check that the bands are clamped to the specifications in steps 14 and 15.
- Over tightening the bands can damage the boot and not provide the proper sealing causing the boots to leak. Conversely, if the bands are under tightened, the boots will leak.

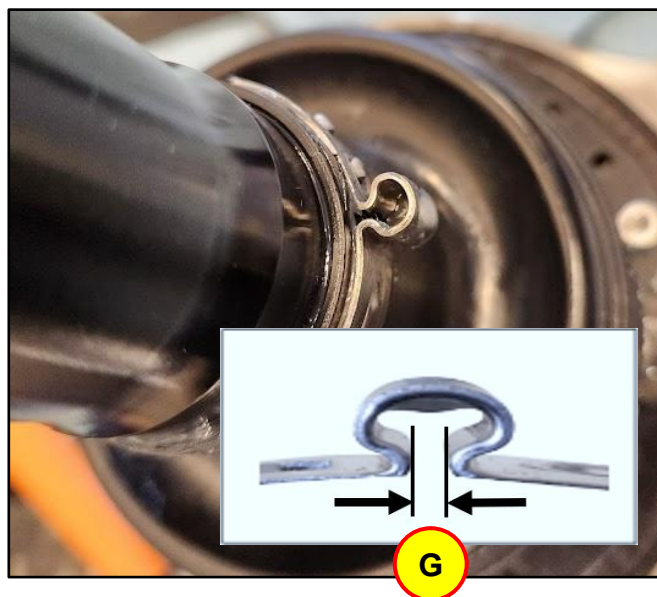
14. Tighten the ears of the small diameter band until it reaches the specified gap (G) of 0.1mm – 2.1mm (0.004in – 0.082in).

Close the handles of the tool slowly and in small increments to reach the specified gap.

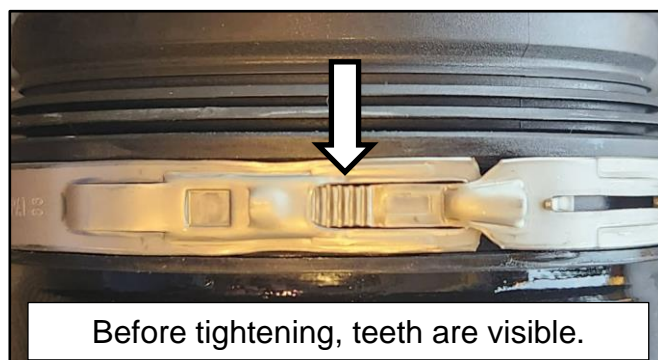
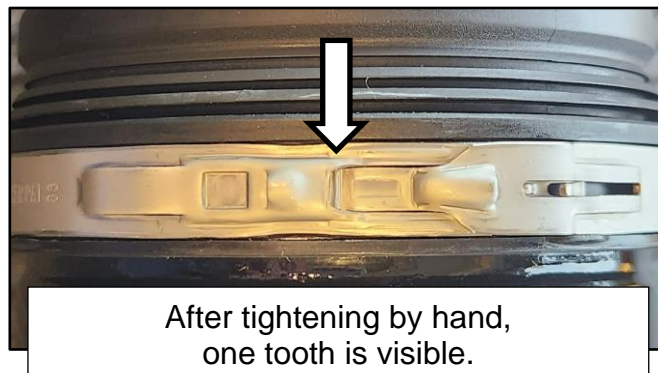
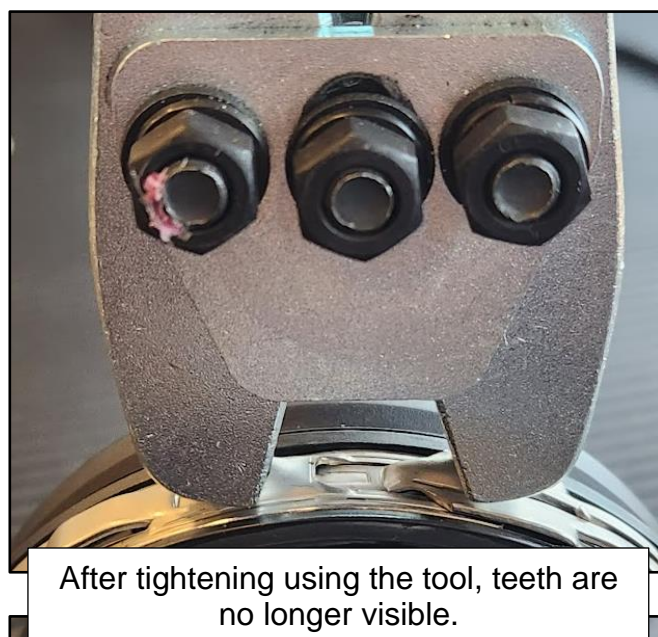
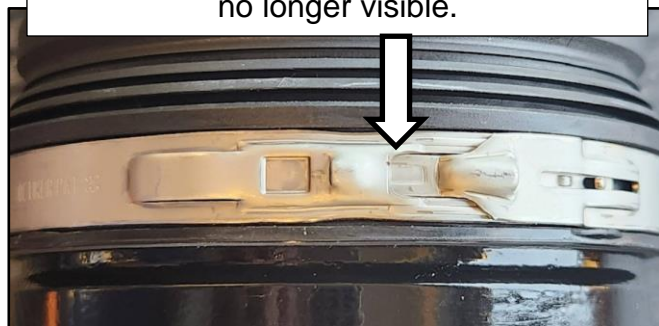
15. Tighten the larger diameter band by hand until only one tooth is visible on the band.

Then use the tool to tighten until the teeth are no longer visible.

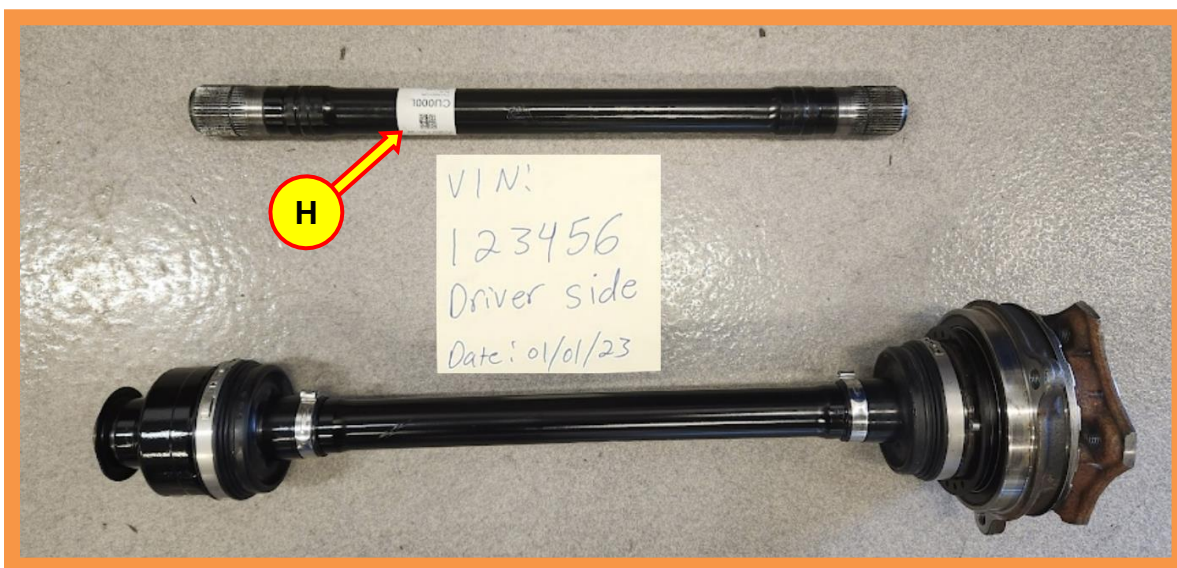
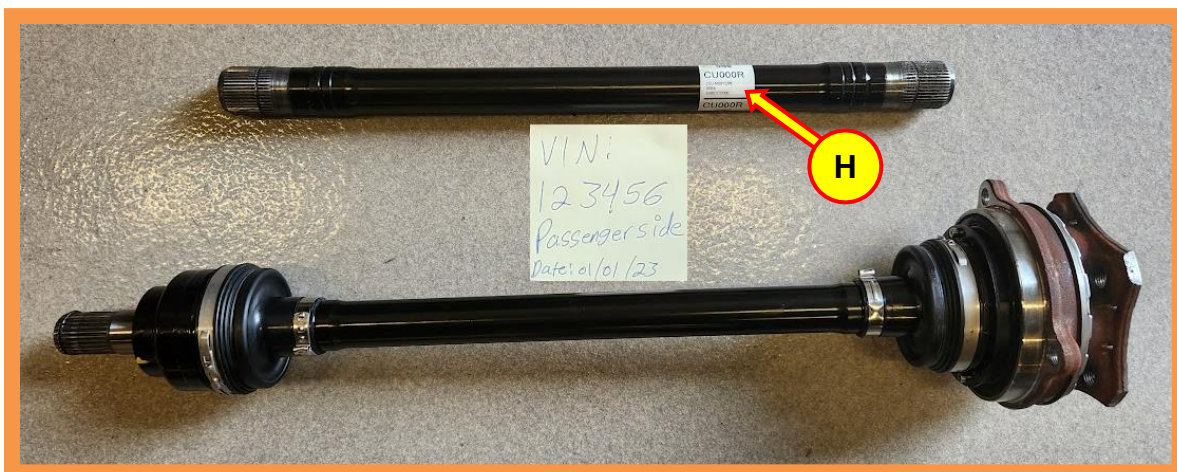
Using STUI, take separate clear photos of the new left (driver) and right (passenger) side assembled IDAs along with the removed shaft, with the shaft's label (H) visible, the last 6 digits of the VIN, IDA side (driver or passenger), and the date of repair on a piece of paper. See examples shown below.

Two photos will be taken, one for the left side and one for the right side.

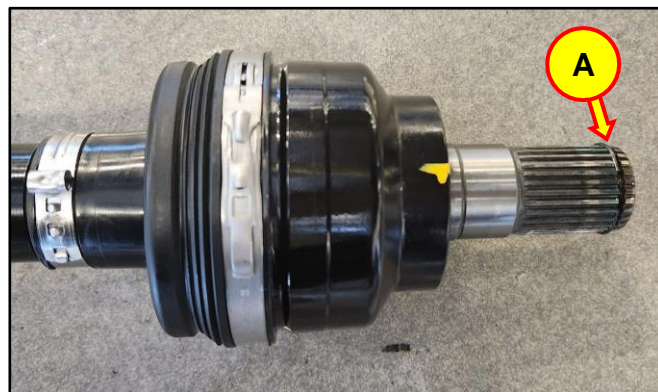
Install a new circlip (A) to the right side inner spline end before inserting the IDA into the reduction gear.
