Technical Service Bulletin

GROUP**RECALL****NUMBER****24-01-037G****DATE****JUNE 2024****MODEL(S)****GV60 (JW1 EV)**

SUBJECT: REAR INTEGRATED DRIVE AXLE (IDA) SHAFT REPLACEMENT
(RECALL 014G)

Description: Certain GV60 (JW1 EV) vehicles are equipped with all-wheel drive powertrain systems containing rear driveshafts that could potentially fracture due to abnormal stress incurred by improper jig alignment during manufacturing. A fractured driveshaft could result in a sudden reduction of motive power, increasing the risk of a crash. This bulletin describes the procedure to replace the rear driveshafts with a revised part.

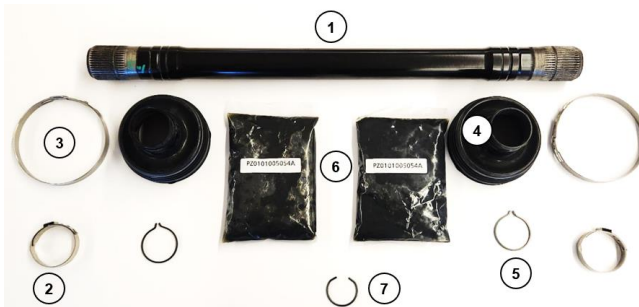
1. Shaft 2. Small diameter band (2 EA) 3. Large diameter band (2 EA) 4. Boot (2 EA) 5. Snap ring (2 EA) 6. Grease (2 EA) 7. Circlip (Only included in right side kit)
Shaft Kit, Right Side	498R7-CU000QQH		
Left

Shaft Length: <ul style="list-style-type: none">Left: 20.1 in. (51.1 cm)Right: 21.4 in. (54.3 cm)
Right

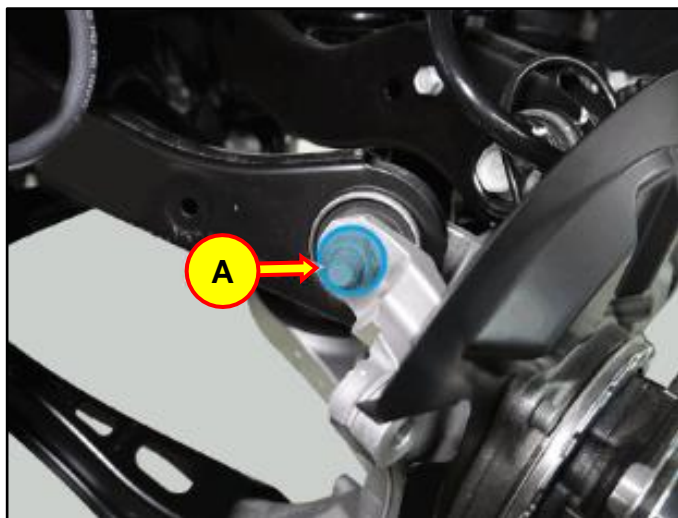
3. Separate the rear upper arm front from the rear carrier after removing the bolt and nut (A) on both sides of the vehicle.

Rear Arm to Carrier Tightening Torque:

lb-ft	123
N.m	167

- Use a transmission jack to lift the rear carrier to prevent the bolt and nut from damage when removing and installing.
- Ensure the bolts are reinstalled without binding to properly torque the nut.

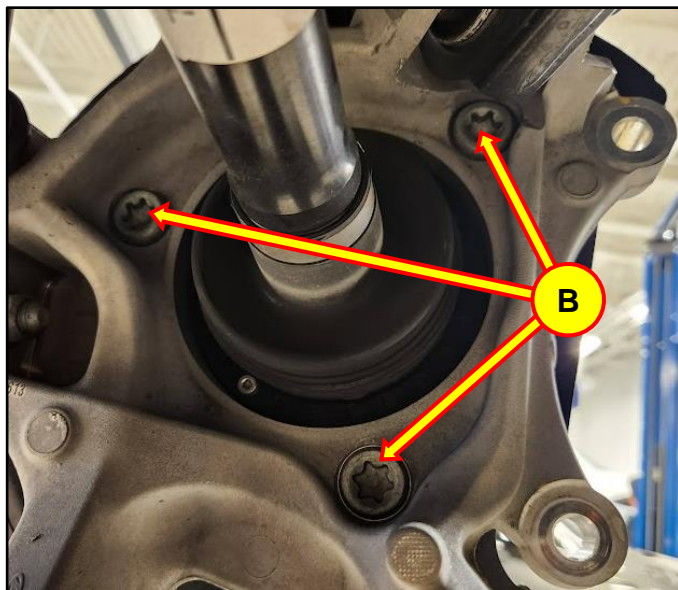
4. Remove the rear carrier mounting bolts (B) on both sides of the vehicle.

Rear Carrier Tightening Torque:

lb-ft	102
N.m	138

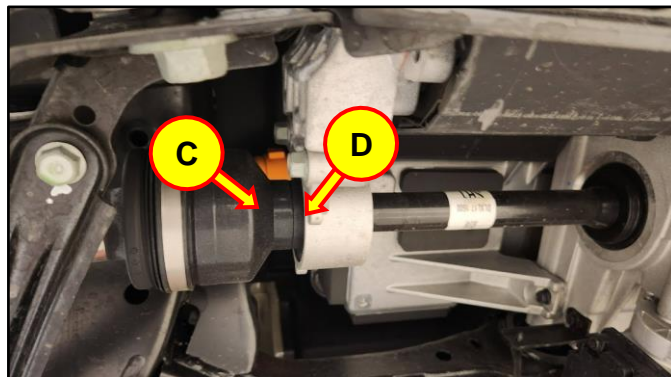
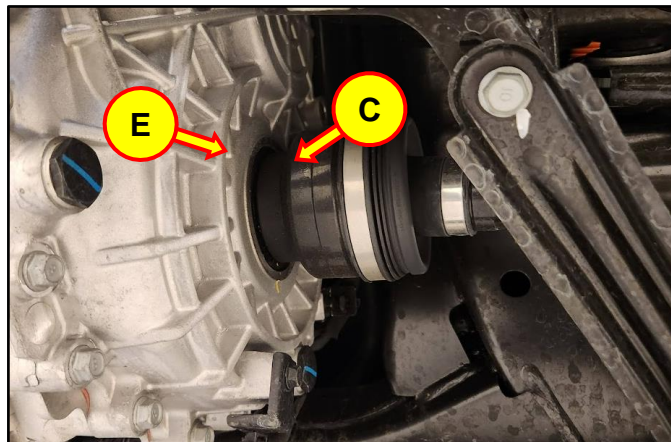
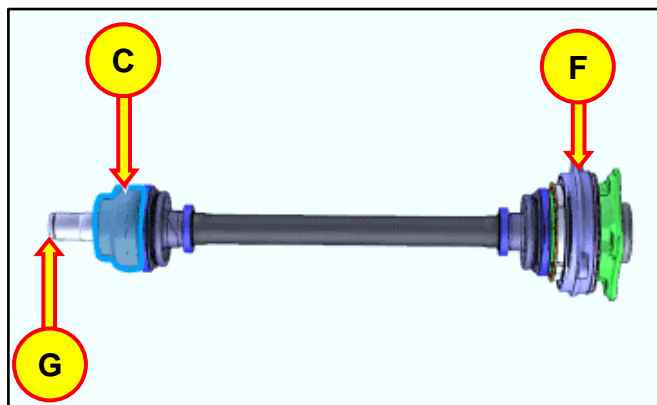
5. Remove both IDAs and place on a work bench.

Insert a pry bar between the IDA inner joint cup (C) and the bearing support bracket (D), then carefully pry the joint cup to separate it from the bearing.

Insert a pry bar between the IDA inner joint cup (C) and the reduction gear case (E), then carefully pry the joint cup to separate it from the reduction gear.

- Do **not** pull the wheel side axle joint (F), or shaft when removing IDA. Damage to the inside of the reduction gear or IDA joint may occur.
- Pull from the inner joint cup (C) to remove it from the bearing or reduction gear case.
- When carrying the IDA, hold the shaft or both joints.
- Do **not** insert the pry bar too deep, as this may damage the oil seal.
- Do **not** use excessive force to remove the IDA.
- After removing the IDA, cover the hole of the reduction gear to prevent contamination.
- Remove the circlip (G) on the inner side spline of the right IDA. Use the new circlip provided in the kit during reassembly.

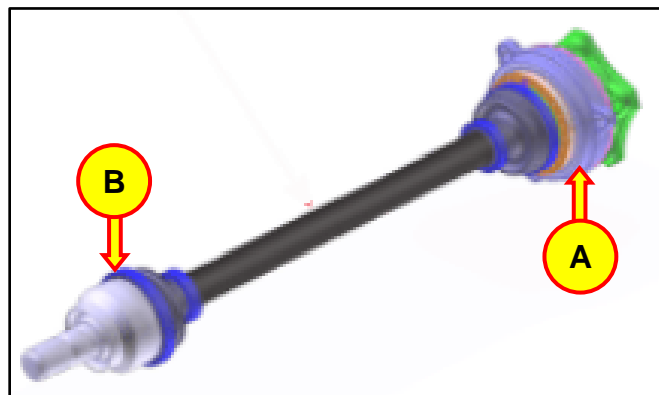
1. The wheel side (A) and inner side (B) joint cup sub-assemblies will be reused during reassembly of the new axle.

Use the new shaft, boots, bands, snap rings, and circlip supplied in the kit.

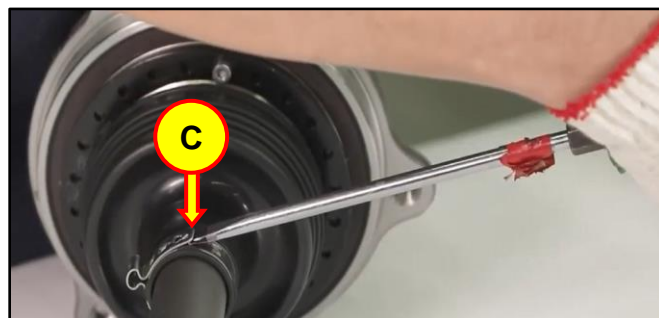
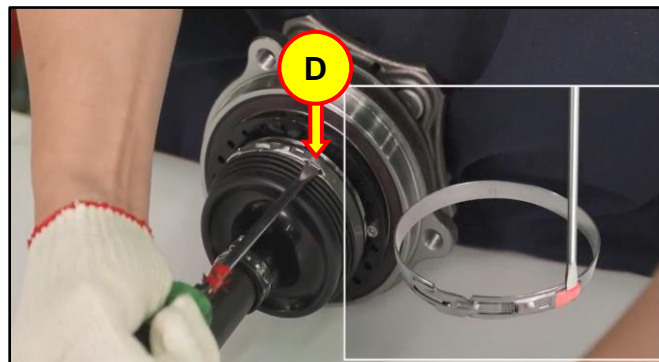
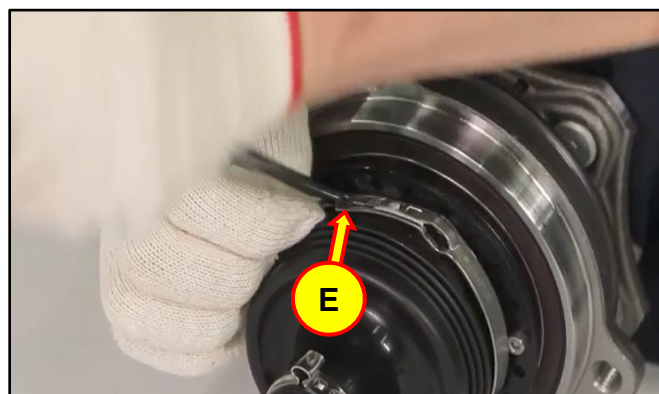
2. Starting from either end of the IDA, remove the small and large boot bands by using a flat-blade screwdriver and pry the bands at the locations shown (C), (D), and (E).

To help pry the bands apart, insert the flat-blade screwdriver into the band as shown and then hit the handle end of the driver with a mallet.

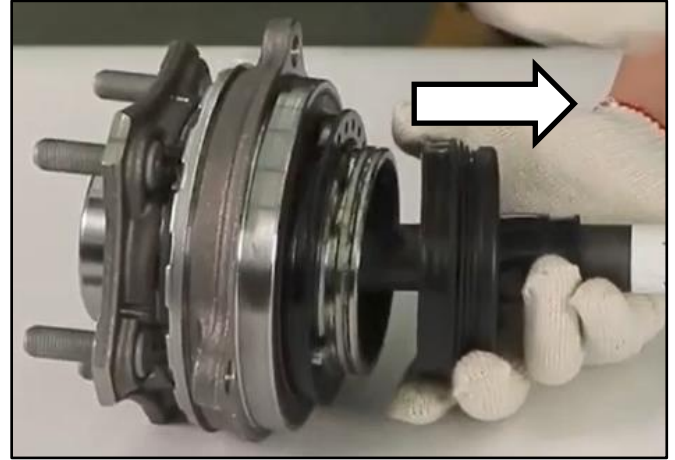
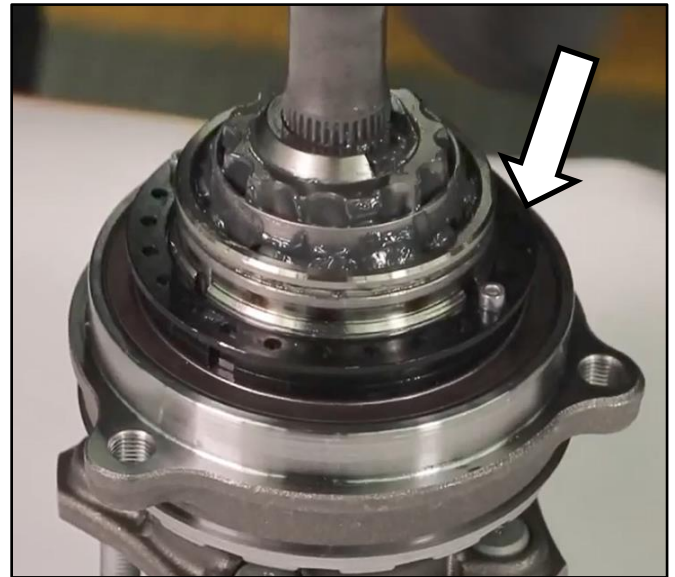
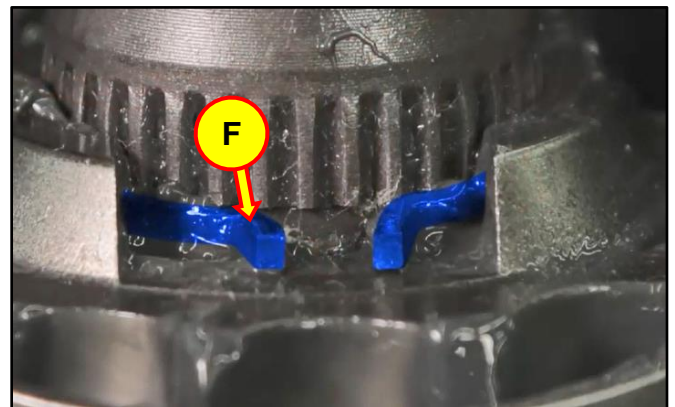
3. Slide the boot off of the joint and down the shaft.
4. Then use a clean cloth to remove as much grease as possible from within the joint to locate and remove the snap ring.
5. Using a rubber mallet, gently tap the joint downward to place the snap ring (F) against the groove.

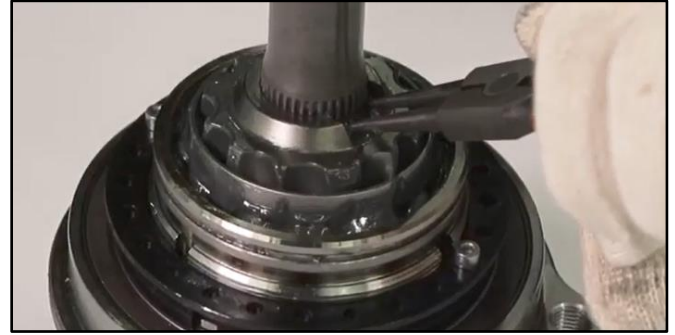
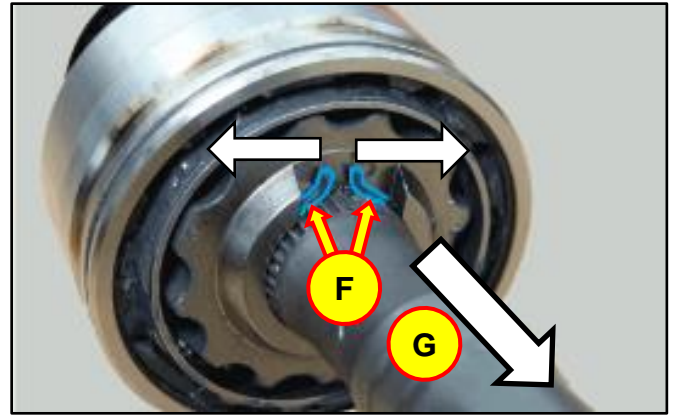
6. Use snap ring pliers to open the snap ring (F). If the snap ring is in position in the groove, the snap ring will stay open. Then pull or gently tap the joint until the shaft (G) is out of the joint.

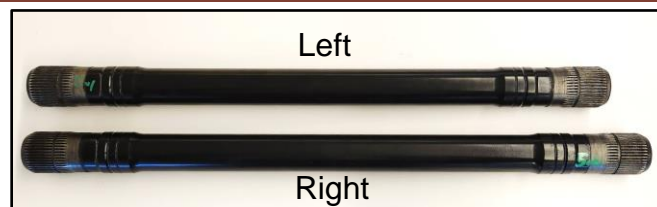
Shaft Length

- Left: 20.1 in. (51.1 cm)
- Right: 21.4 in. (54.3 cm)

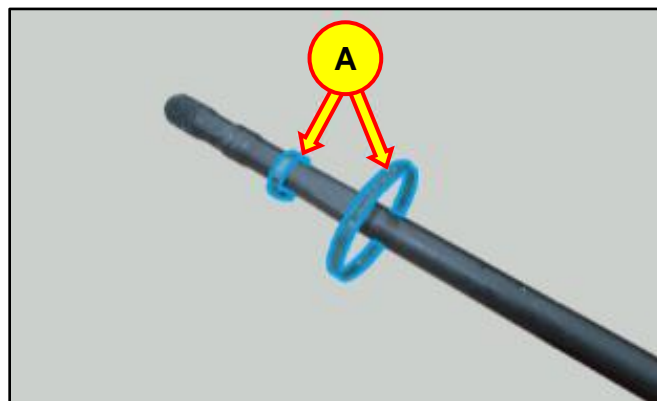
2. Slide the new small and large diameter boot bands (A) on the new shaft.

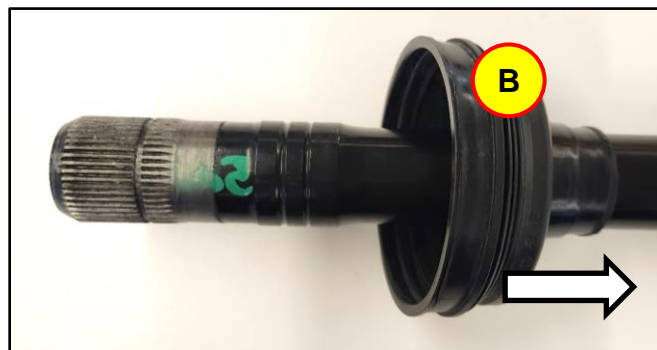
3. Slide a new boot (B) on the shaft.
Keep the interior of the boot clean.

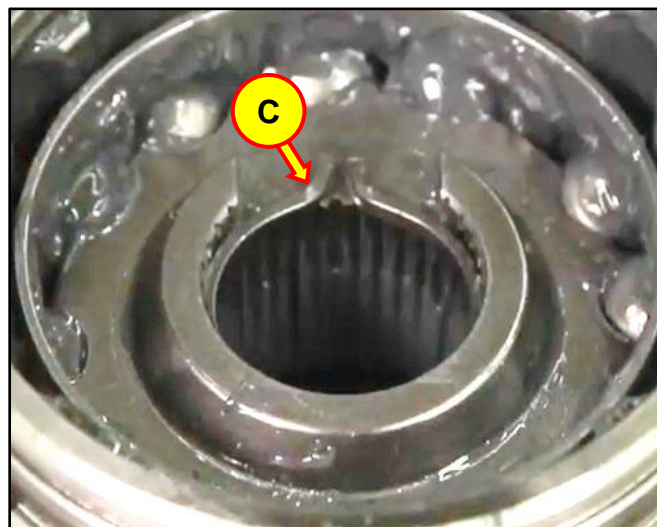
4. Place a new snap ring (C) inside the joint.

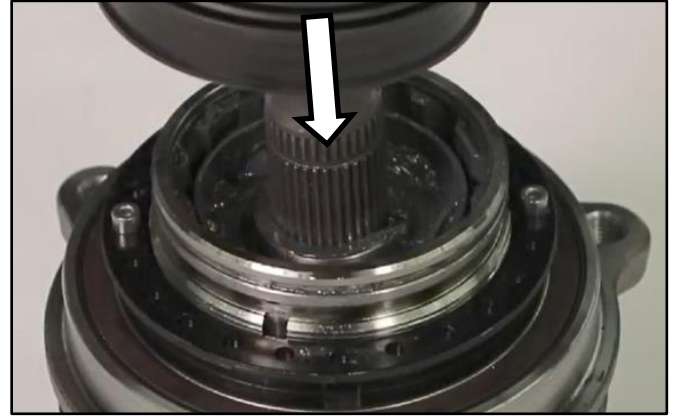
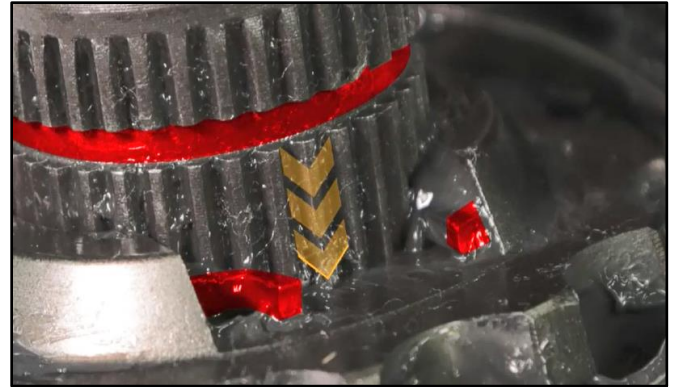
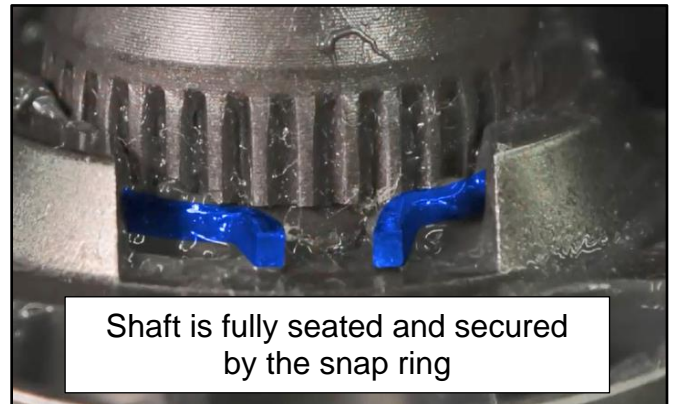
5. Insert the axle splines into the joint until the shaft is secured by the snap ring.

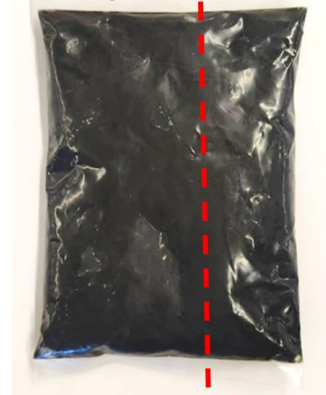
6. Use one grease packet for each joint/boot.

The IDA requires the use of the supplied grease. Do **NOT** add or use any other type of grease.

2/3rds for
the joint 1/3rd for
the boot

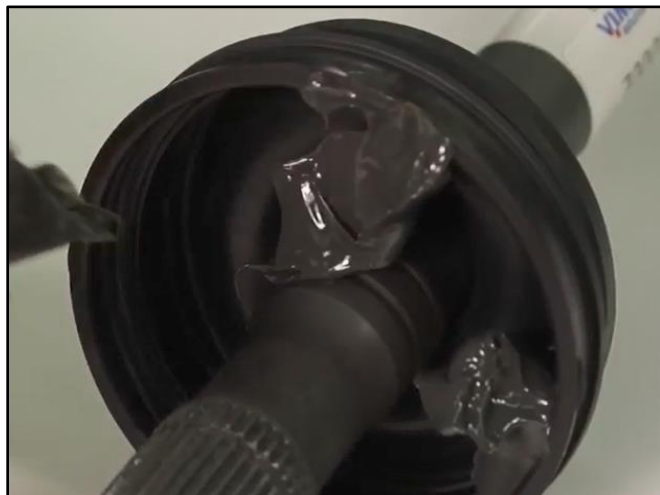
7. Apply approximately one-third of the grease inside the boot.

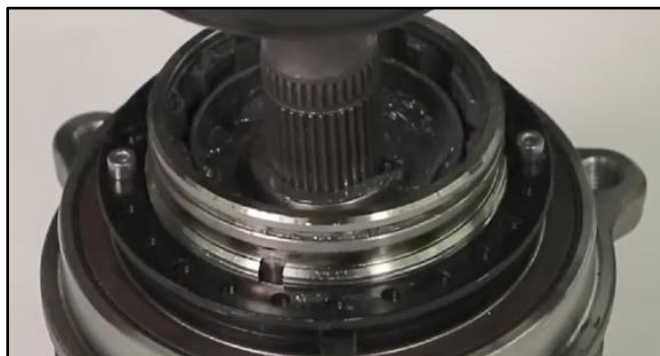
8. Apply the remaining two-thirds of the grease in the joint.

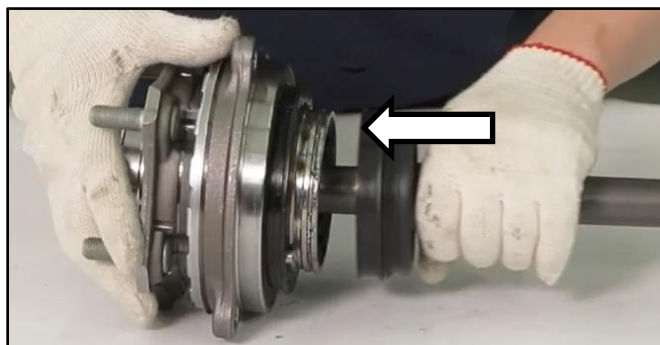
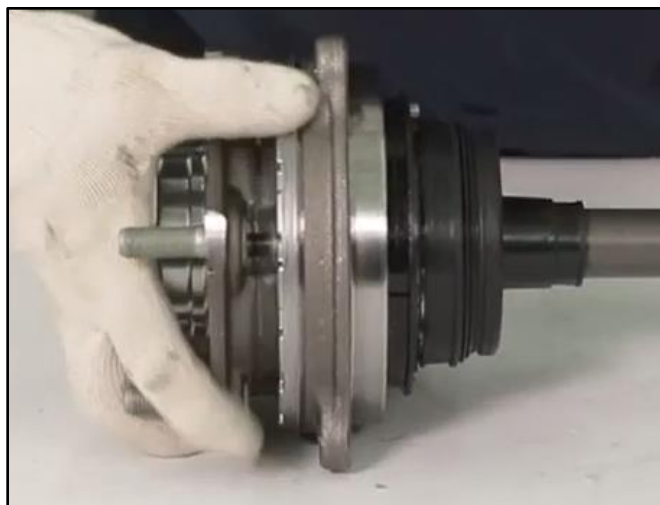
9. Install the boot onto the joint.

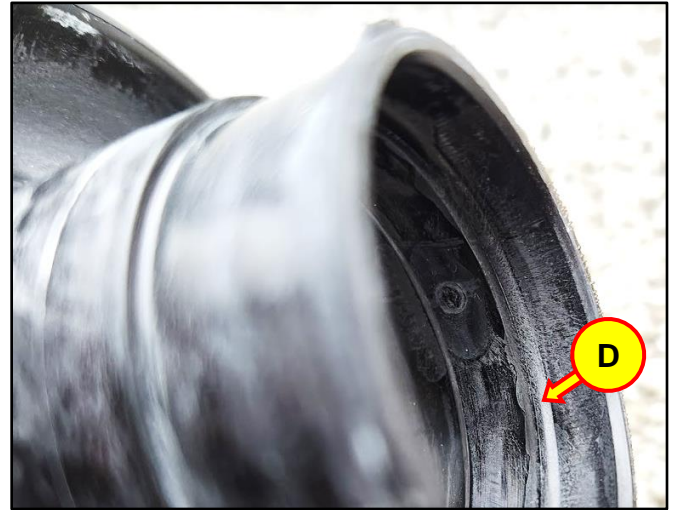
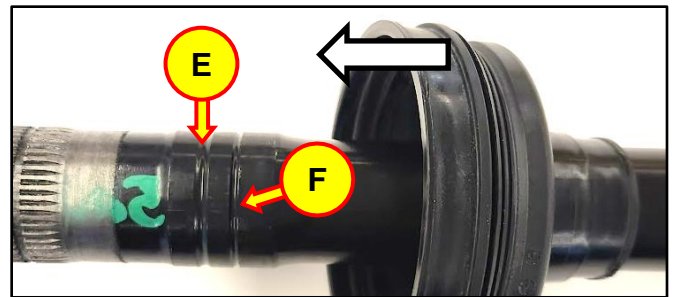
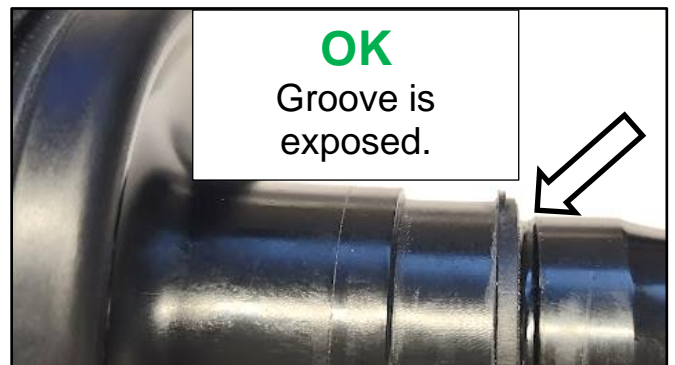
10. Ensure the molded ridge (D) in small end of the boot slides on to the groove that is closest to the spline end (E) when installing the boot onto the joint.

If the boot is installed correctly, the other groove (F) will be visible.

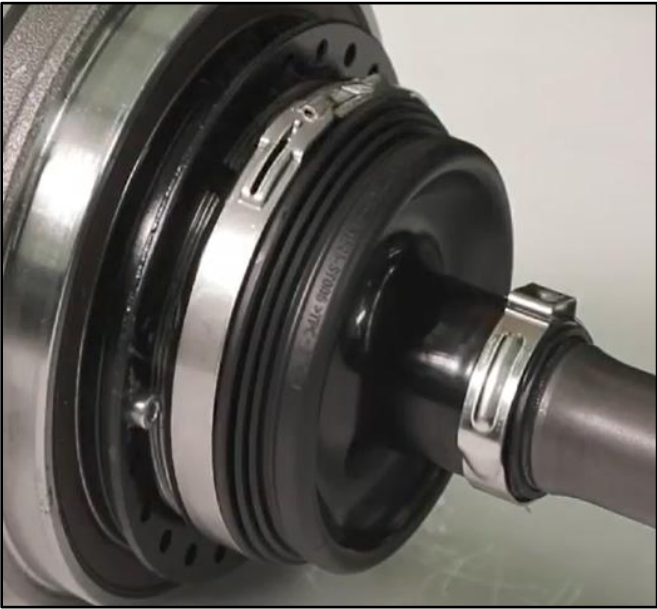
11. Clean the excess grease from the shaft and boots.
12. Place the small and large diameter bands into their respective positions.

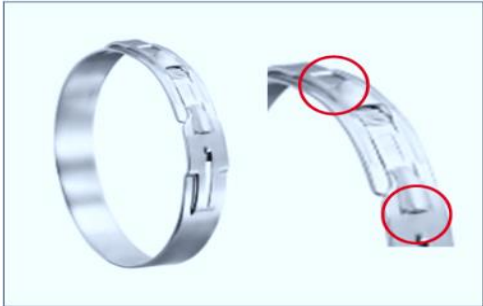
13. Use the correct tool to clamp each band type.

Small Diameter Band	Larger Diameter Band

Ear type Band Tool (SST: 0K495-C5000)	IDA type (Low profile) Tool (SST: 09495-GI100)

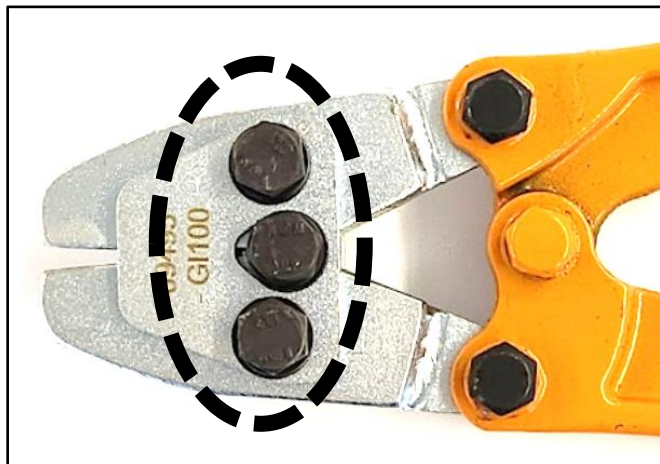
If it is difficult to open and close the tool smoothly, loosen the three bolts that are circled.

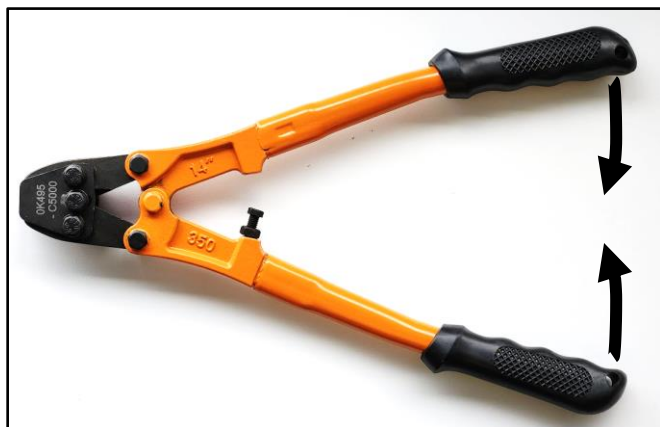
- Do **NOT** close the tool handles all the way in one motion to clamp the bands on the boot.
- Close the handles slowly and in small increments.
- Check that the bands are clamped to the specifications in steps 14 and 15.
- Overtightening the bands can damage the boot and not provide the proper sealing causing the boots to leak. Conversely, if the bands are under tightened, the boots will leak.

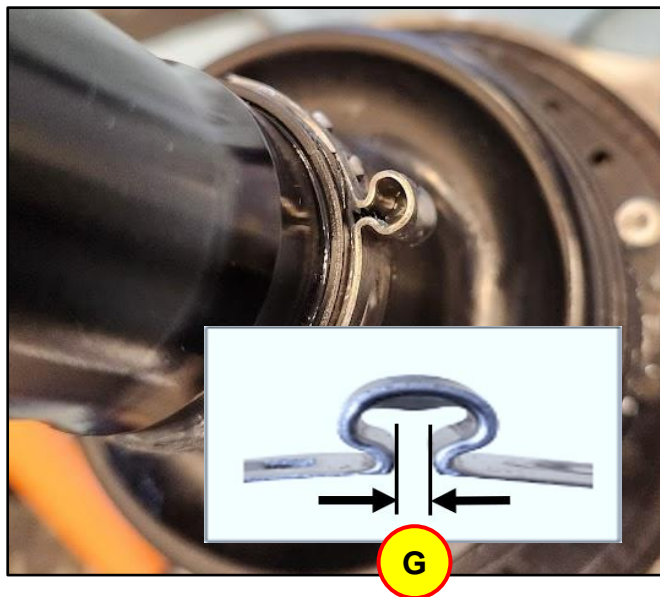
14. Tighten the ears of the small diameter band until it reaches the specified gap (G) of 0.1 mm – 2.1 mm (0.004 in. – 0.082 in.).

Close the handles of the tool slowly and in small increments to reach the specified gap.

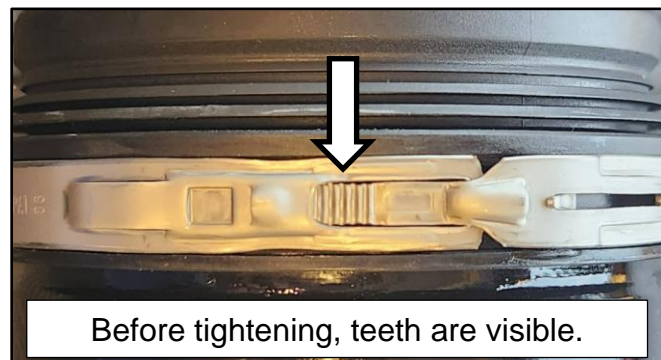
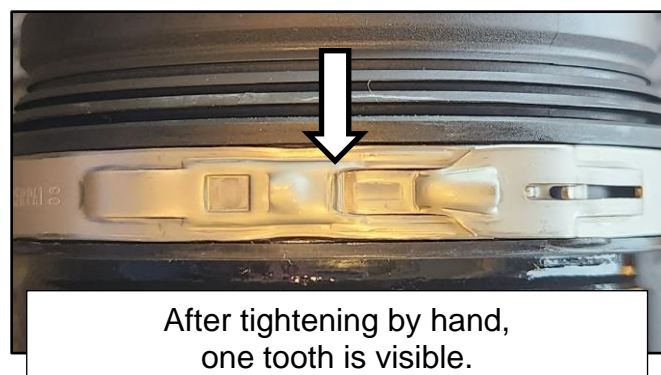
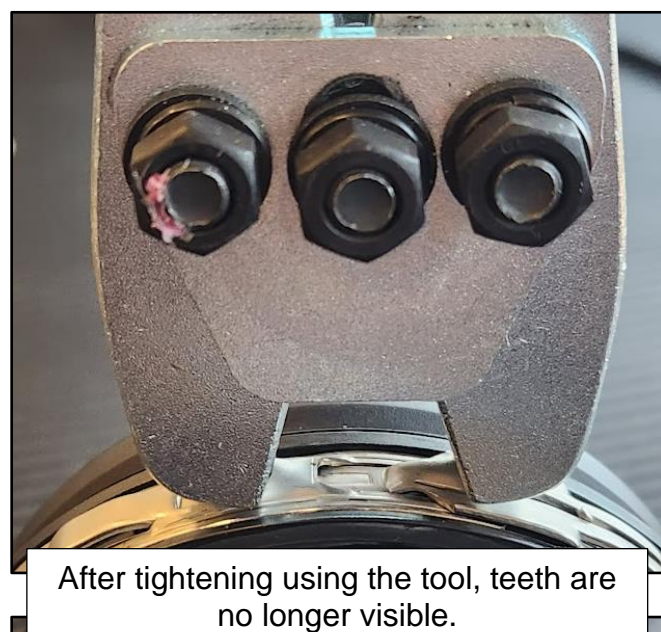
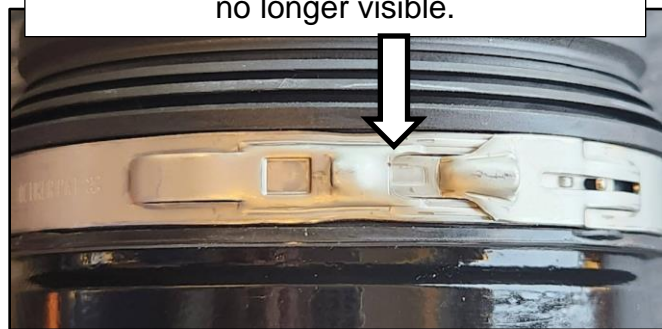
15. Tighten the larger diameter band by hand until only one tooth is visible on the band.

Then use the tool to tighten until the teeth are no longer visible.

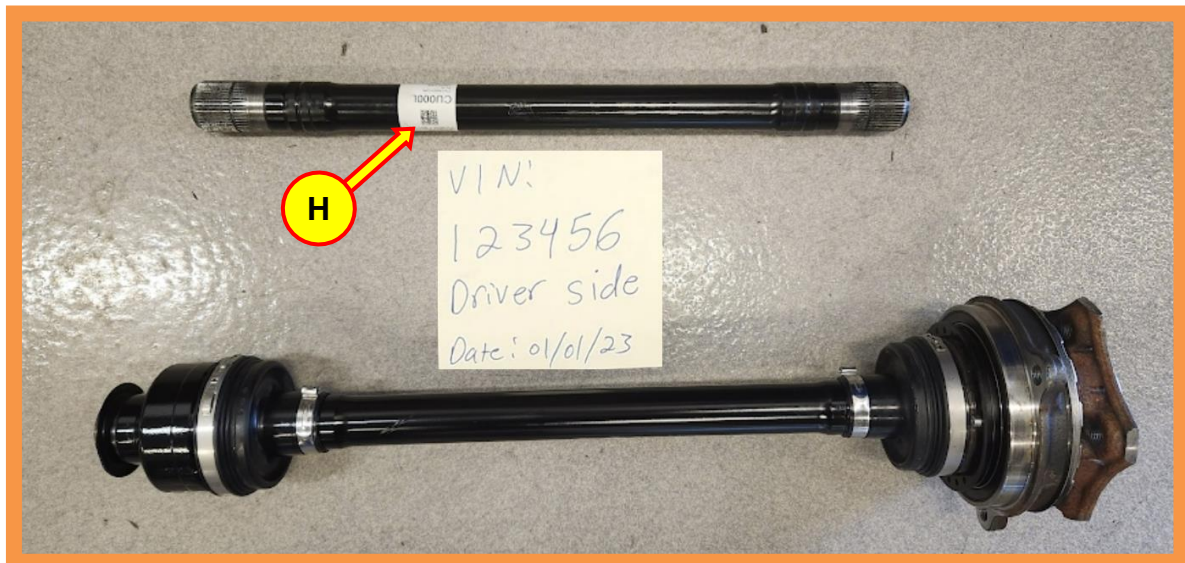
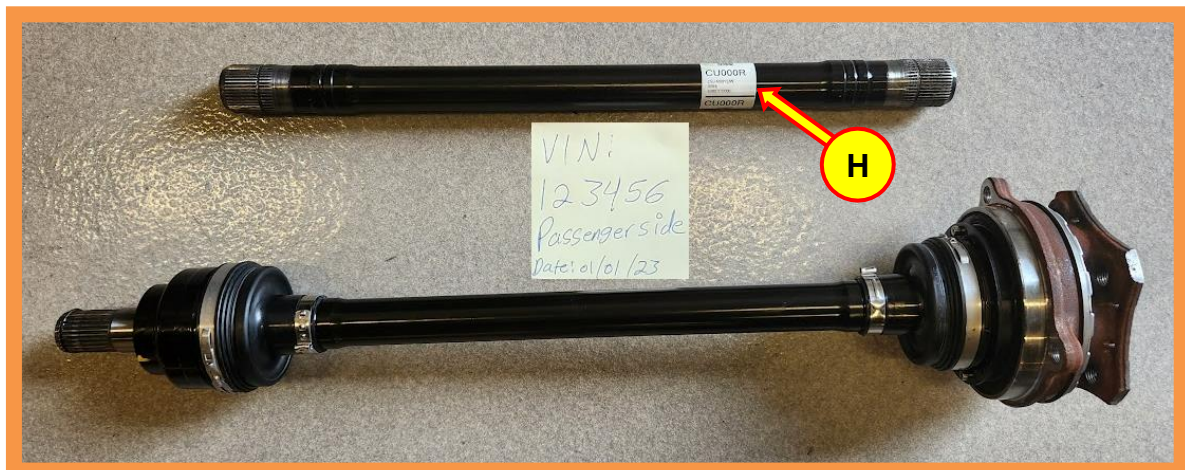
Using STUI, take separate clear photos of the new left (driver) and right (passenger) side assembled IDAs along with the removed shaft, with the shaft's label (H) visible, the last 6 digits of the VIN, IDA side (driver or passenger), and the date of repair on a piece of paper. See examples shown below.

Two photos will be taken, one for the left side and one for the right side.

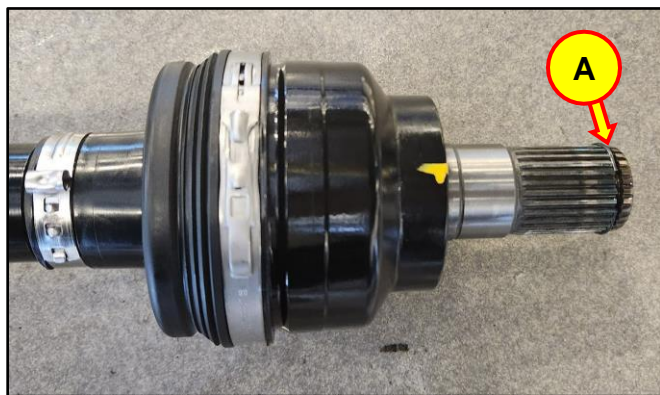
Install a new circlip (A) to the right side inner spline end before inserting the IDA into the reduction gear.

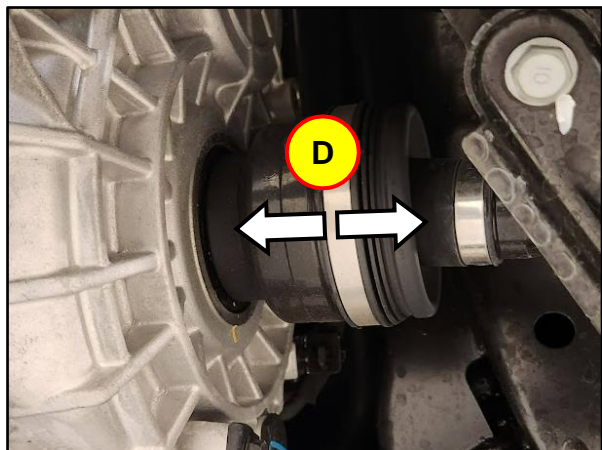
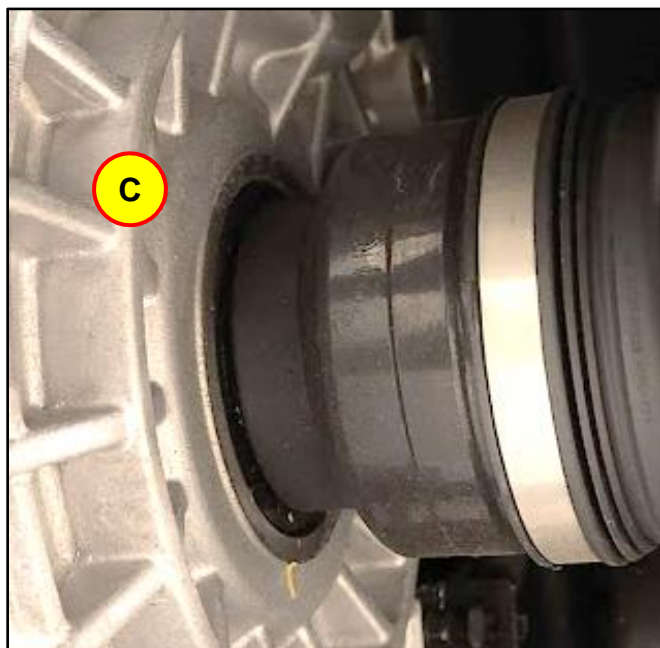
2. Ensure that the right IDA is fully inserted into the reduction gear (C) and secured by the circlip.

The IDA joint cup (D) should not slide back and forth within the reduction gear.

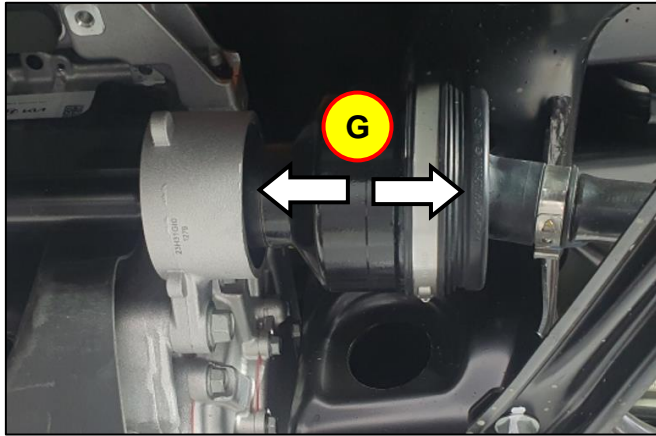
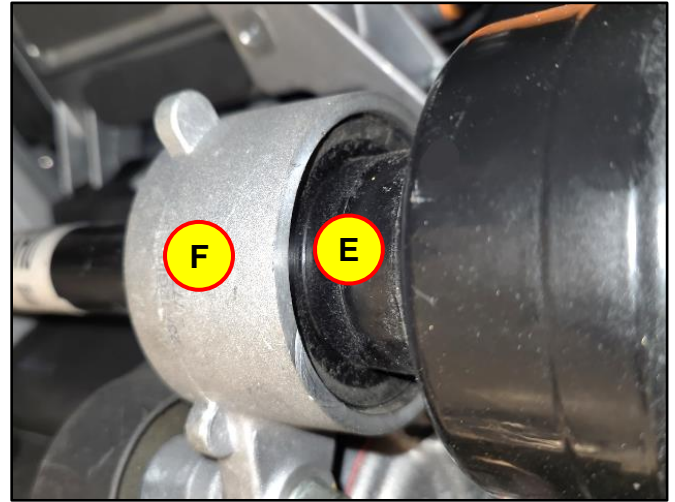
3. Ensure that the left IDA dust cover (E) is properly installed on the inner shaft bracket (F) and secured by the inner shaft circlip.

The IDA joint cup (G) should not slide back and forth on the inner shaft.
