**RAM** Remedy available for  
 2019-2021 (VF) Ram ProMaster

The transmission on about 24,250 of the above vehicles may not allow the park pawl to fully engage the park gear due to debris interference. A partially engaged park pawl may lead to a vehicle roll away increasing the likelihood of a vehicle crash without prior warning and/or injury to those in or around the vehicle.

## Park Engagement

Reference: 61A / NHTSA 23V-301

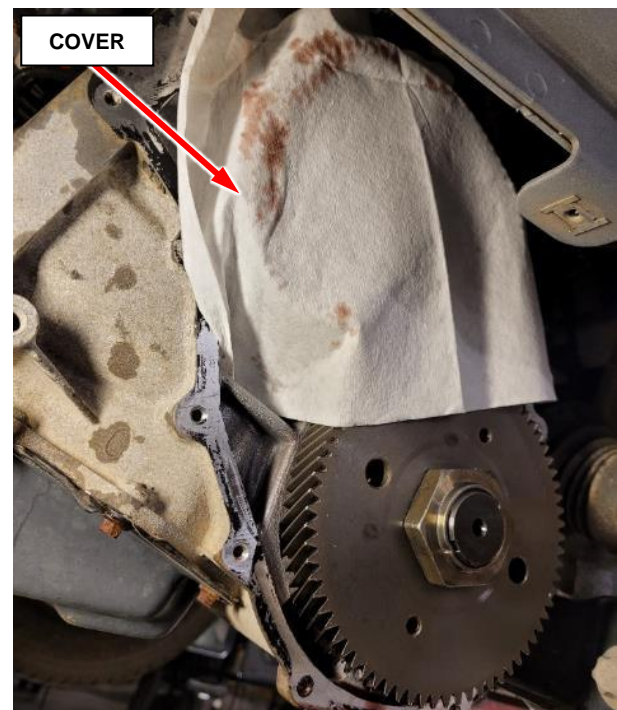
**Figure 20 – Protect Transmission**

31. Protect the areas surrounding the transfer gear to prevent metal grinding chips from entering the transmission (Figure 20).

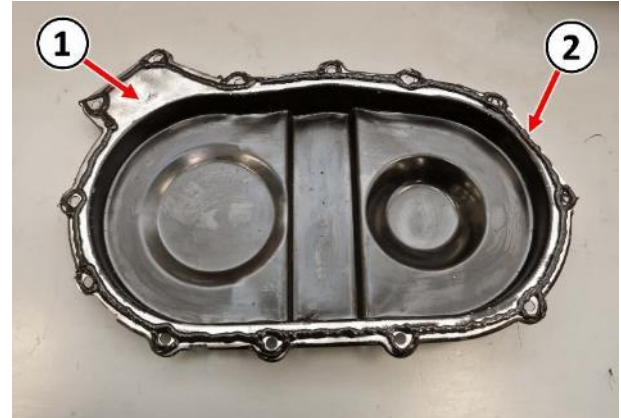
**Figure 45 – Transfer Gear Cover**

81. Clean the mating surfaces on the transmission and transfer gear cover (1) then apply a bead of MOPAR® ATF RTV (MS-GF41) (2) to the cover sealing surface (Figure 45).

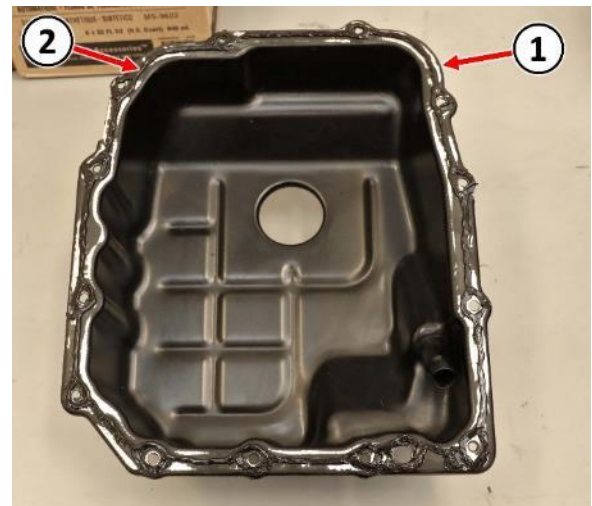
**Figure 46 – Valve Body Oil Pan**

89. Install the electrical connector (1) to the range sensor (2) (Figure 13).
90. Clean the mating surfaces on the valve body oil pan (1) then apply a bead of MOPAR® ATF RTV (MS-GF41) (2) to the oil pan (1) sealing surface (Figure 46).
