# Safety Recall

## Code: 57J5

### Door Handles

### Problem Description

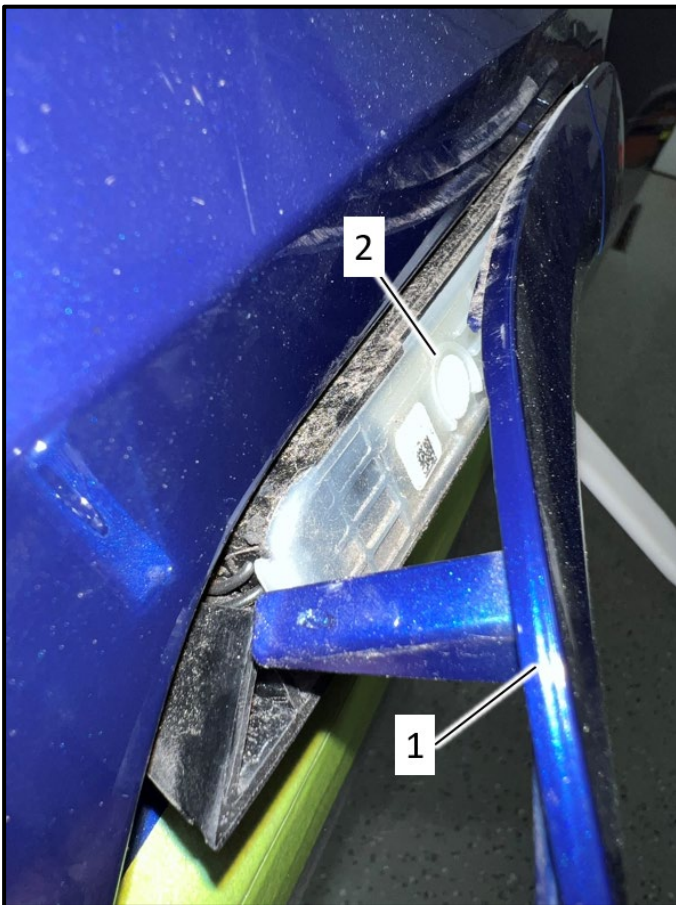
- Insert suitable plastic wedge into the cut outs to keep the door handle in the extended position.

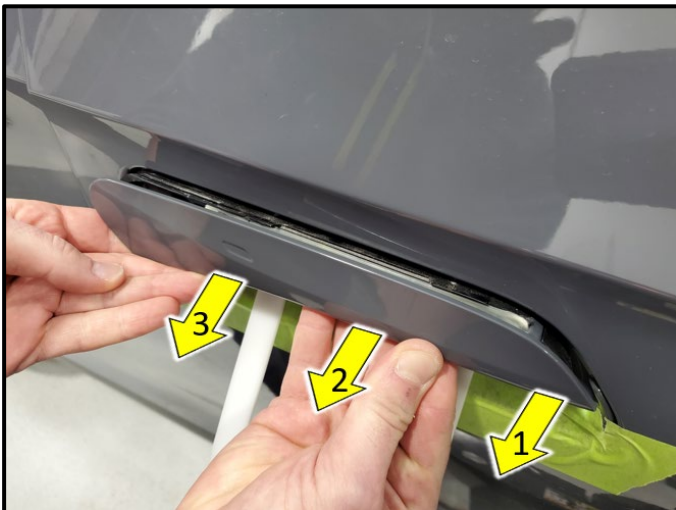
- Insert suitable plastic wedges <1> into the cut outs to keep the door handle in the extended position.

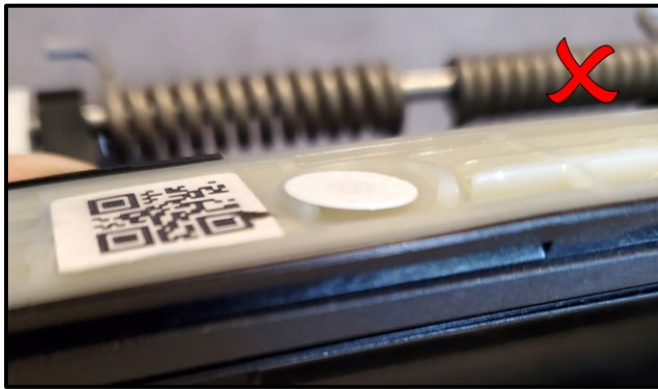
- Locate the membrane <1> on the door handle.

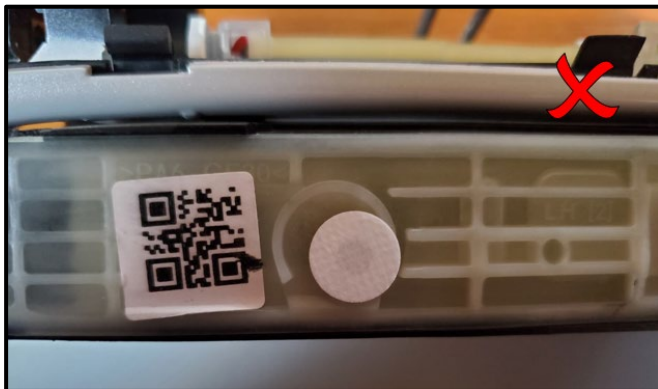
- Check the current installation of the membrane.
- If the membrane is not adhered properly (membrane is missing, edge is lifted or partially applied on the circular boss, for example):

- The door handle must be replaced.
- Front doors - Proceed to Section C for front door handle assembly removal.
- Rear doors – Proceed to Section D for rear door handle assembly removal.

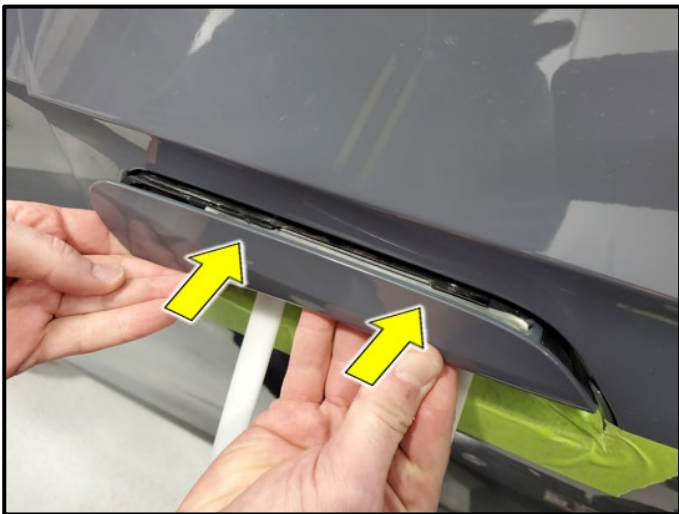
As long as the membrane is located completely in the recessed area, the door handle would be considered OK.

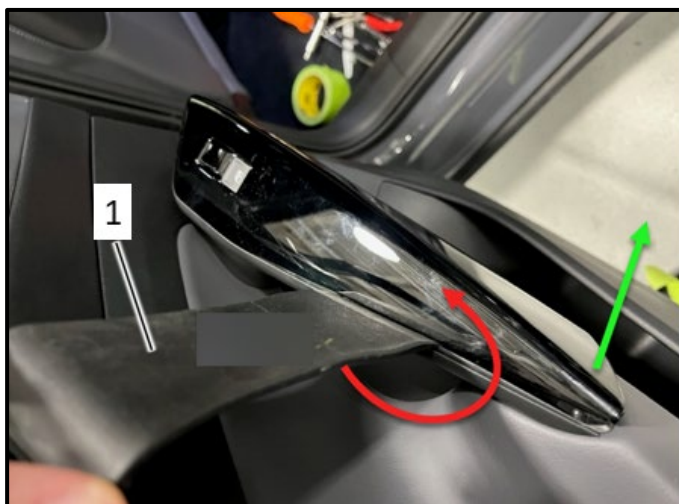
- Unclip the button trim <1> with controls <2> using the Wedge -T10383- <3>.
- Disconnect the connectors.
- Replace the button trim if damaged.
