Safety Recall

N232404980 Driver Front Airbag Inflator May Rupture

Release Date: September 2024

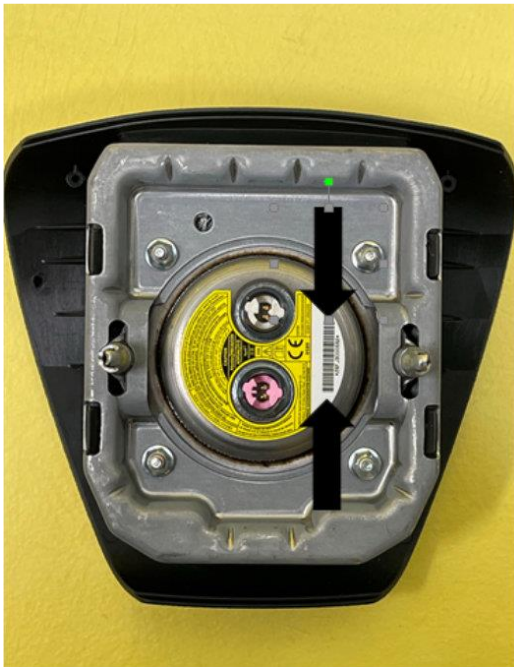
6524631

Important: (TECHNICIAN and WARRANTY ADMINISTRATOR) SERIAL NUMBER RECORDING REQUIREMENT. The replacement steering wheel airbag serial number must be captured by the technician and recorded on the job card. The Warranty Administrator **MUST** enter the serial numbers in GWM (Global Warranty Management) or in DMS (Dealer Management System). Enter the serial number of the **replacement airbag** in the 'Labor Operation Dependency Code' field per the screen shown.

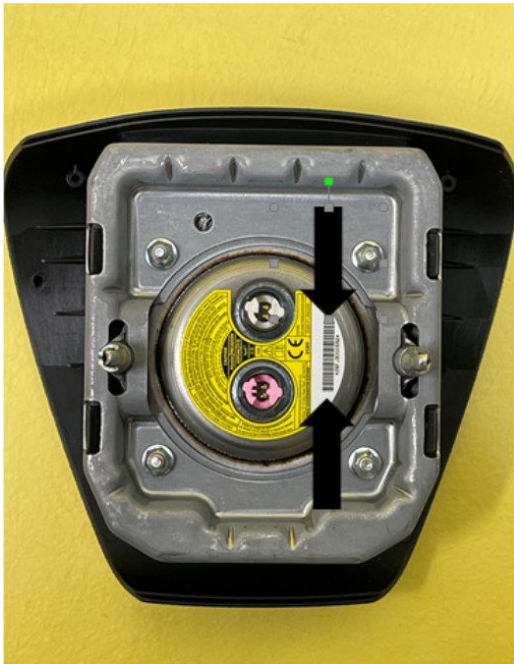
6524631

Note: DO NOT SCAN THE QR CODE ON THE SIDE OF THE AIRBAG MODULE. SCAN THE INFLATOR SERIAL NUMBER BARCODE ON THE BACK OF THE AIRBAG MODULE AS PICTURED ABOVE.

Note: Scanning the Inflator Serial Number Barcode will not populate all fields within the CSMT app. THE REMAINING FIELDS ARE NOT REQUIRED FOR THIS FIELD ACTION.

1. Scan the VIN (door pillar QR code or windshield VIN barcode) and
2. Scan the new part barcode and
3. Check the information and if correct then, Submit.

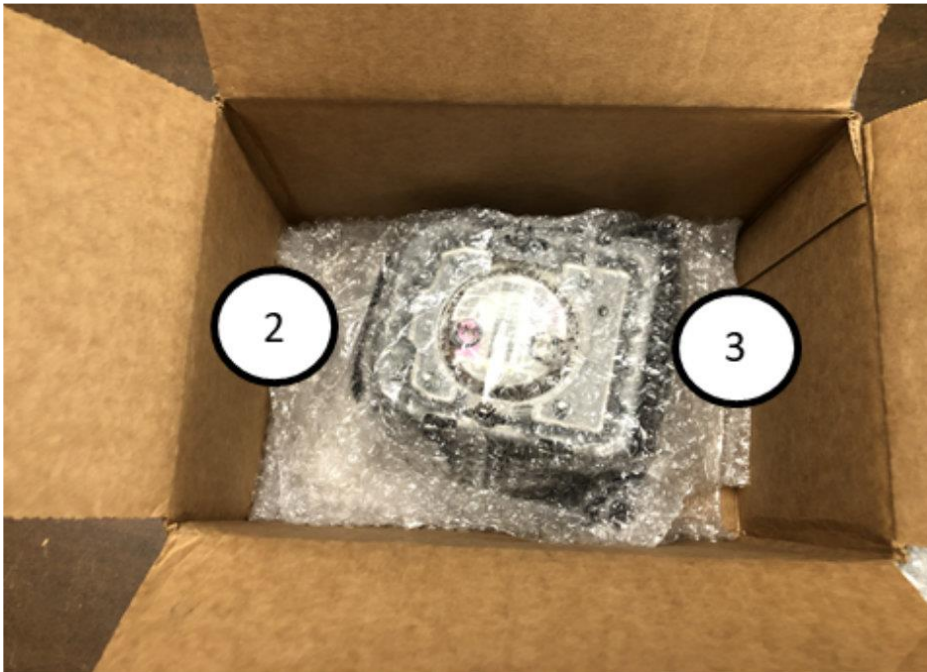
6543372

1. Confirm the original box is not damaged, allowing it useable to return ship. If a new box is required contact: tgpartreplacement@toyodagosei.com for a replacement box. There should be enough bubble wrap that the part will not shift during transport.

2. Wrap the airbag module in the bubble wrap from the original packaging.
3. Place the airbag module in the center of the box on top of bubble wrap.

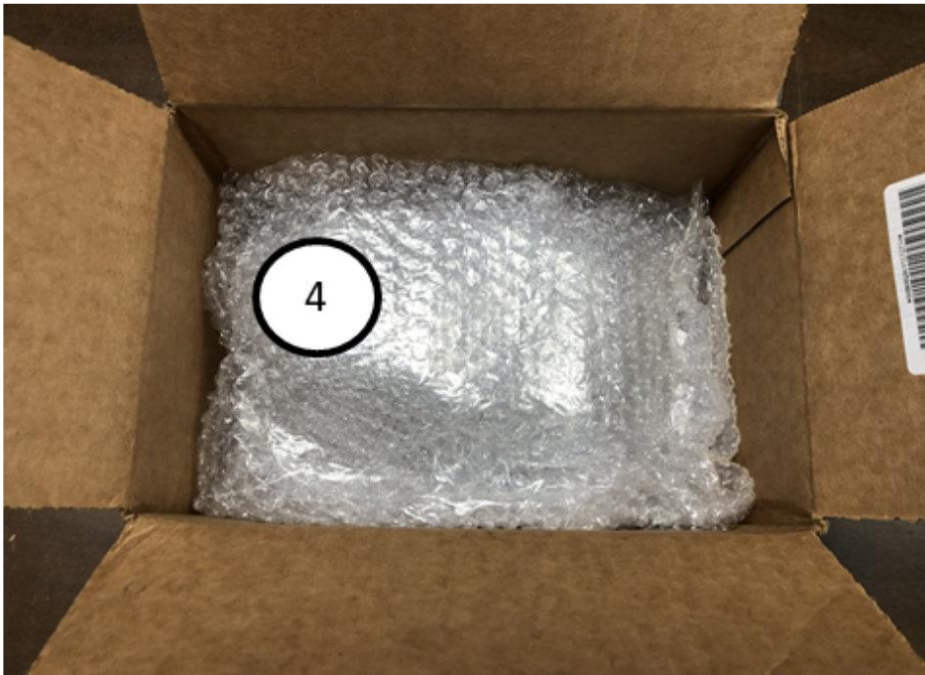
6543373

4. Place original bubble wrap around the airbag module to prevent movement inside the box.
Closure Instructions:

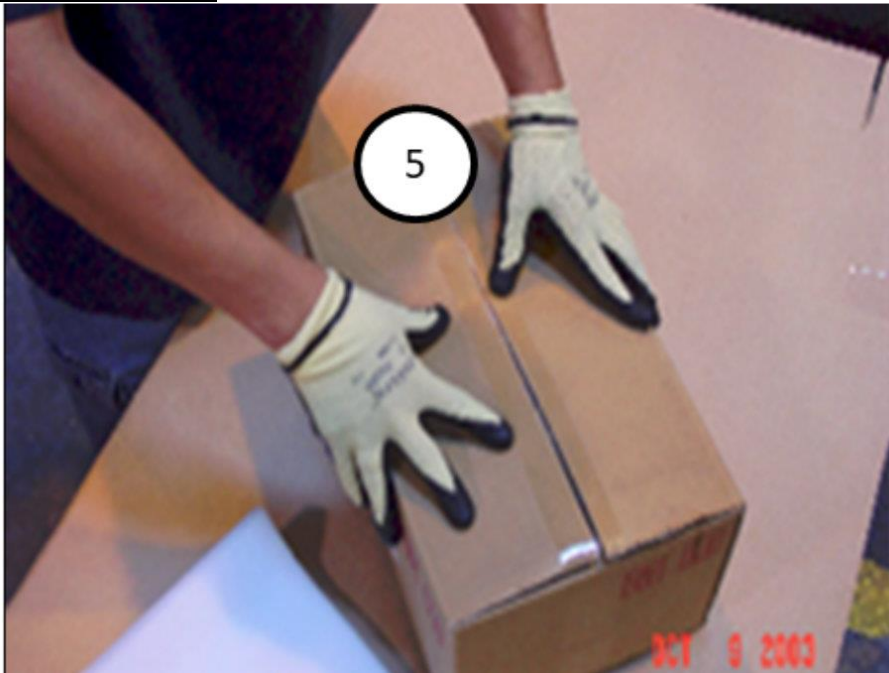
6543374

5. Use box sealing tape.
- Confirm flaps are flush prior to taping.

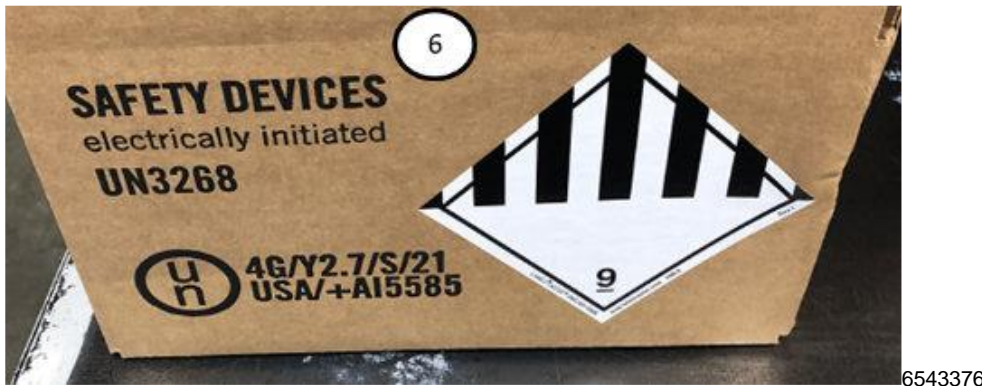
6. Compliance checks on box

- Confirm UN Specification number is in the upright position.
- DO NOT COVER “Up Arrows” and “Handle with Care” Markings.
- DO NOT COVER UN Package specification markings.
- Confirm the Class 9 label is not damaged or covered.
