SAFETY RECALL – NORTH AMERICA

Dashboard Airbag Warning Label

Reference: 52A / NHTSA 23V-336

Remedy available for
2021-2023 (WL) Jeep Grand Cherokee and Grand Cherokee L

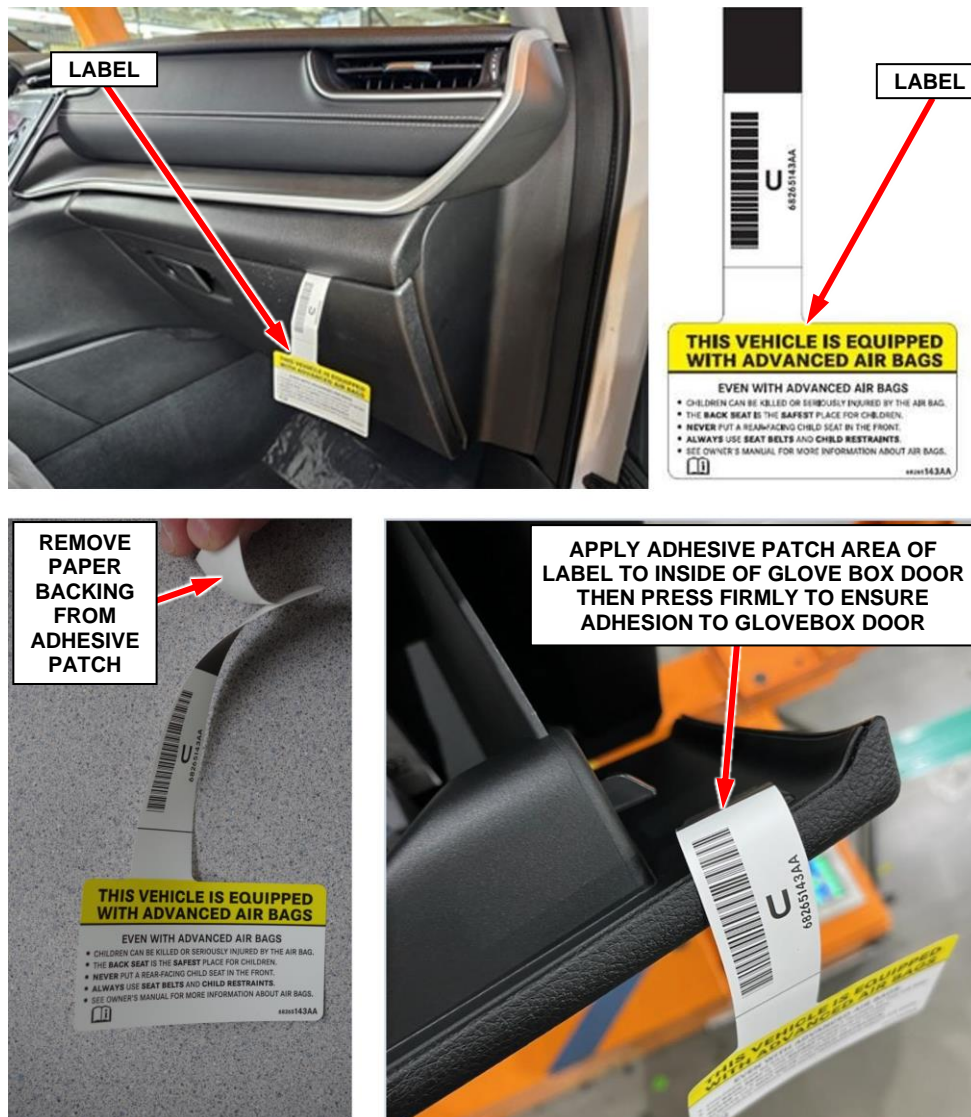
Figure 1 – Passenger Side Glovebox Door Airbag Warning Label

The dashboard airbag warning label on about 17,100 of the above vehicles may be missing. If a dashboard airbag warning label is missing, the occupant may not be aware of the risks a deploying airbag may pose to an infant or child occupying the front passenger seat.

Inspect passenger side glovebox door for airbag warning label (Figure 1).

- Label attached to glovebox door >>> No further action required.
- Label missing from glovebox door >>> Install the label listed in parts section to the glovebox door.
