Remedy available for
 2014-2016 (KL) Jeep Cherokee

SAFETY RECALL
NORTH AMERICA
Power Liftgate Module

Reference: 49A / NHTSA 23V-338

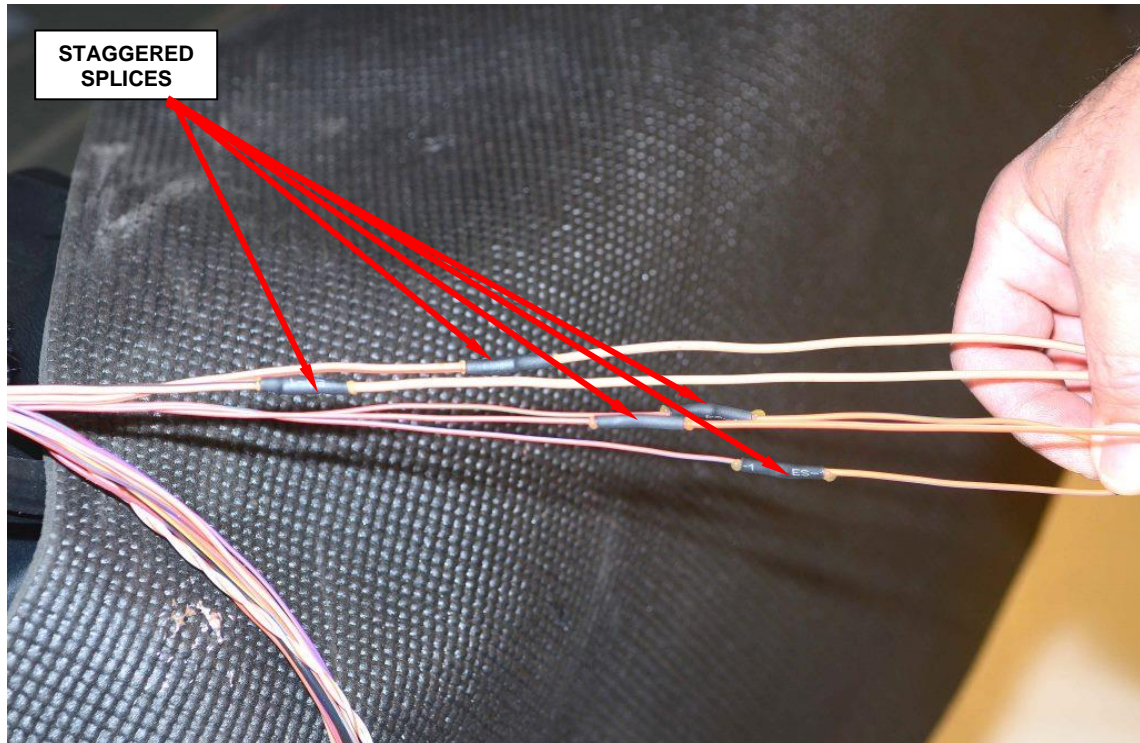
Figure 14 – Correctly Spliced Wires (Staggered/Crimped/Soldered/Heat Shrink)

CAUTION: Be sure to stagger the splice joints to prevent a large “ball” of wire splices in one location on the wire harness (Figure 14).

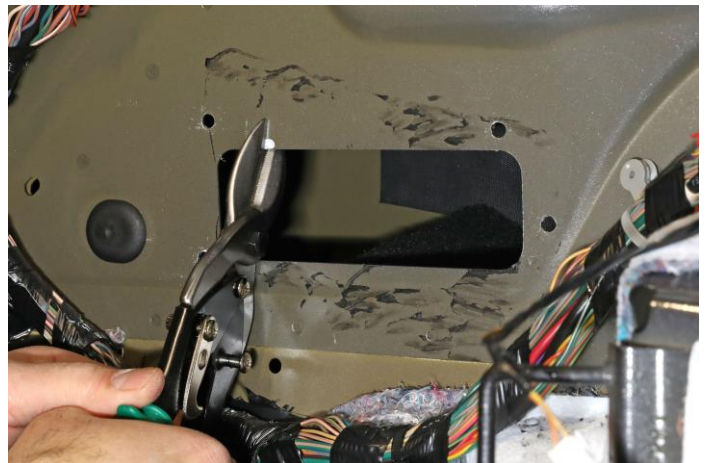
Figure 25 – Vertical Cuts in Body Structure

17. Remove the plate. Using tin snips, make two vertical cuts in the body structure from behind the upper left square hole, and bend the metal out of the way. Center punch the four marked holes, and drill four 1/4” holes for the push pins. Vacuum up the metal chips from drilling (Figure 25).

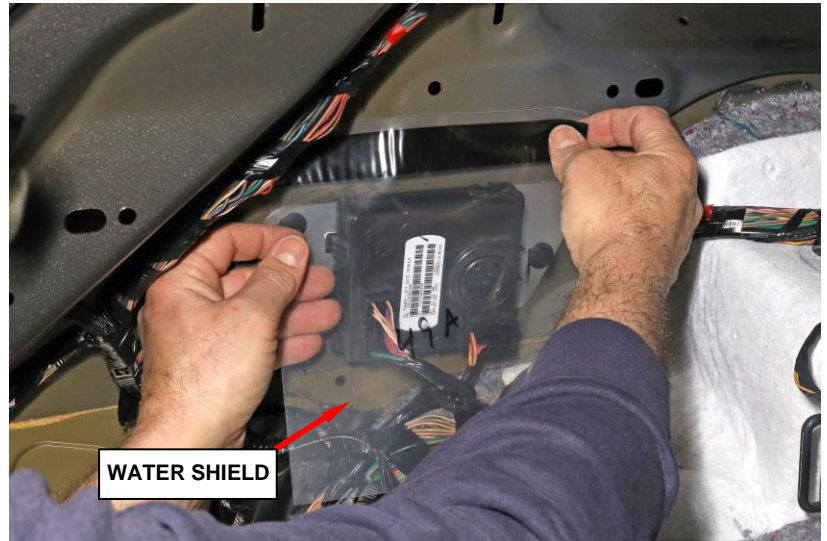
Figure 28 – Install Water Shield

23. Using isopropyl alcohol and a clean cloth, clean the surface above the PLGM where the water shield will be attached. Allow the alcohol to evaporate before applying the water shield.
24. With the adhesive at the top, apply the water shield over the PLGM, so that the PLGM is covered side to side and top to bottom (Figure 28).
