<b>REFERENCE:</b>	Nova Bus Manuals
<b>SECTION:</b>	12: Driver's seat
<b>RS N°:</b>	MQR 7621-2304
<b>EFFECTIVE IN PROD.:</b>	LF08 (2023NO)
<b>TC RECALL N°:</b>	2023-291
<b>NHTSA RECALL N°:</b>	23v350

<b>SUBJECT:</b>	Driver's seat belt
<b>JUSTIFICATION:</b>	On certain vehicles, the driver's seat back panel could interfere with the driver's seat belt. As a result, the driver's seat belt may not retract properly.

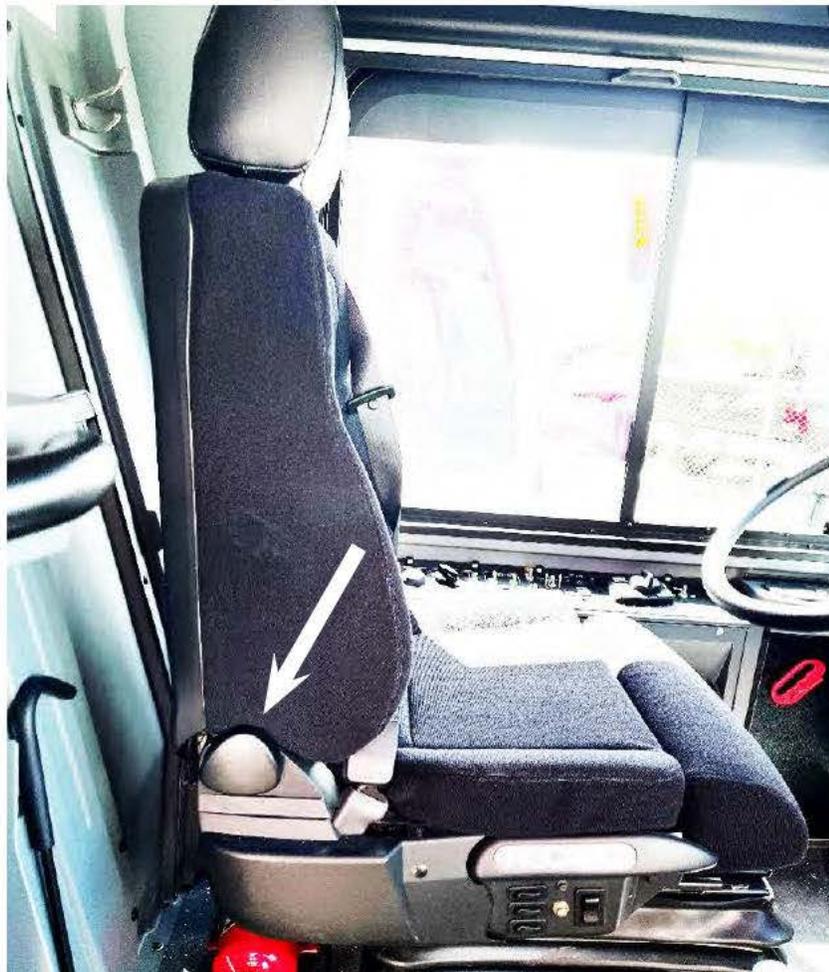
Back incline wheel

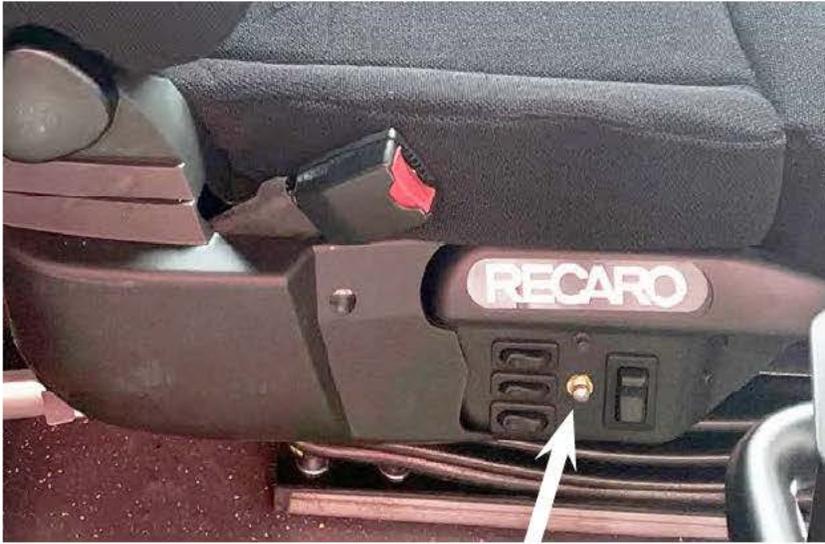
Slide back or forward button

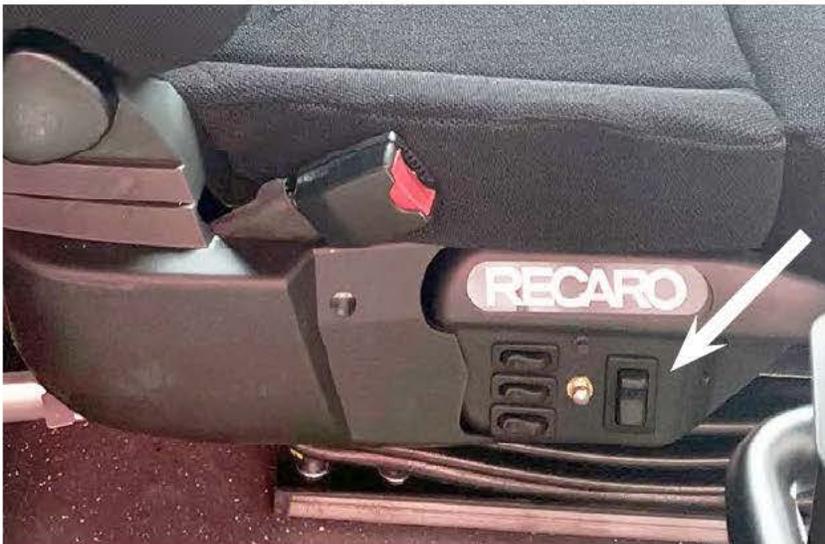
Up or down button

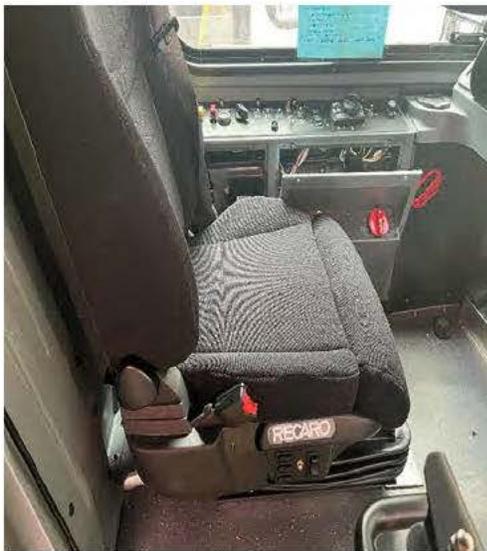
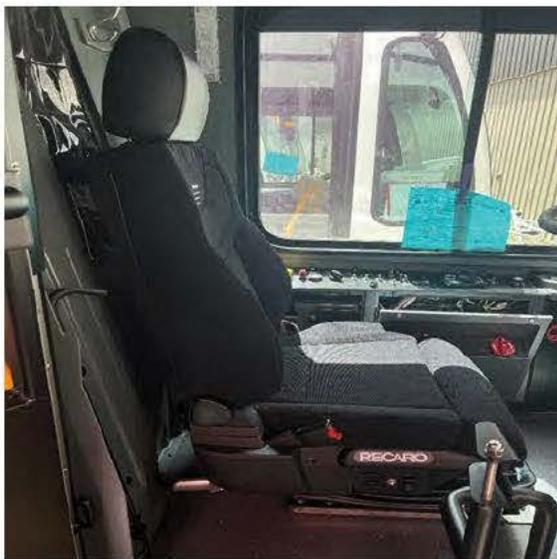
**TEST # 1 - FULLY DOWN, FULLY RECLINE, SLIDE ALL THE WAY BACK**

- Lower the seat completely.
- Recline the seat back completely.
- Slide the seat all the way back
- Pull the seat belt

Fully down  
Fully reclined

Fully reclined  
Slide back

**If the seat belt does not retract follow the retrofit instructions at the end of this document (see page 11).**

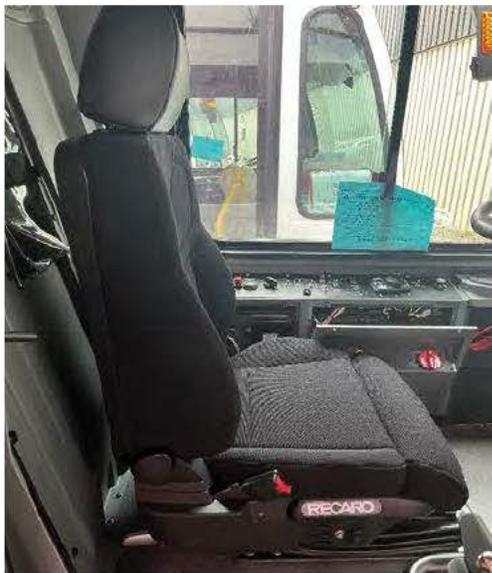
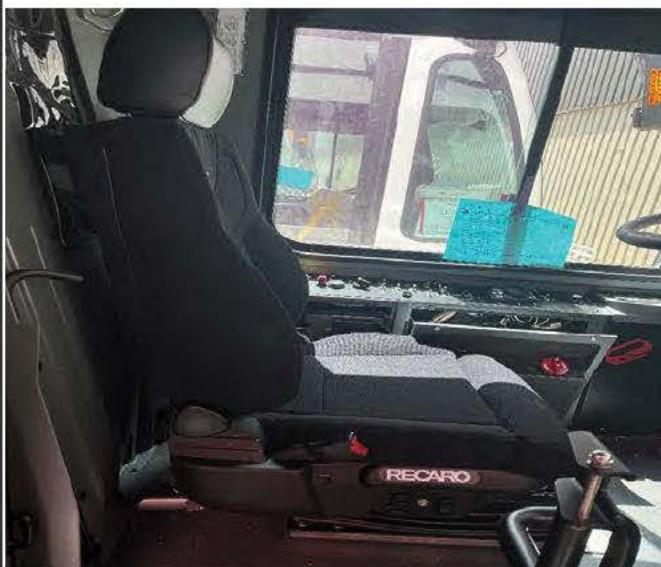
**TEST # 2 - FULL DOWN, 90 DEGREE BACK, SLIDE BACK, RECLINE UNTIL CONTACT**

- Lower the seat completely.
- Put the seat back at a 90 degree position.
- Slide the seat all the way back.
- Recline the seat back completely or until contact.
- Pull the seat belt.

Put the seat back at a 90 degree position

Slide back the seat and recline it fully

**If the seat belt does not retract follow the retrofit instructions at the end of this document (see page 11).**

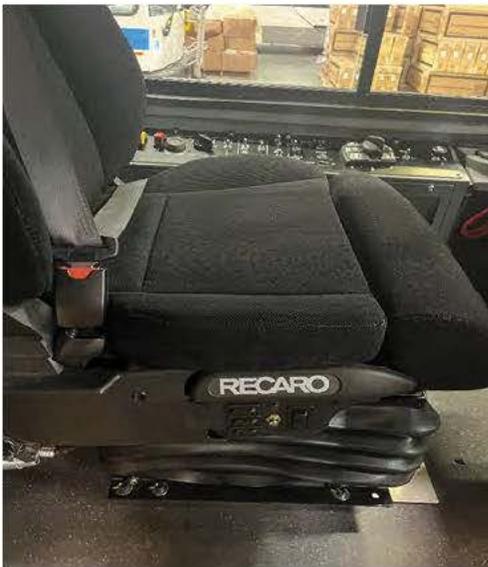
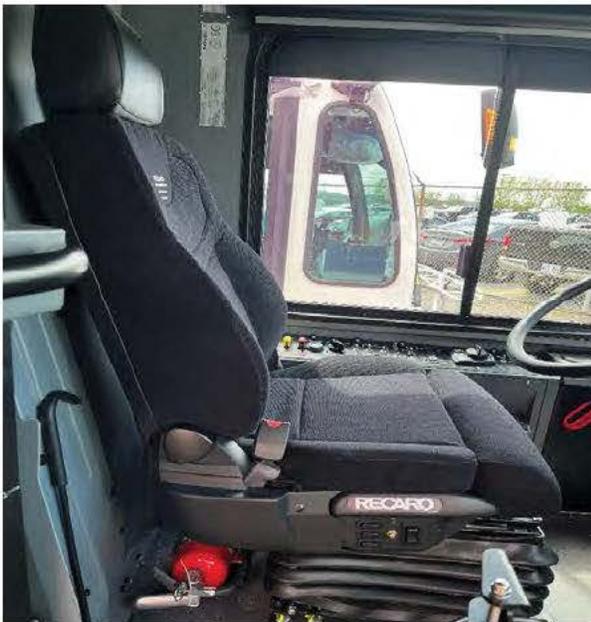
**TEST # 3 - FULL UP, FULL RECLINE, SLIDE BACK**

- Raise the seat at its maximum height.
- Recline the seat back completely.
- Slide the seat all the way back.
- Pull the seat belt.

Raise the seat at its maximum height

Recline the seat back completely  
Slide the seat all the way back

**If the seat belt does not retract follow the retrofit instructions at the end of this document (see page 11).**

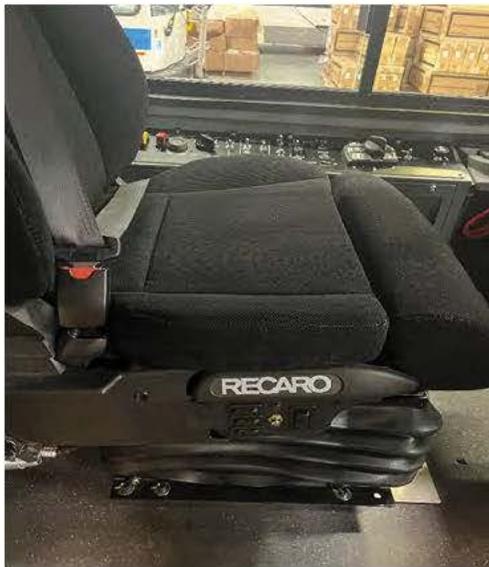
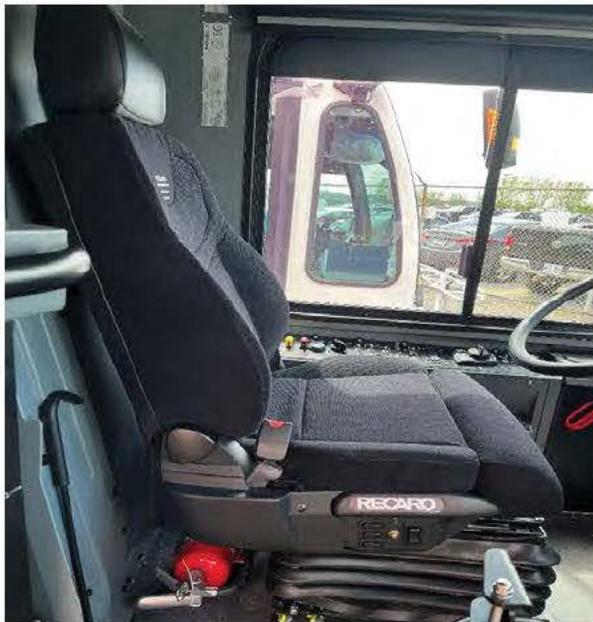
**TEST # 4 - FULL UP, FULL RECLINE, SLIDE BACK, LOWER THE SEAT**

- Raise the seat at its maximum height.
- Recline the seat completely.
- Slide the seat all the way back.
- Lower the seat completely.
- Pull the seat belt.

Raise the seat at its maximum height

Recline the seat back completely  
Slide the seat all the way back  
Lower the seat completely

**If the seat belt does not retract follow the retrofit instructions at the end of this document (see page 11).**

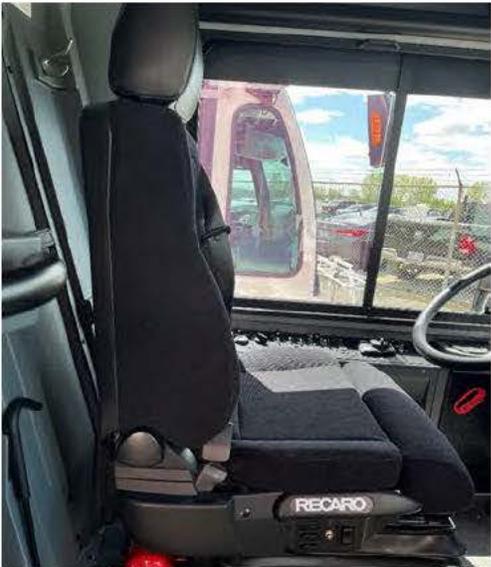
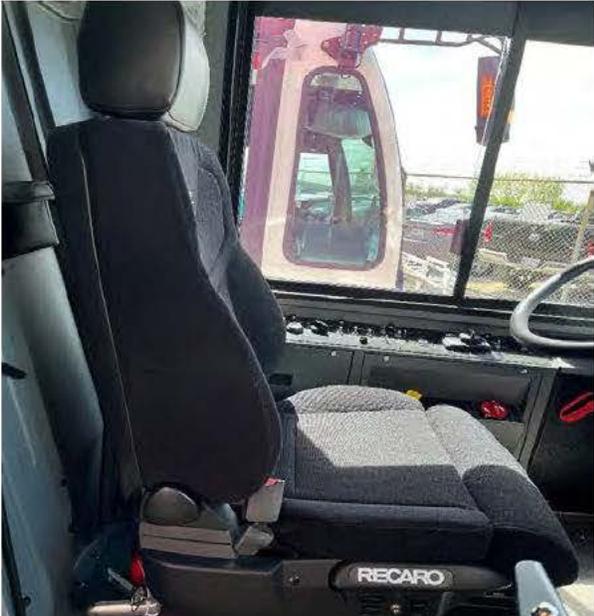
**TEST # 5 - FULL UP, 90 DEGREE BACK, SLIDE BACK, RECLINE UNTIL CONTACT**

- Raise the seat to its maximum height.
- Put the back at a 90 degree position.
- Slide the seat all the way back.
- Recline the seat back completely or until contact.
- Pull the seat belt.

<p>Raise the seat at its maximum height</p>

<p>Put the back at a 90 degree position          Slide the seat all the way back          Recline the seat back completely or until contact          Pull the seat belt</p>

**If the seat belt does not retract follow the retrofit instructions at the end of this document (see page 11).**

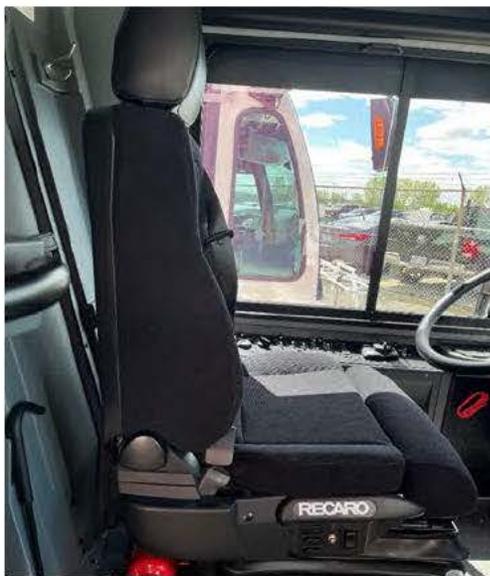
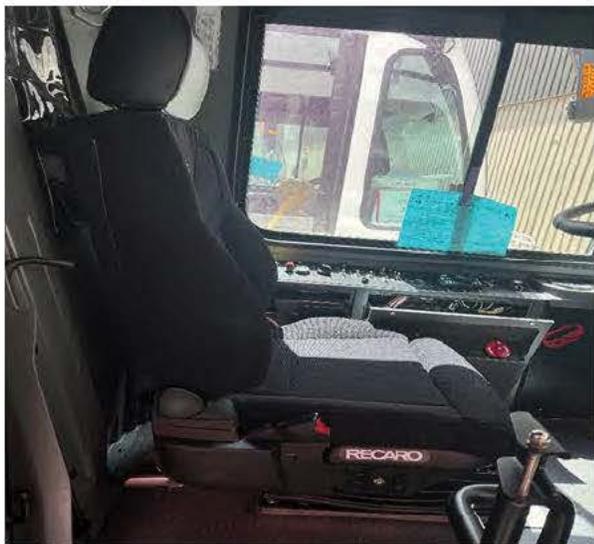
**TEST #6 - FULL UP, 90 DEGREE BACK, SLIDE BACK, RECLINE UNTIL CONTACT, LOWER SEAT**

- Put the back in a 90 degree position.
- Slide the seat all the way back.
- Recline the back of the seat until contact.
- Lower the seat completely.
- Pull the seat belt.

Put the back in a 90 degree position  
Slide the seat all the way back

Recline the back of the seat until contact  
Lower the seat completely

**If the seat belt does not retract follow the retrofit instructions at the end of this document (see page 11).**
