VOLUNTARY RECALL CAMPAIGN

Classification: RS23-005	Reference: NTB23-047	Date: May 25, 2023
-----------------------------	-------------------------	-----------------------

VOLUNTARY SAFETY RECALL CAMPAIGN REAR SEAT BELT ANCHOR

CAMPAIGN ID #: PC979
APPLIED VEHICLES: 2023 Rogue (T33)

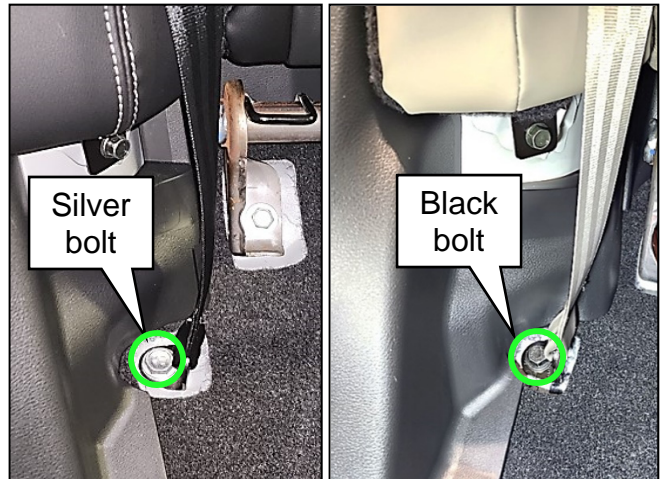
Figure 1

1. Remove the rear seat bottom cushion.
 - Refer to the **ESM: BODY INTERIOR > SEAT > REMOVAL AND INSTALLATION > REAR SEAT > Removal and Installation**
2. Locate and inspect BOTH outboard lower rear seat belt anchor bolts and note the bolt color on the repair order for each side (Figure 1 and Figure 2).
 - For bolts that are **BLACK** with a 14mm head, continue to step 3.
 - For bolts that are **SILVER** with an 18mm head, skip to step 4 on page 4.

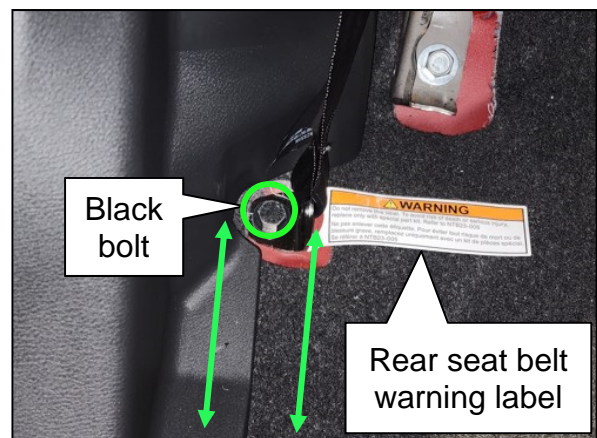
Figure 3

3. Loosen the **BLACK** outboard lower rear seat belt anchor bolt one (1) turn and then remove the rear seat belt warning label (Figure 3).
 - Make sure the anchor plate is parallel to the door opening and torque the **BLACK** outboard lower rear seat belt anchor bolt(s).
 - Outboard lower rear seat belt anchor bolt torque: 49 N•m (5.0 kg-m, **36 ft-lb**)
 - Skip to step 6 on page 4.

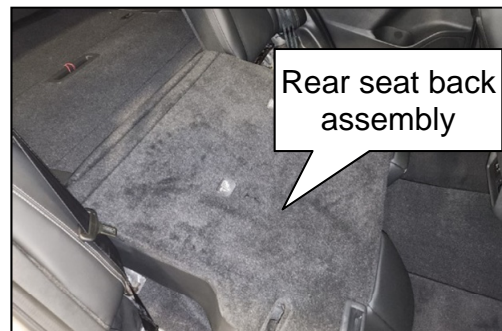
Figure 7

7. Lower the rear seat back assembly.

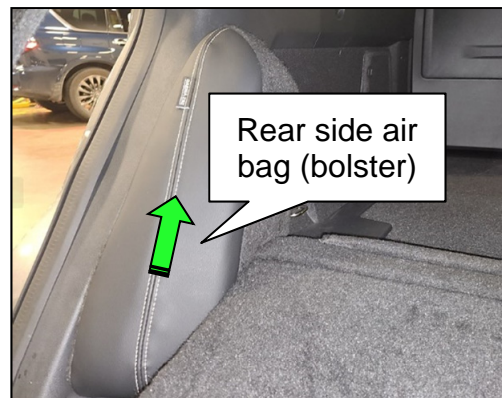
Figure 8

8. Remove the rear side air bag (bolster) for both sides.
 - a. Push the rear side air bag upward to disengage the upper retainer for both sides.
 - b. Remove both rear side air bags (bolsters) and place them next to the folded rear seatback assembly, as shown in Figure 9.

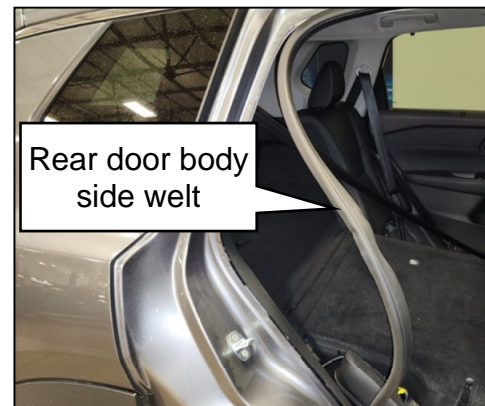
Figure 10

9. Partially remove the rear door body side welt (weather strip), as shown in Figure 10, for both sides.

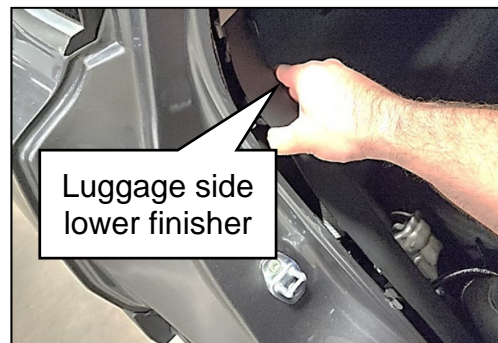
Figure 11

10. Lift the edge of the luggage side lower finisher to separate the retainers from the body, as shown in Figure 11, for both sides.

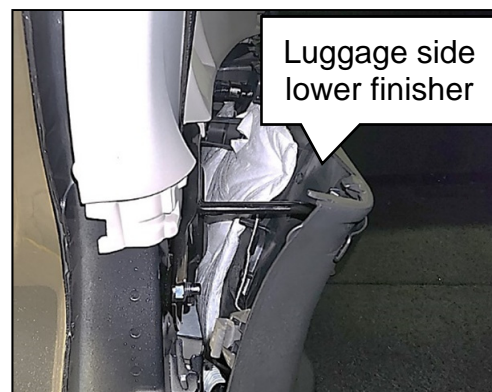
Figure 12

11. Carefully separate the luggage side lower finisher from the upper finisher, as shown in Figure 12, for both sides.

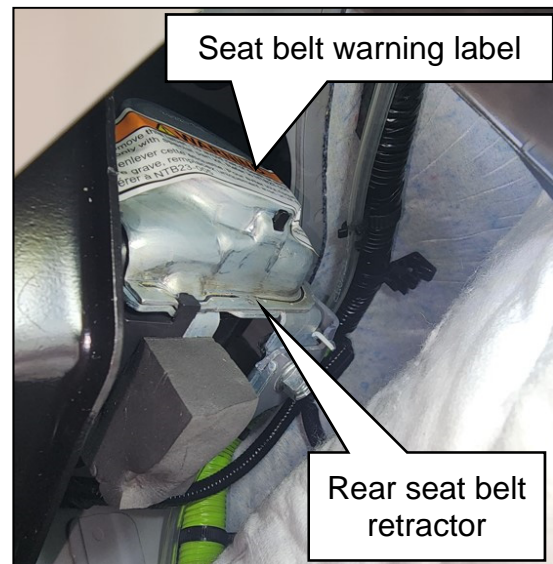
Figure 13

12. Remove the seat belt warning label only from the rear seat belt retractor with a **BLACK** lower anchor bolt (14mm head).

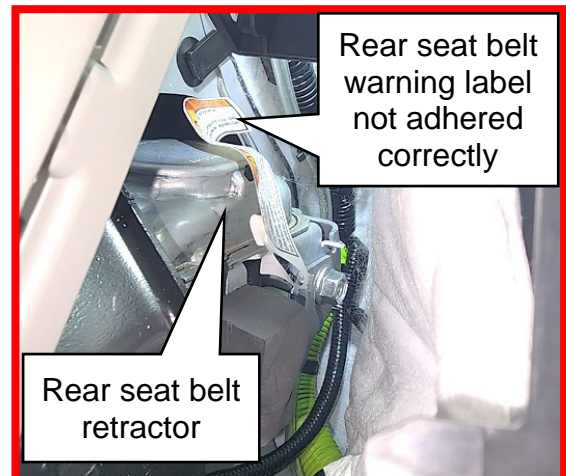
Figure 14

13. Inspect the rear seat belt warning label(s).
 - If a rear seat belt warning label is not adhered correctly, as shown in Figure 14, remove and reinstall the warning label correctly, as shown in Figure 15.

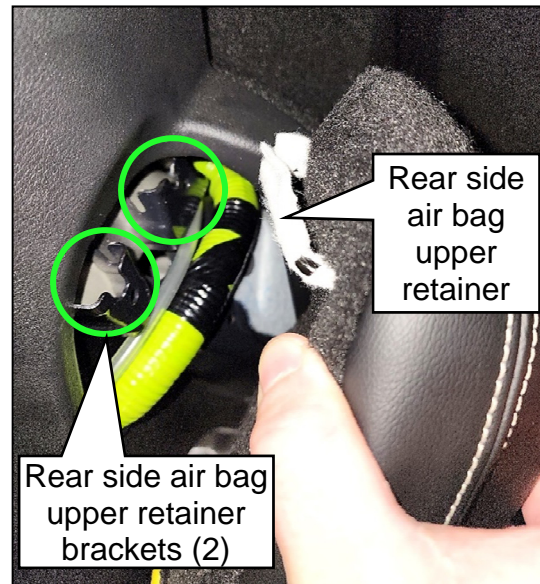
Figure 16

- a. Raise the rear seat back assembly.
- b. Torque the rear side air bag (bolster) bolts.
 - o Rear side air bag (bolster) bolt torque: 25 N•m (2.6 kg-m, **18 ft-lb**)

IMPORTANT: When reinstalling the rear side air bags (bolsters), be sure the upper retainer is locked into place by pulling the upper side of the bolster forward (toward the front of the vehicle).
