VOLUNTARY RECALL CAMPAIGN

Classification: RS23-005A	Reference: NTB23-047A	Date: September 19, 2023
------------------------------	--------------------------	-----------------------------

VOLUNTARY SAFETY RECALL CAMPAIGN 2023 ROGUE; REAR SEAT BELT ANCHOR

CAMPAIGN ID #: PC979
APPLIED VEHICLES: 2023 Rogue (T33)

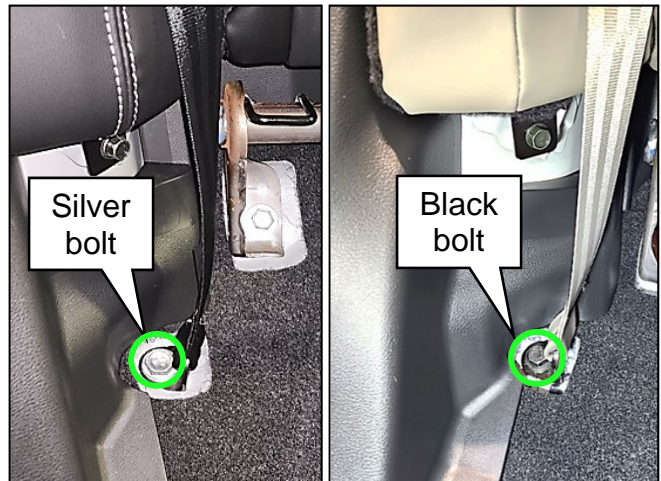
Figure 1

1. Remove the rear seat bottom cushion.
 - Refer to the ESM: **BODY INTERIOR > SEAT > REMOVAL AND INSTALLATION > REAR SEAT > Removal and Installation**
2. Locate and inspect BOTH outboard lower rear seat belt anchor bolts and note the bolt color on the repair order for each side (Figure 1 and Figure 2).
 - For bolts that are **BLACK** with a 14mm head, continue to step 3.
 - For bolts that are **SILVER** with an 18mm head, skip to step 5 on page 5.

HINT: Some vehicles may have SILVER lower rear seat belt anchor bolts on both sides of the vehicle.

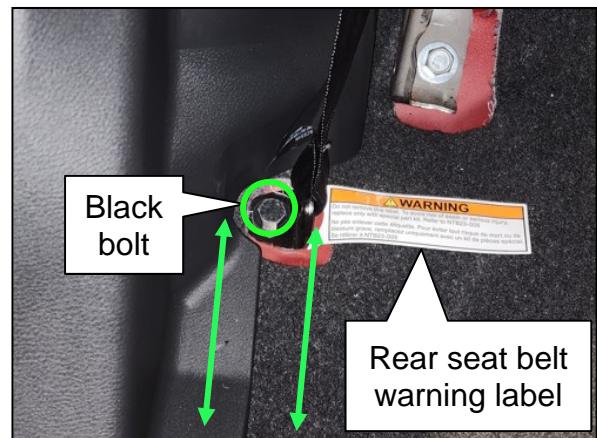
Figure 3

3. Loosen the **BLACK** outboard lower rear seat belt anchor bolt one (1) turn and then remove the rear seat belt warning label (Figure 3).
4. Make sure the anchor plate is parallel to the door opening and torque the **BLACK** outboard lower rear seat belt anchor bolt(s).
 - a. Outboard lower rear seat belt anchor bolt torque: 49 N•m (5.0 kg-m, **36 ft-lb**)
 - b. Skip to step 9 on page 6.

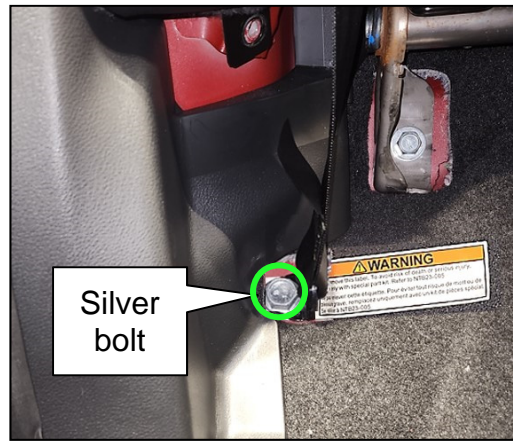
Figure 4

5. Remove the **SILVER** outboard lower rear seat belt anchor bolt.

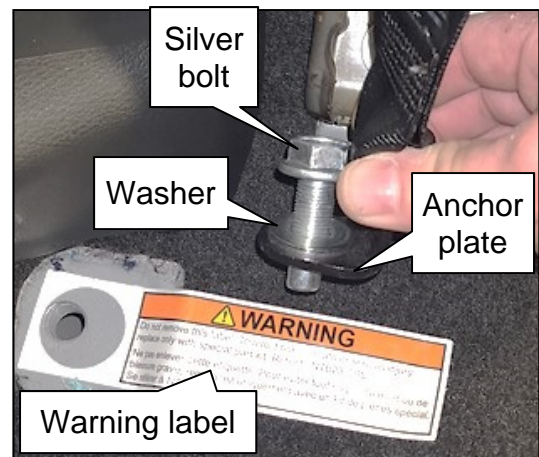
Figure 5

6. Verify correct positioning of the **SILVER** outboard lower rear seat belt anchor bolt washer and the seat belt warning label (Figure 5).

- a. Verify the seat belt warning label is installed as shown in Figure 5.
 - o Correct the warning label installation as needed.
- b. Verify the outboard lower rear seat belt anchor bolt washer is positioned between the bolt and the anchor plate.
 - o Correct the washer placement as needed.

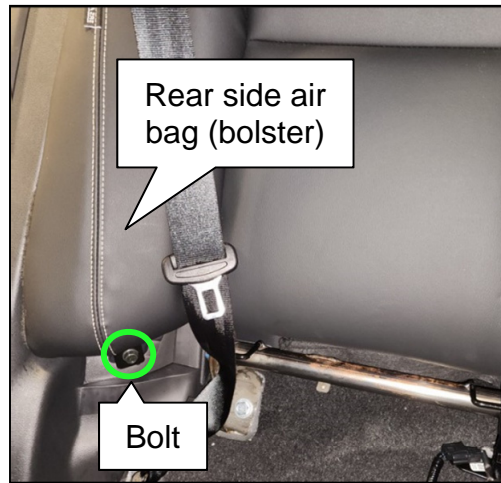
15. Remove the rear side air bag (bolster) bolts shown in Figure 6 for both sides.

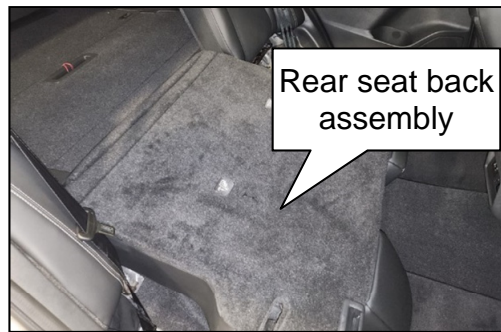
Figure 7

16. Lower the rear seat back assembly.

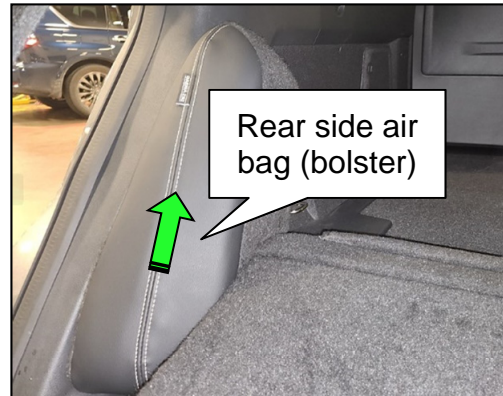
Figure 8

17. Remove the rear side air bag (bolster) for both sides.
 - a. Push the rear side air bag (bolster) upward to disengage the upper retainer for both sides.
 - Do **NOT** disconnect the rear side air bag connectors.

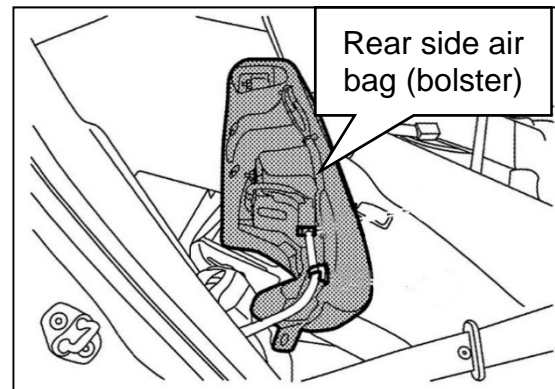
Figure 9

- b. Pull the rear side air bag (bolster) away from the body, but do not disconnect the wiring harness connector.

HINT: There is no need to disconnect the rear side air bags (bolsters).

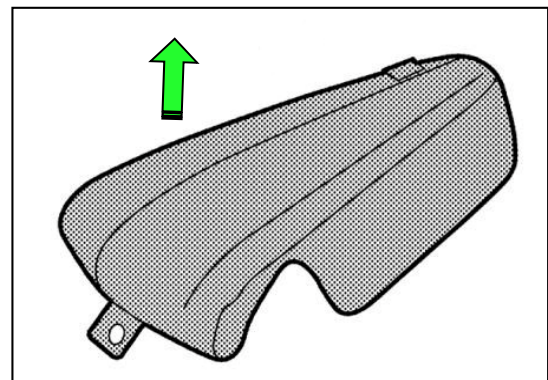
Figure 10

- c. Place the rear side air bag (bolster) next to the folded rear seat back assembly, with the air bag module deploying direction facing upward, as shown in Figure 10.

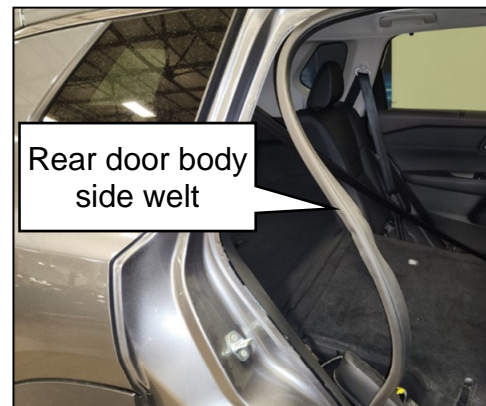
Figure 11

18. Partially remove the rear door body side welt (weather strip), as shown in Figure 11, for both sides.

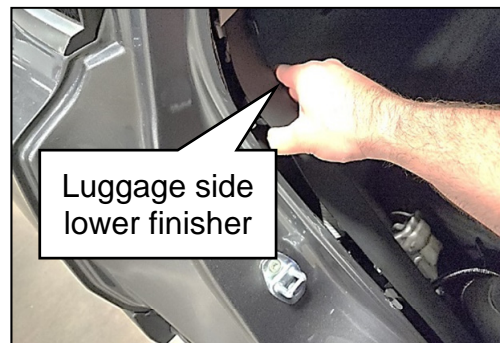
Figure 12

19. Lift the edge of the luggage side lower finisher to separate the retainers from the body, as shown in Figure 12, for both sides.

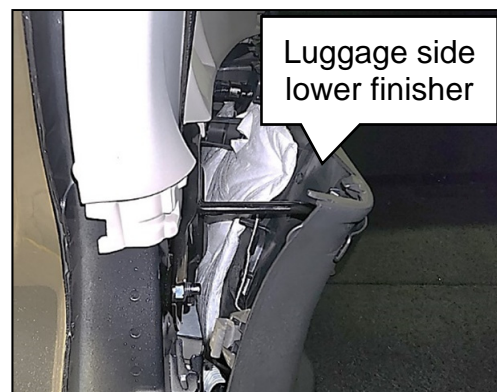
Figure 13

20. Carefully separate the luggage side lower finisher from the upper finisher, as shown in Figure 13, for both sides.

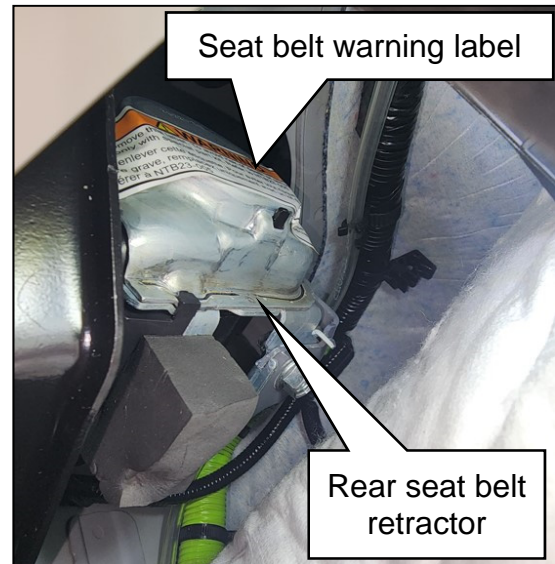
Figure 14

21. Remove the seat belt warning label only from the rear seat belt retractor with a **BLACK** lower anchor bolt (14mm head).

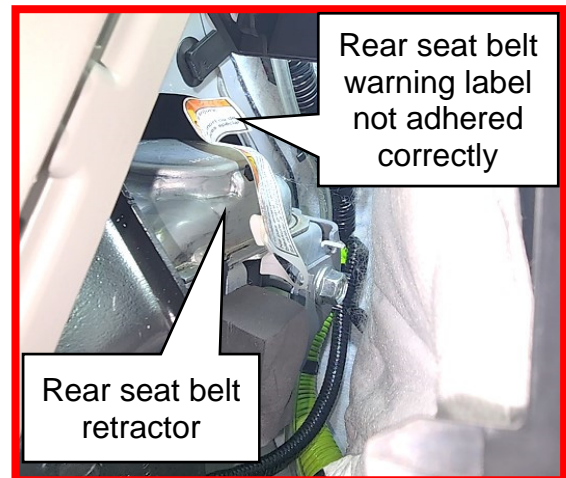
Figure 15

22. Inspect the rear seat belt warning label(s).
 - If a rear seat belt warning label is not adhered correctly, as shown in Figure 15, remove and reinstall the warning label correctly, as shown in Figure 16.

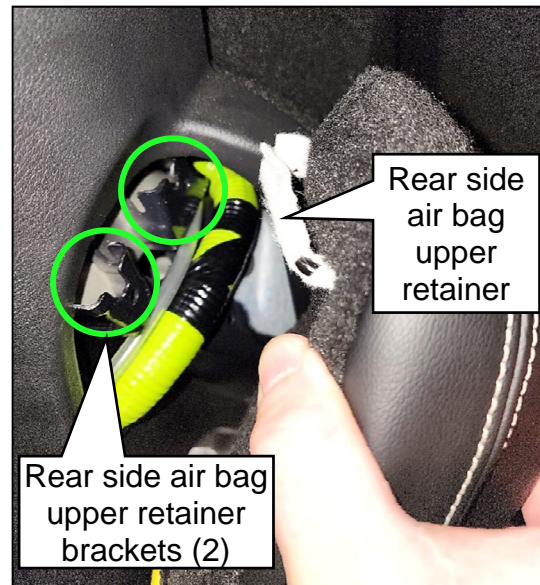
Figure 17

IMPORTANT: When reinstalling the rear side air bags (bolsters), be sure the upper retainer is locked into place by pulling the upper side of the bolster forward (toward the front of the vehicle).

- a. Raise the rear seat back assembly.
- b. Torque the rear side air bag (bolster) bolts.
 - o Rear side air bag (bolster) bolt torque: 25 N•m (2.6 kg-m, **18 ft-lb**)
