Keystone RV Company

SAFETY ADVISORY # 23-444

Arcadia Wardrobe Slide

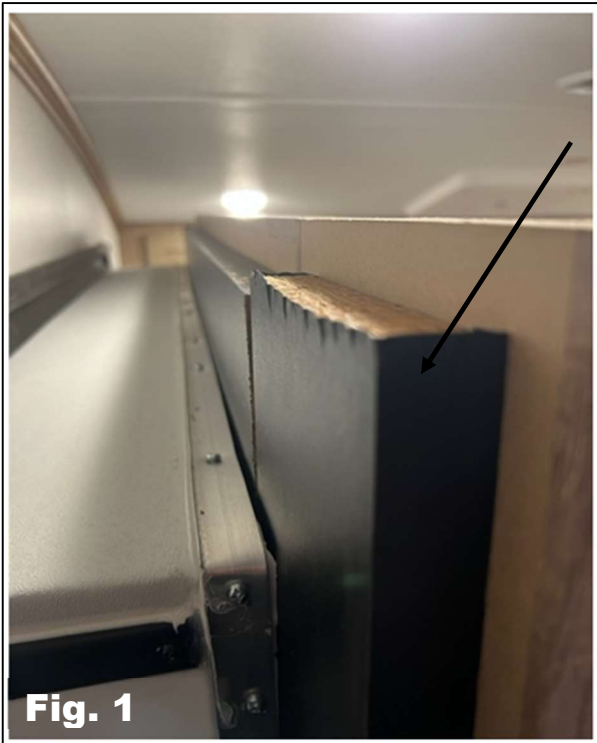
Go to the front bedroom wardrobe slide. With the slide room retracted (IN) check to see if the backer board is installed behind the cabinet front. See Figure 1. If the backer is there proceed to warranty reimbursement. If it is not there proceed to Step 3.

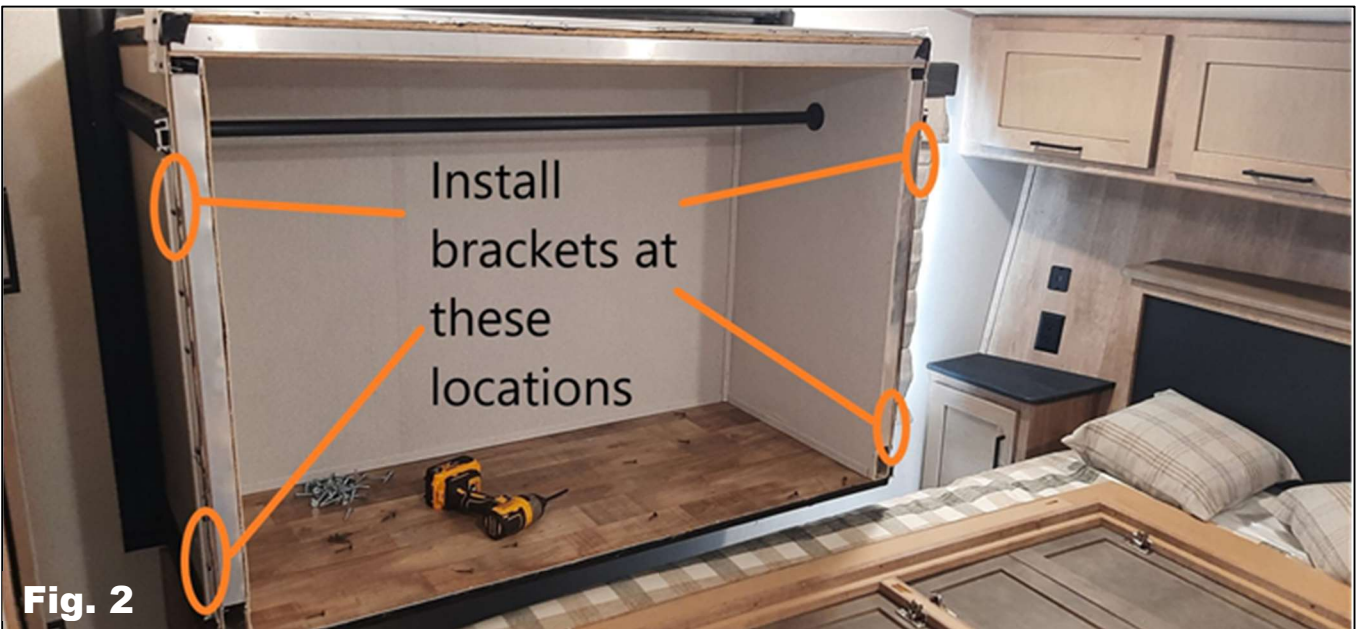
With the room in the retracted (IN) position open the cabinet doors on each side and remove the screws from inside wardrobe cabinet front cleat across the top, bottom, and sides. Carefully remove the cabinet front from the opening and lay it face down on the bed. See Figure 2.

Using KRV # 244953 - Mechanism - Inside Stand Off Bracket mark the slide box gutter and cut out sections with metal shears to allow mounting of the bracket in between the In-wall racks. The entire gutter trim does not need to be removed to do this. Remove just enough screws out of the trim to get your metal shears behind the main part of the trim and make a cut, make another cut into the gutter section itself and bend the trim to snap it off and remove. See Figures 2, 3A and 3B.

Position the KRV # 244953 - Mechanism - Inside Stand Off Bracket between the In-wall racks on the end wall of the slide box, two on each side, see figure 2. Make the bracket flush with the front of the end wall. Install a #10x1" screw in each available screw hole, six per bracket. Repeat on other side.
