BULLETIN

Subject:	Coupler Replacement		
Date:	July 10, 2023	Rev.: FR	No.: B23002
Re.:	Upper Coupler Inspection and Replacement.	Type:	Safety
Priority:	Earliest Opportunity		
Units Affected:	Please see VIN # listing.

The King Pin may not be welded to our internal standards in certain 2024 Wabash Van Trailers. The following Safety Bulletin describes the inspection process and the replacement procedure when needed.

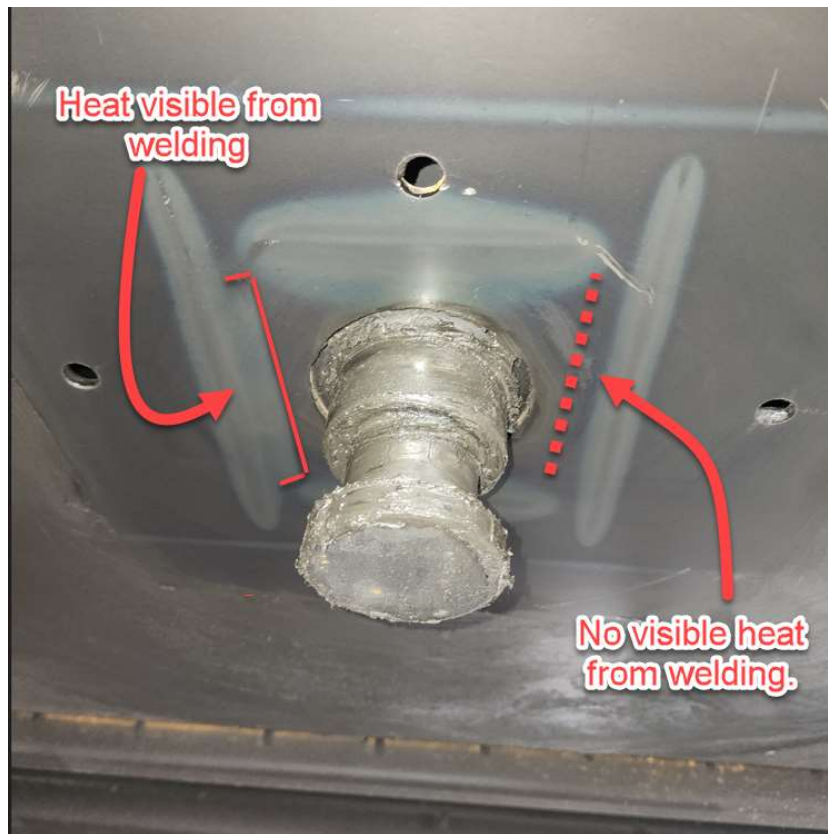
1. Select a trailer from the manufacture's provided vin listing.
 - a. Use a putty knife to scrape off grease and undercoating from around the king pin area.
 - b. Use acetone and shop rags to clean the area around the king pin to expose the heat effected areas from welding.
 - c. Look for the presencets or absencets of the inner weld on the drivers side and illustrated below:

2. If the weld is present, no action is needed. The area can be re-greased to your company's standard and the unit can be returned to service.
 - a. Please file a claim on-line to Wabash for this vin noting that the unit passed inspection and to be reimbursed for the 30 minutes for your time.
3. If the weld is missing, then the upper coupler assembly should be replaced as described starting on page 3.
