SAFETY RECALL

Date	Number	Release	Page
07. 2023	RVXX2305	01	1(21)

RollTek Seat Jumper Harness VN, VHD

RECALL INFORMATION

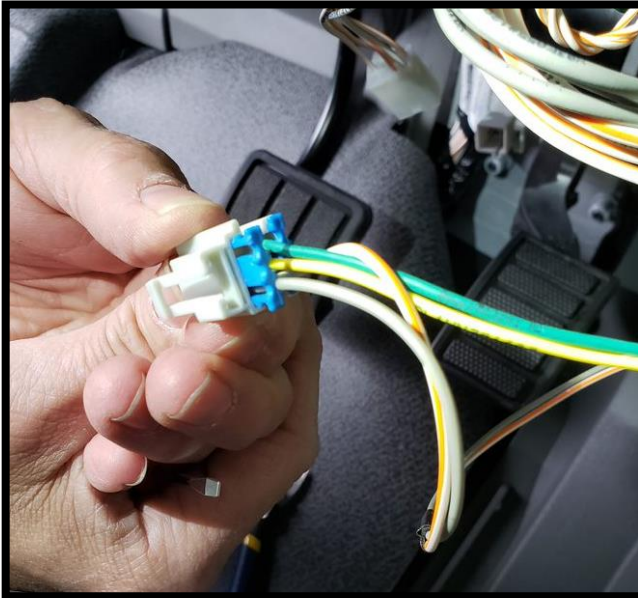
44. Insert the W/OR wire from jumper harness **24611200** into cavity C of the SRS connector

45. Insert the gray wire from the jumper harness **24611200** into cavity D of the SRS connector.

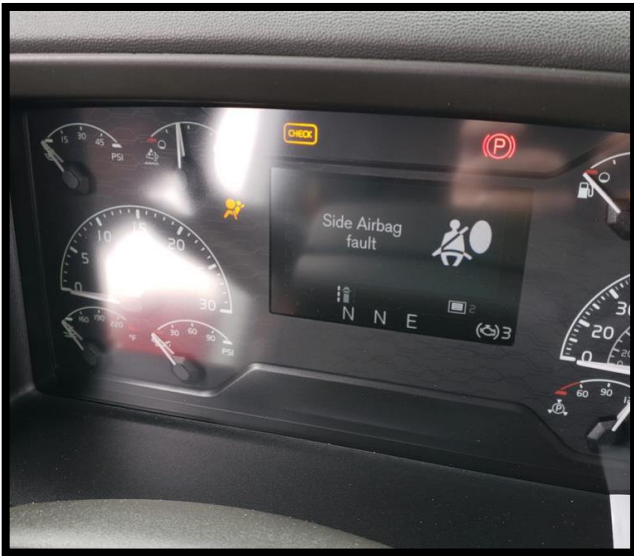
72. Once Fuse 59 as been removed cycle the ignition switches to the off position and then back on again.
73. If the system is functioning correctly there will be a message in the cluster showing a Side air bag system fault. (This could take up to 2 minutes)
