Recall Inspection and Repair Instructions

NHTSA Recall # 23V-406

Tiffin Motorhomes Recall # TIF-131

Purpose: To provide instructions on how to add an inline fuse to the A/C compressor power harness.

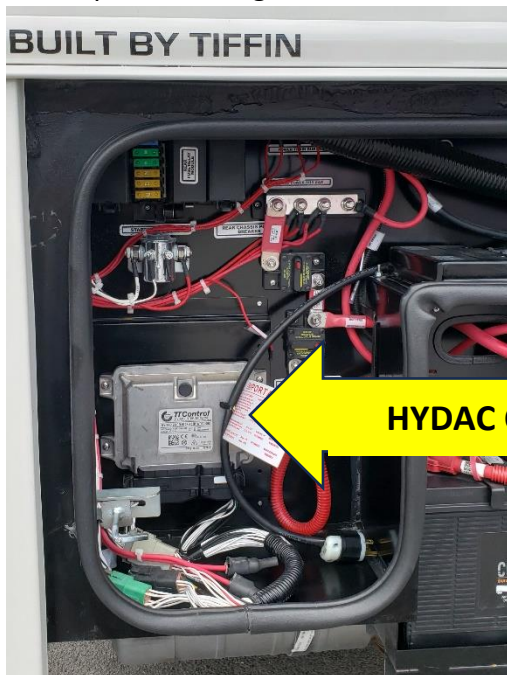
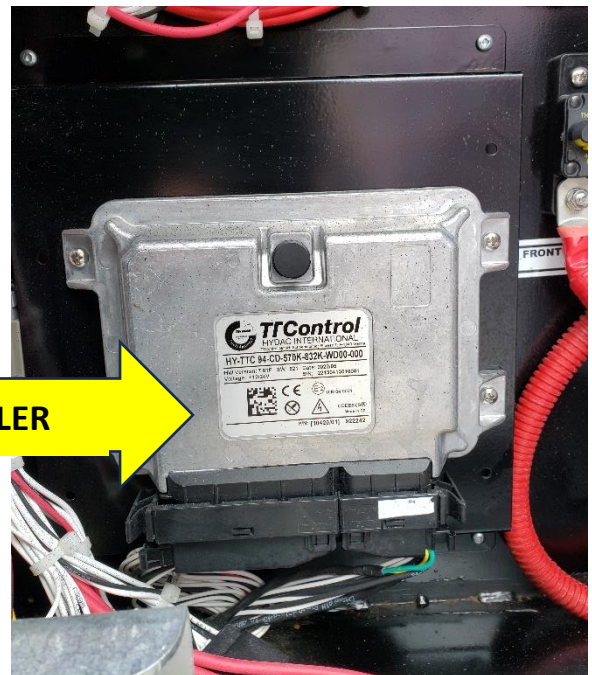
Figure 1a

1. Open passenger side rear compartment and visually inspect the chassis control module. The “HYDAC” brand (Figure 1a& 1b) is not involved. If a “HYDAC” brand is installed, file a claim for the inspection using the not involved flat rate code above.

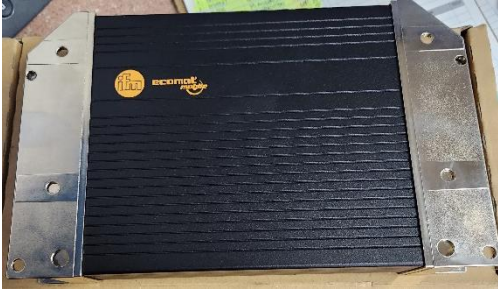
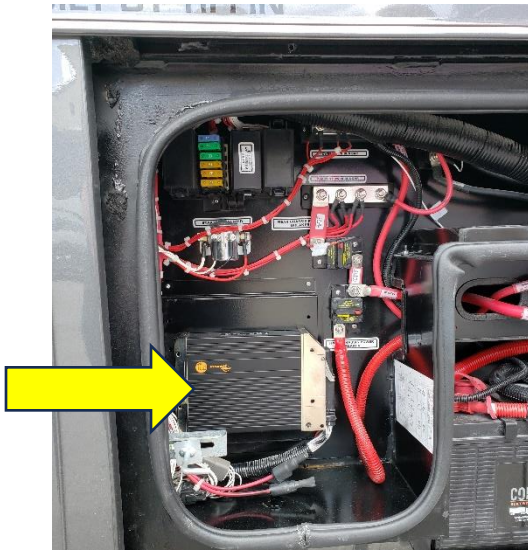
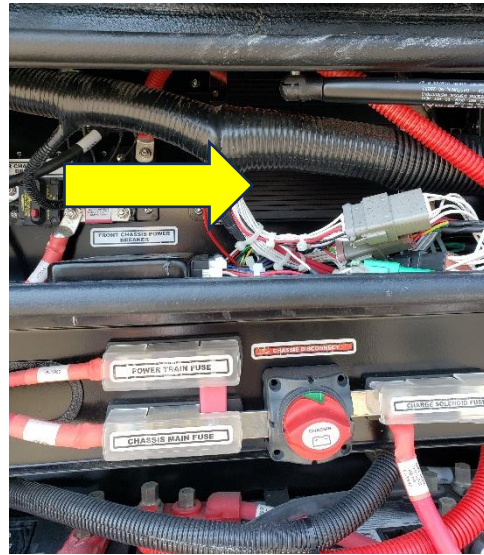
Figure 2a

2. If the chassis has an IFM Controller, shown in Figures 2a, 2b & 2c, please proceed with repair instructions.

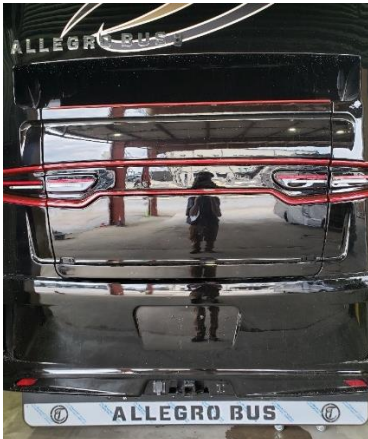
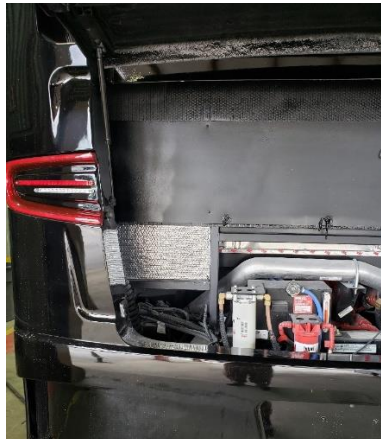
1. For Allegro Buses and Zephyrs with a side mounted radiator, open the engine compartment door at the rear of the coach.

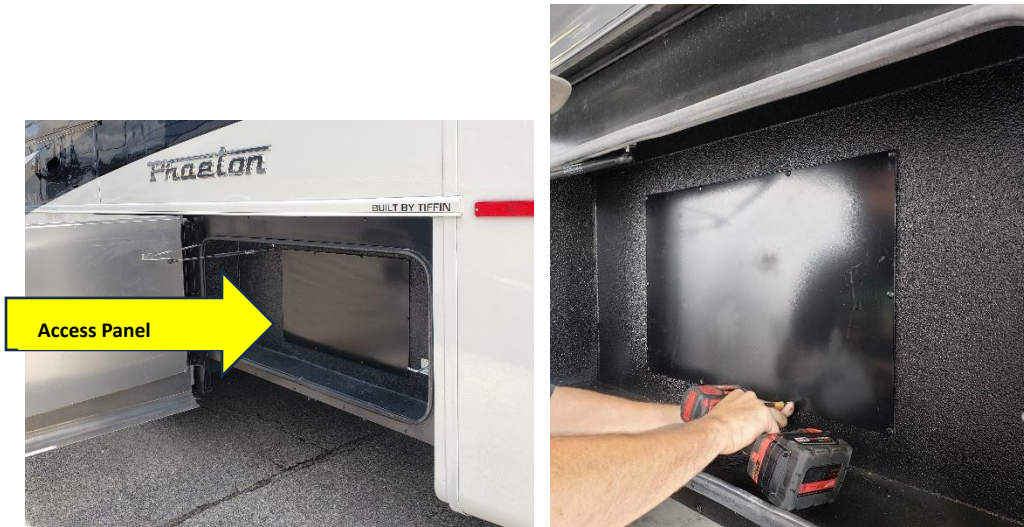
- For Phaetons equipped with a rear radiator, open the driver's side rear compartment and using the impact driver equipped with a Phillips head bit, remove the screws securing the access panel.

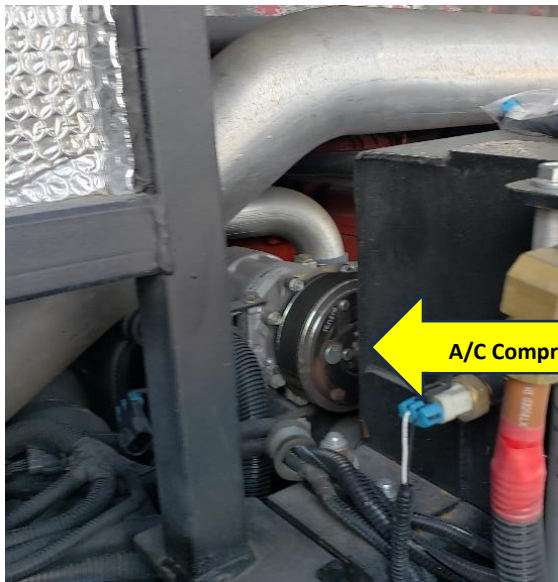
Allegro Bus & Zephyr

- Locate the A/C compressor on the driver's side, just behind the rear header.

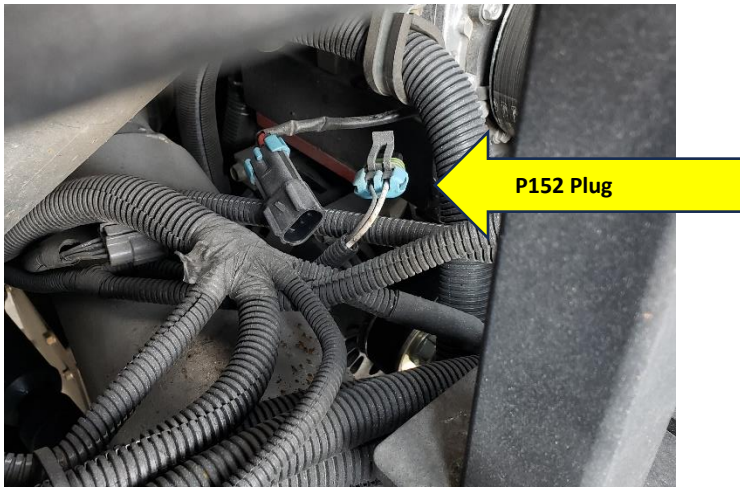
4. Unplug P152 at the A/C compressor.

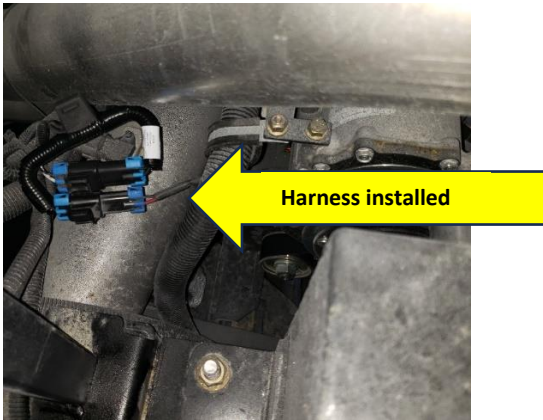
5. Install the 10-amp fuse jumper in between the chassis harness and the A/C compressor.

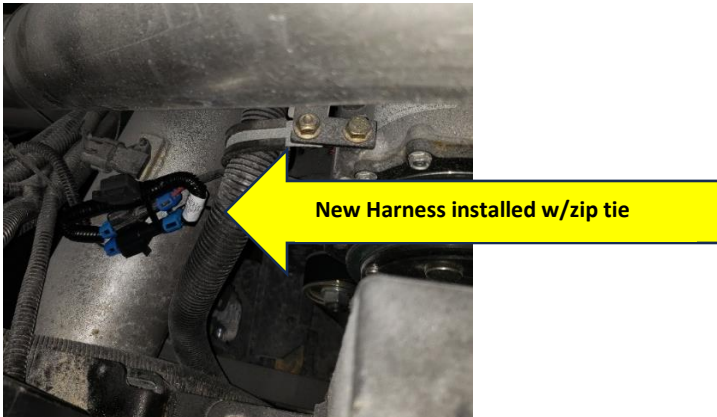
6. Secure the harness away from the exhaust with a zip tie.
