Remedy available for  
 2021 – 2023 Grand Cherokee / Grand  
 Cherokee L

**SAFETY RECALL**  
NORTH AMERICA  
**Rear Coil Spring**

Reference: 64A / NHTSA 23V-413

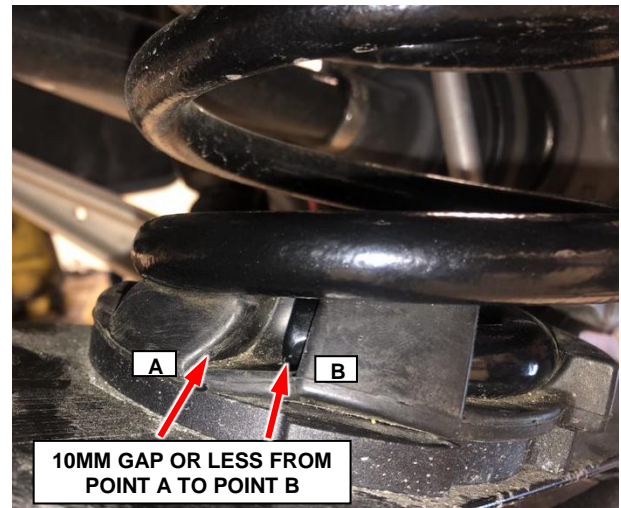
**Figure 1 – Check Coil Spring to Isolator Gap at Largest Point**

**NOTE:** If the spring stop is slightly deformed, measure the area of the largest gap.

**NOTE:** Neither the coil spring end nor the isolator spring stop are machined surfaces. If the ends of these surfaces are not parallel to each other, measure the area of the largest gap.

**NOTE:** In the following step, you will need to measure for a 10mm or less gap at the end of the coil spring. Use a stack of feeler gauges, toolmakers calipers and dividers, the square end of a 3/8" extension, or any tool that measures 10mm and will reach into the space to be measured.

2. Inspect for a 10mm or less gap from the end of coil to isolator spring stop, and for the coil not sitting on top of the center pilot of the isolator (Figures 1 and 2).

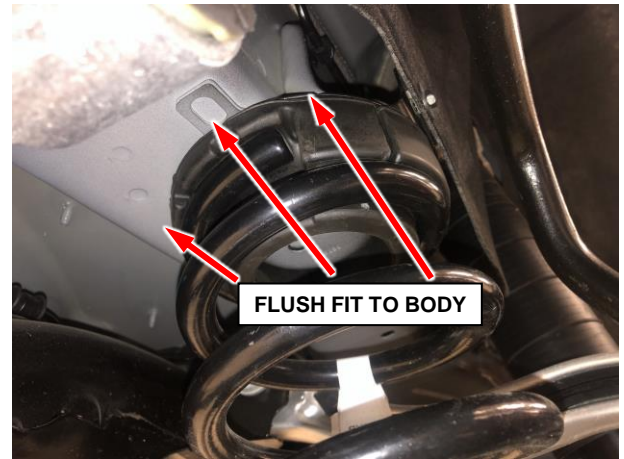
**Figure 3 – Upper Spring Isolator to Body**

- 3. Verify that the upper spring isolator is seated flush to the body on the welded pilot on the body (Figures 3 and 4).

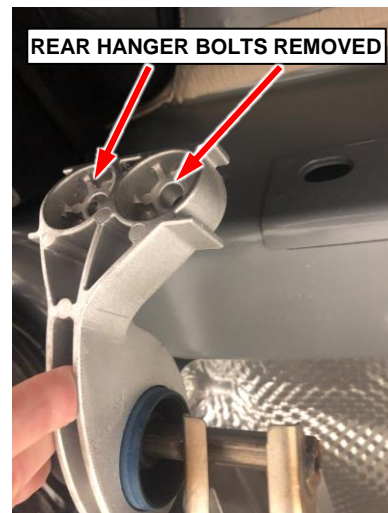
**Figure 5 – Rear Exhaust Hangers**

5. Remove both rear wheels.
6. Lower the exhaust system at its rear hangers at the rear of the vehicle to create clearance to lower the rear suspension crossmember. Support the system with a jack stand or strap (Figure 5).

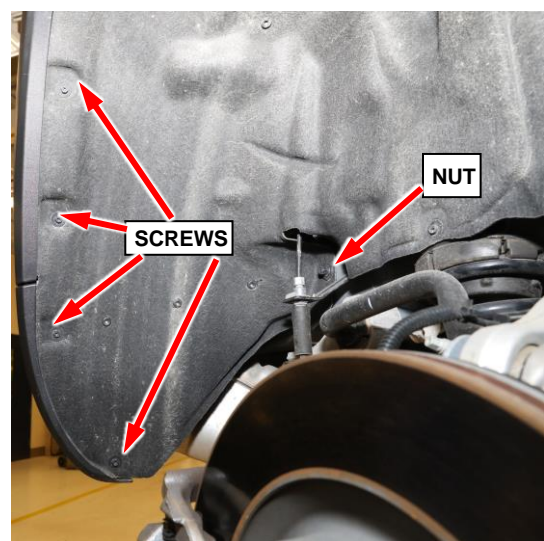
**Figure 6 – L Rear Wheel Liner Fasteners**

7. On L models with 3 row seating, the exhaust hangers can be accessed by removing the bottom of the wheel well liner and rolling it up out of the way (Figure 6).

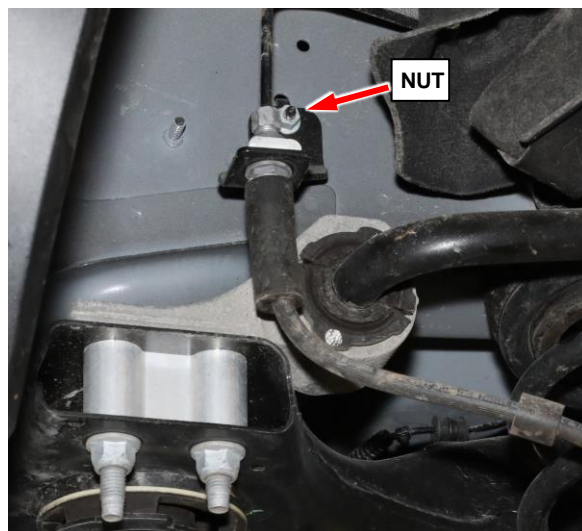
**Figure 7 – Brake Pipe Bracket**

- 8. Remove the nut holding the brake pipe bracket to the body (Figure 7).

24. Install the lower shock absorber clevis to the compression link. Install the clevis bolt and **NEW** nut and tighten the nut to 50 + 178° N·m (37 + 178° Ft. Lbs.) (Figure 9).
25. Install the nut holding the brake pipe bracket to the body tighten to 7 N·m (62 in. lbs.) (Figure 7).
26. Install the ride height sensor cable fastener (clip) to the body (if equipped) (Figure 12).
27. If needed, repeat steps 6-26 for the other side of the vehicle.
28. Raise the exhaust system at the rear of the vehicle and reattach it. On L models, resecure the wheel well liner, tightening the fasteners securely.
29. Perform a four-wheel alignment.
30. Return the vehicle to the owner.

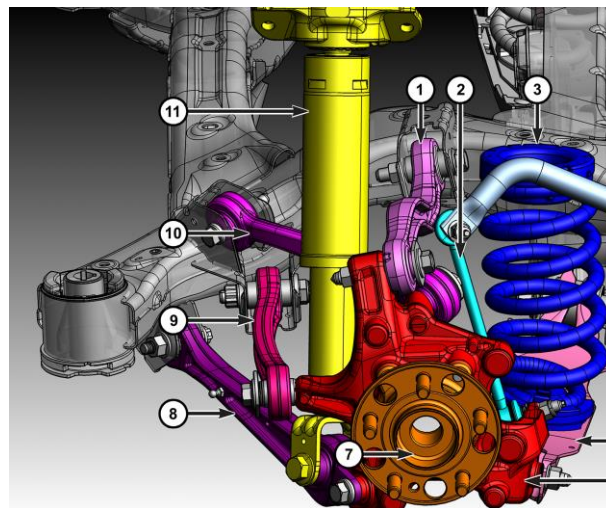
**Figure 8 – Rear Suspension**

- 9. Place a jack under the compression link (8) at the shock absorber end (Figure 8).

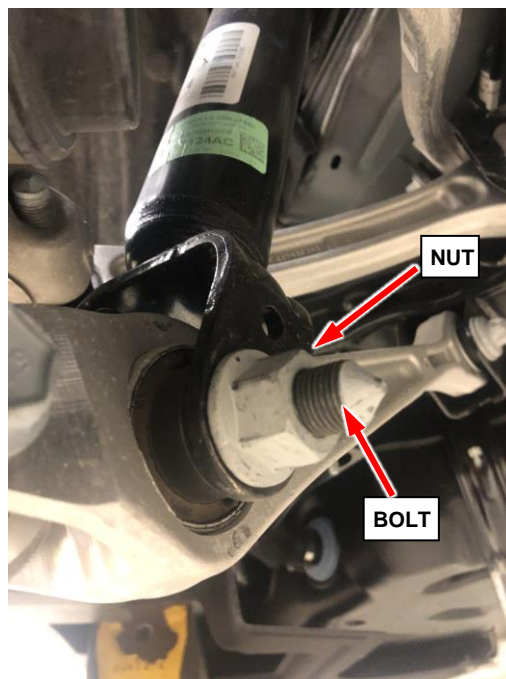
**Figure 9 – Lower Shock Clevis**

10. Remove the lower shock absorber clevis nut and bolt, then lower the jack under the compression link (Figure 9).

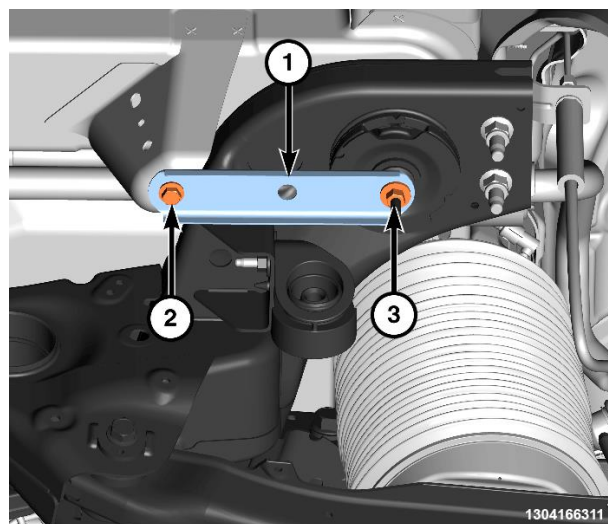
**Figure 10 – Rear Support Bracket**

11. Remove the bolt (2) and nut (3) and remove the rear crossmember rear support bracket (1) (Figure 10).

20. Raise the rear suspension crossmember, aligning the reference marks made previously. Install the **NEW** front and rear bolts, and tighten to 180 N·m (133 ft. lbs.) (Figure 13).
21. Perform the inspections in Steps 1-3 and verify that the vehicle now meets specifications. If it does not, repeat steps 15-20.
22. Install the rear crossmember front support bracket (3), bolt (2) and nut (1) and tighten to 20 N·m (15 ft. lbs.) (Figure 11).
23. Install the rear crossmember rear support bracket (1), bolt (2) and nut (3) and tighten to 20 N·m (15 ft. lbs.) (Figure 10).

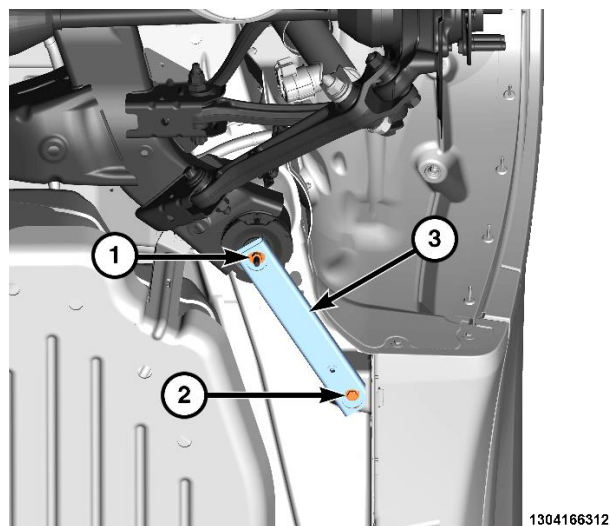
**Figure 11 – Front Support Bracket**

12. Remove the bolt (2) and nut (1) and remove the rear crossmember front support bracket (3) (Figure 11).

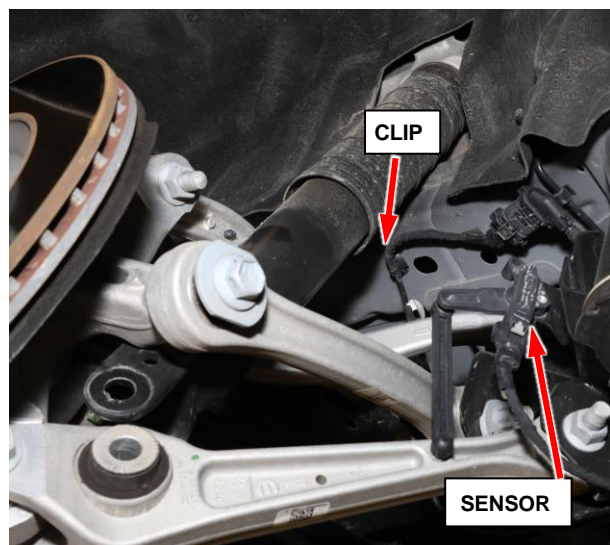
**Figure 12 – Ride Height Sensor Cable Fastener**

13. Remove the ride height sensor cable fastener (clip) at the body (if equipped) (Figure 12).

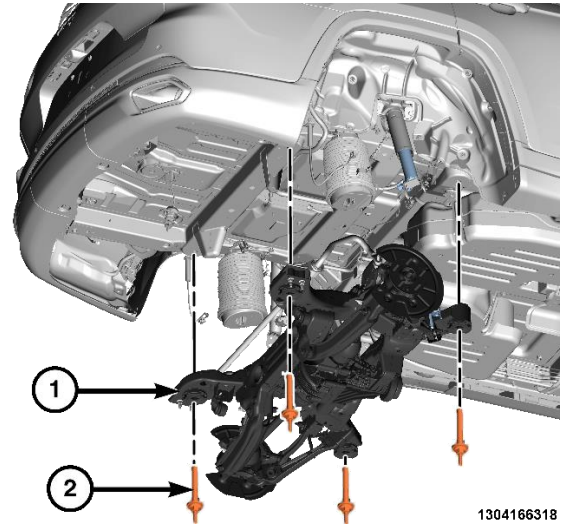
**Figure 13 – Rear Suspension Crossmember**

14. Using a suitable marking device, mark the position of the crossmember on the rear frame rails.
15. Support the crossmember at the center with a suitable lifting device and remove the front and rear bolts from one side. (Figure 13).

**NOTE: A second technician will be required to work the lifting device and control the rear spring during removal, and keep it properly aligned during installation.**
