GROUP	NUMBER
RECALL	23-01-057H
DATE	MODEL(S)
<b>JUNE 2023</b>	PALISADE (LX2)

BRAKE BOOSTER INSPECTION & REPLACEMENT (RECALL 245)

**Description:** Due to improper manufacturing of the brake booster, the diaphragm could slip out of position resulting in a loss of vacuum and a loss of power brake assist. This would result in increased vehicle stopping distance. This bulletin describes the procedure to inspect the brake booster and replace if necessary on certain 2023MY Palisade (LX2) vehicles.

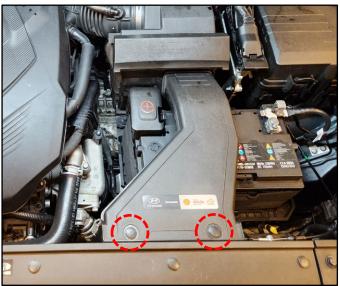
3. Remove the air intake duct.

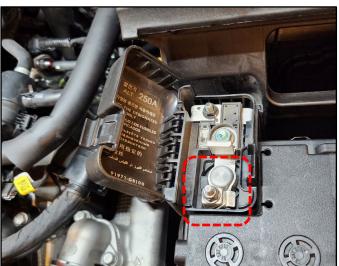
4. Disconnect the battery positive (+) terminal.

lb-ft	6.5
lb-in	78
N.m	8.8

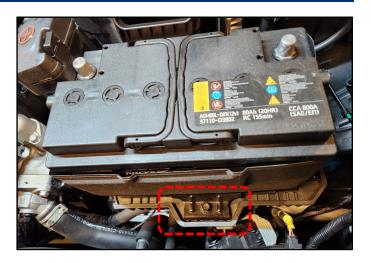
5. Remove the battery bracket, and the battery.

lb-ft	9.1
lb-in	109
N.m	13.7

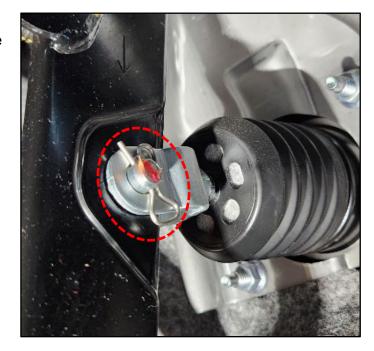
11. From the driver's footwell area, remove the retaining snap pin, and the clevis pin from the brake pedal.

- Replace the snap pin in the same (original) position when reassembling.
- If the snap pin is visually deformed, replace it with a new one.
- Apply a thin layer of general purpose grease before installing the clevis pin.

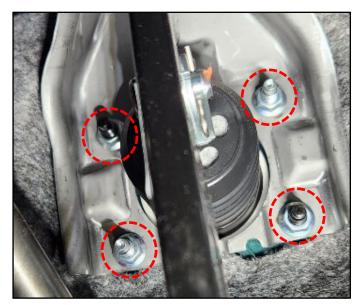
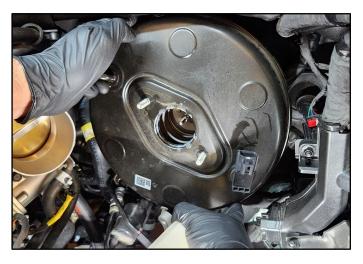
12. Remove the brake booster mounting nuts. Remove the brake booster from the vehicle.

lb-ft	16
N.m	21

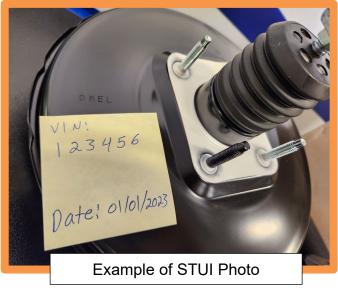
13. Check the LOT number of the brake booster on the **BACK shell** (brake pedal side of the booster).

There are two LOT #s on each brake booster. One on the front shell, one on the back shell. Check the LOT# on the back shell.

- If the LOT number is "DSA2", replace the brake booster with a new one.
- For all other LOT numbers, reinstall the original brake booster.
