December 18, 2024

Version 6

## Safety Recall: 2019–23 Multi-Model Install FAKRA Service Cables at MOST Bus Network

Supersedes 23-047, dated August 11, 2023, to revise the information.

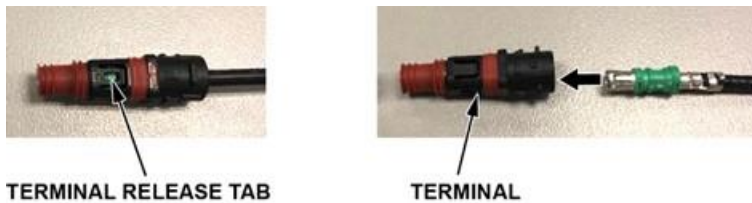
2. Release the lock tab and remove the terminal from the vehicle harness.

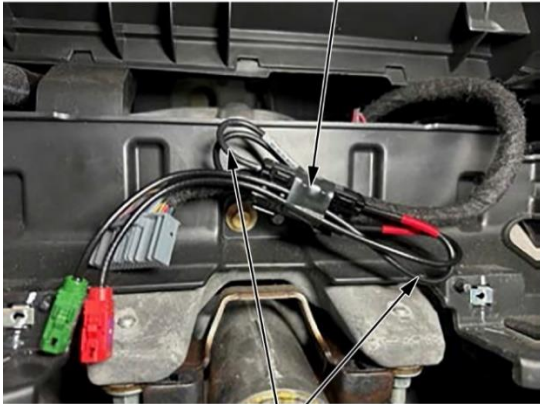
Attach FAKRA service cables and splice boxes to the appropriate component harness with tape to prevent any rattles.

Keep smooth curves with a radius bend greater than 25 mm.

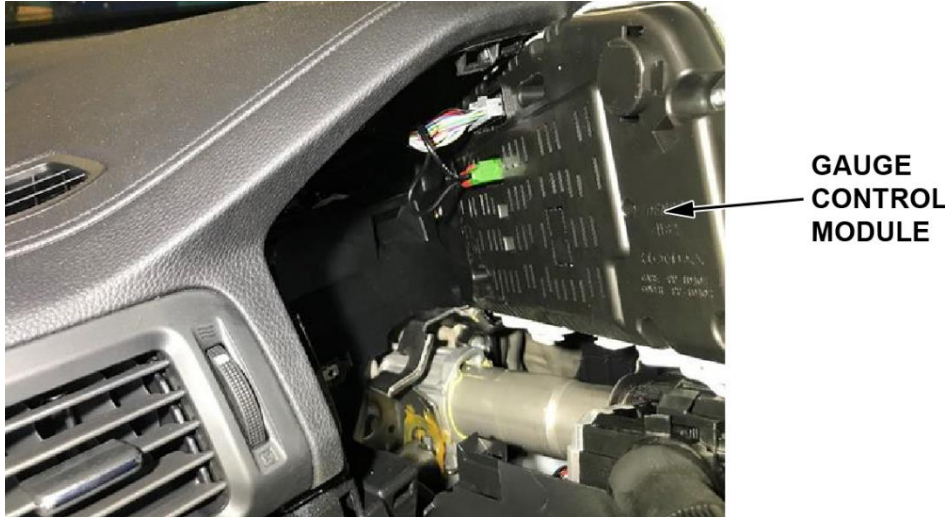
1. Locate and turn the gauge control module to access the rear connectors.

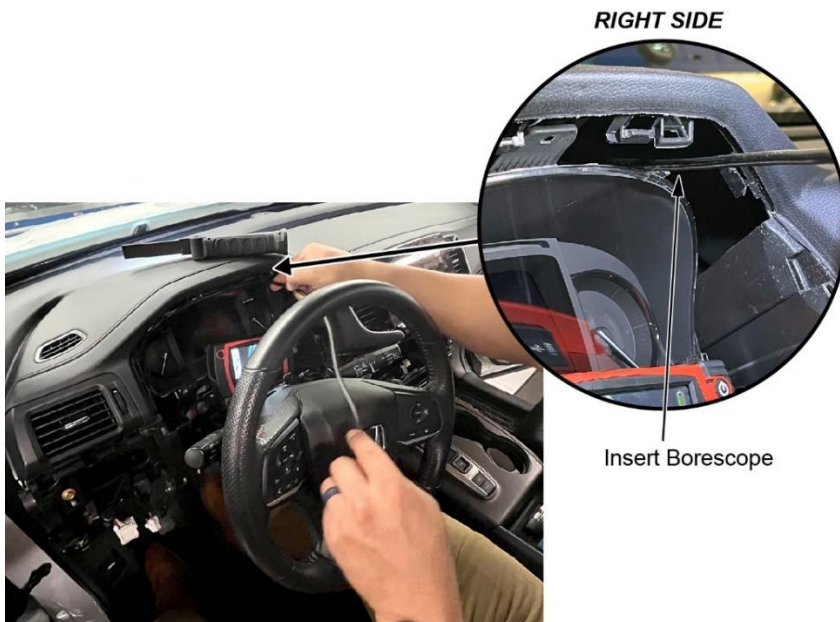
9. Using the digital borescope (T/N BK5600DUAL55) or a commercially available borescope with multiple view angles, inspect the cable routing at the back of the gauge control module as shown below to make sure the cables are routed straight and not bent at the connector(s). Adjust gauge control module harness as needed to achieve proper cable routing.

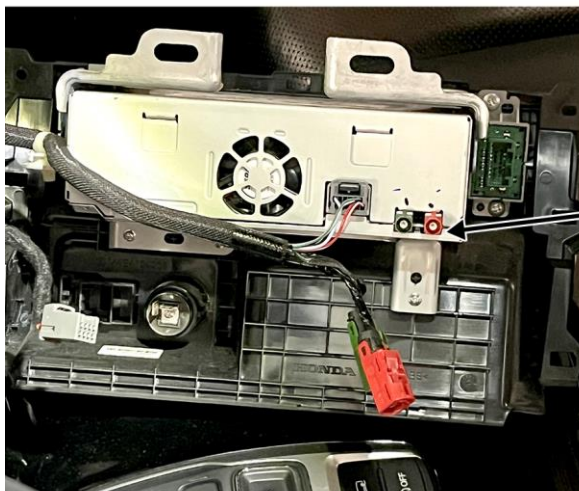
NOTE: Disassemble the connectors one at a time to avoid swapping the green and red wires.

EXTENSION CABLES  
Remove and discard.

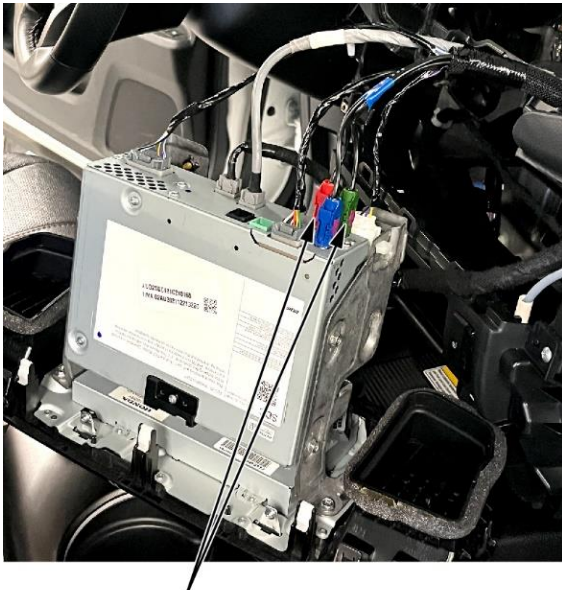
FAKRA CONNECTORS

- Make sure to protect the center console and the surrounding surfaces when working on the infotainment control unit.
- Disassemble the connectors one at a time to avoid swapping the green and red wires.
- If a CD player is present, begin the **PILOT – ACCESSORY CD PLAYER REPAIR PROCEDURE**.
- **If not**, proceed to **step 3**.

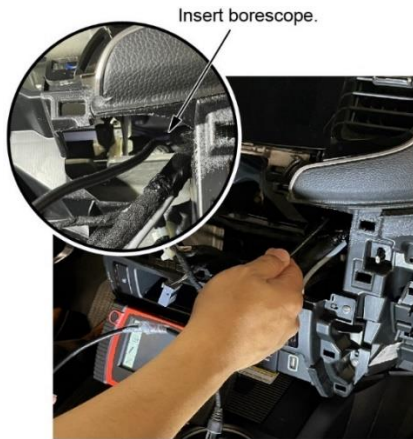
BORESCOPE

5. Reconnect the FAKRA connectors and any other related connectors to the infotainment control unit.
6. Position the infotainment control unit into its mounting location.
7. Using the digital borescope (T/N BK5600DUAL55) or a commercially available borescope with multiple view angles, inspect the cable routing at the back of the gauge control module as shown below to make sure the cables are routed straight and not bent at the connector(s). Adjust infotainment control unit harness as needed to achieve proper cable routing.

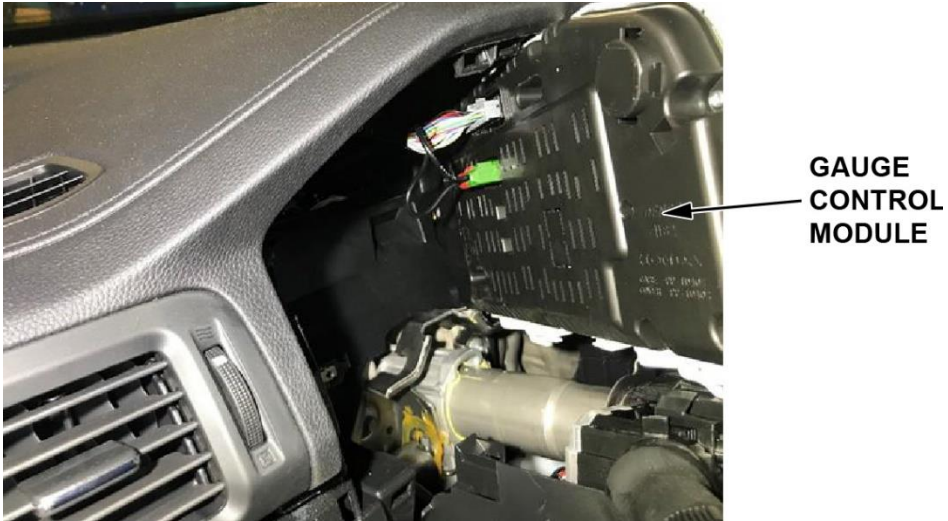
1. Locate and turn the gauge control module to access the rear connectors.

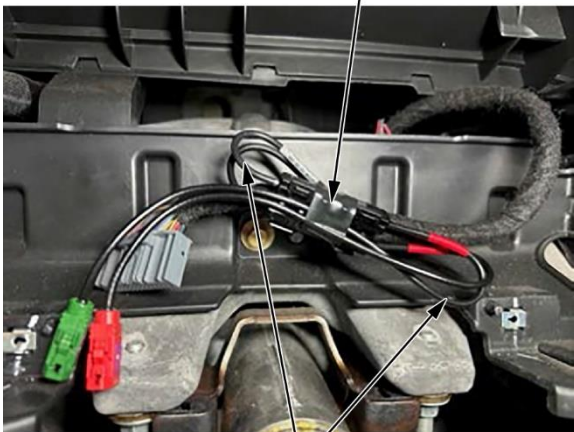
Attach FAKRA service cables and splice boxes to the appropriate component harness with tape to prevent any rattles.

Keep smooth curves with a radius bend greater than 25 mm.

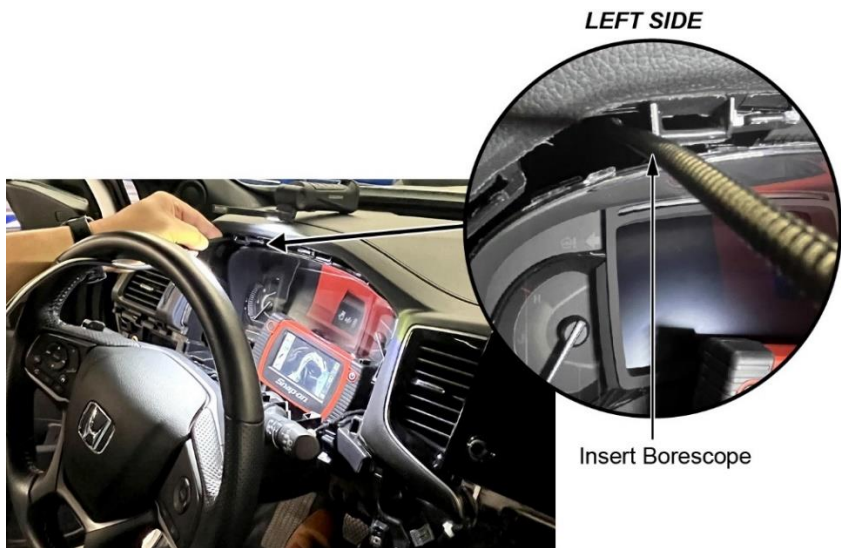
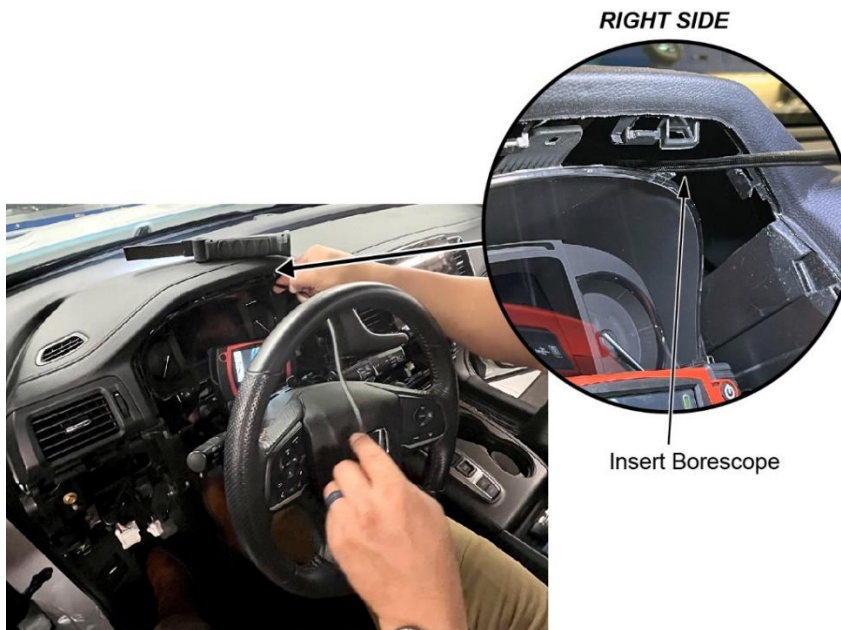
8. Using the digital borescope (T/N BK5600DUAL55) or a commercially available borescope with multiple view angles, inspect the cable routing at the back of the gauge control module as shown below to make sure the cables are routed straight and not bent at the connector(s). Adjust gauge control module harness as needed to achieve proper cable routing.
