Safety Recall: 2019–23 Multi-Model Install FAKRA Service Cables at MOST Bus Network

Supersedes 23-047, dated July 5, 2023, to revise the information.

BACKGROUND

CORRECTIVE ACTION

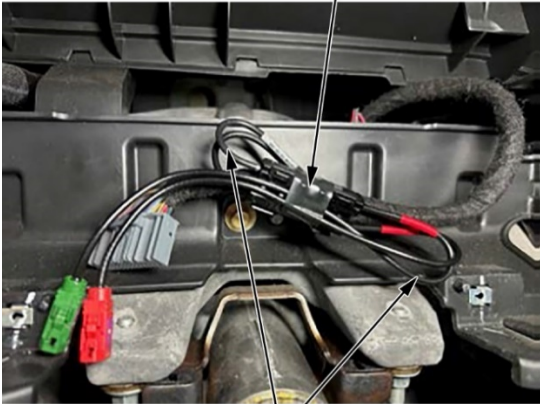
Attach FAKRA service cables and splice boxes to the appropriate component harness with tape to prevent any rattles.

Keep smooth curves with a radius bend greater than 25 mm.

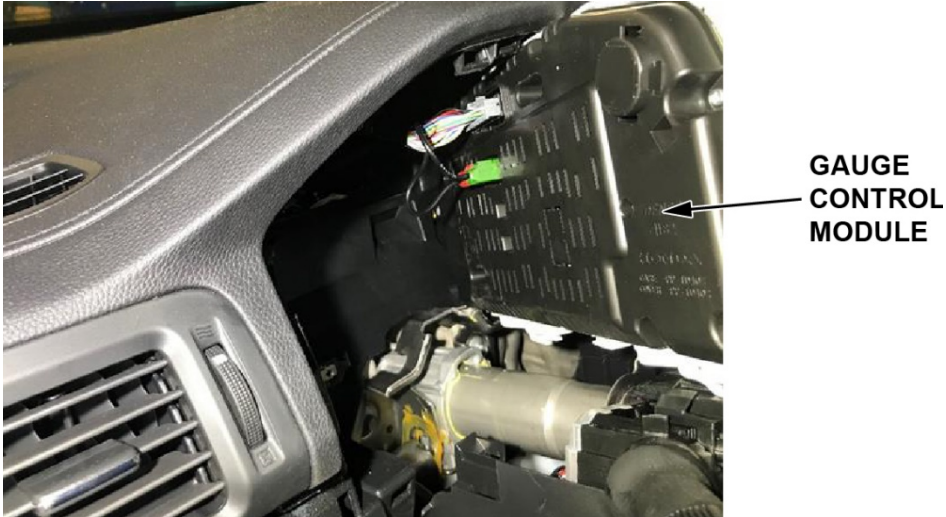
1. Locate and turn the gauge control module to access the rear connectors.

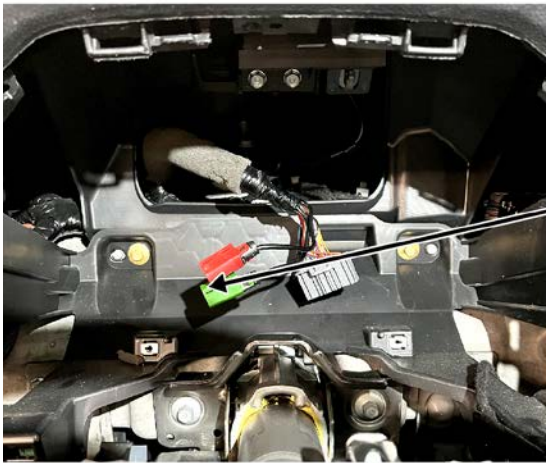
NOTE: Disassemble the connectors one at a time to avoid swapping the green and red wires.

EXTENSION CABLES
Remove and discard.

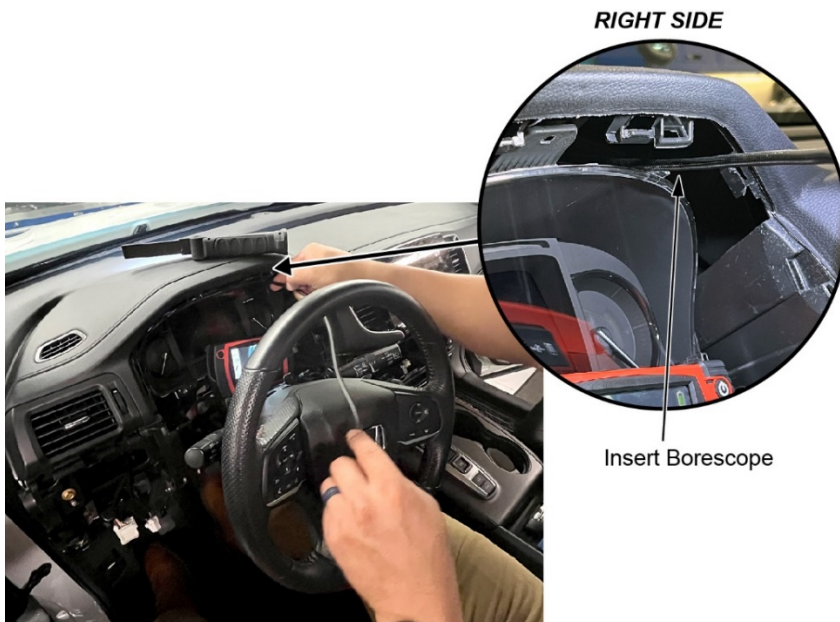
9. Using the digital borescope (T/N BK5600DUAL55) or a commercially available borescope with multiple view angles, inspect the cable routing at the back of the gauge control module as shown below to make sure the cables are routed straight and not bent at the connector(s). Adjust gauge control module harness as needed to achieve proper cable routing.

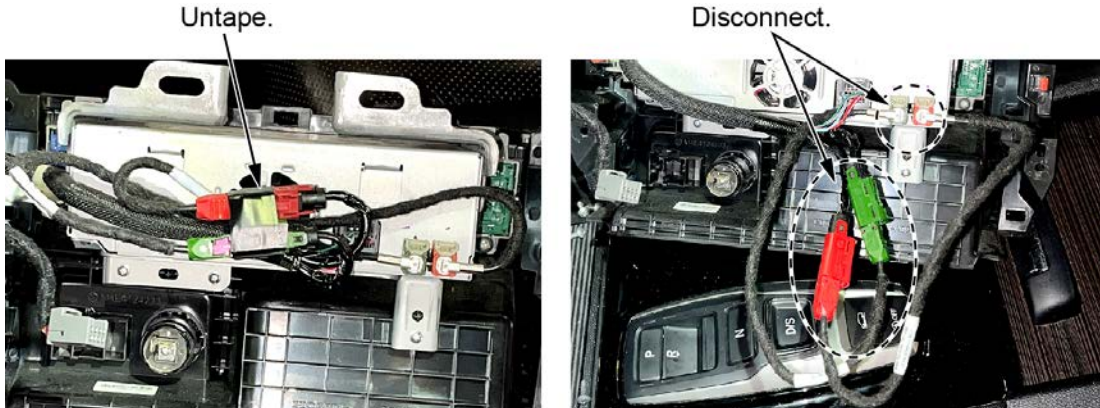
1. Disconnect the red and green FAKRA connectors and any other related connectors at the Blu-Ray player.
2. If the WPC FAKRA service housings and 90° extension cables are installed, untape the WPC connectors and extension cables from the vehicle harness.

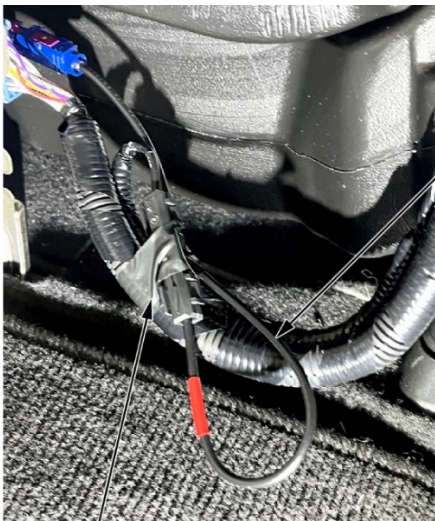
3. Tape the splice box and cable to the in-line harness.

Attach FAKRA service cable and splice box to the appropriate component harness with tape to prevent any rattles.

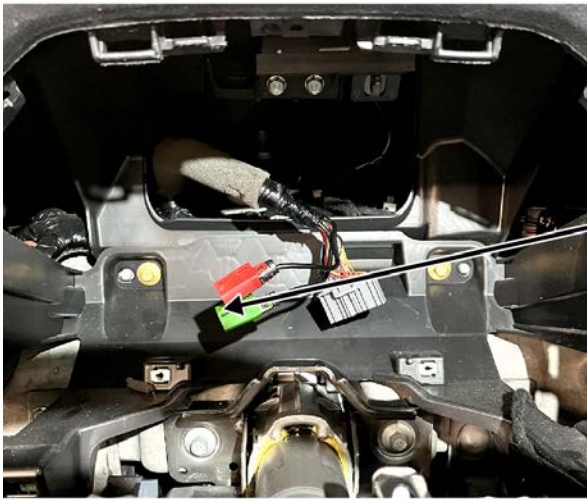
NOTE: Disassemble the connectors one at a time to avoid swapping the green and red wires.

EXTENSION CABLES
Remove and discard.

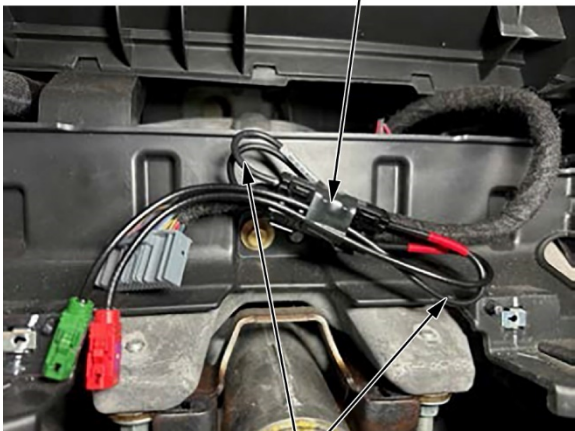
Attach FAKRA service cables and splice boxes to the appropriate component harness with tape to prevent any rattles.

Keep smooth curves with a radius bend greater than 25 mm.

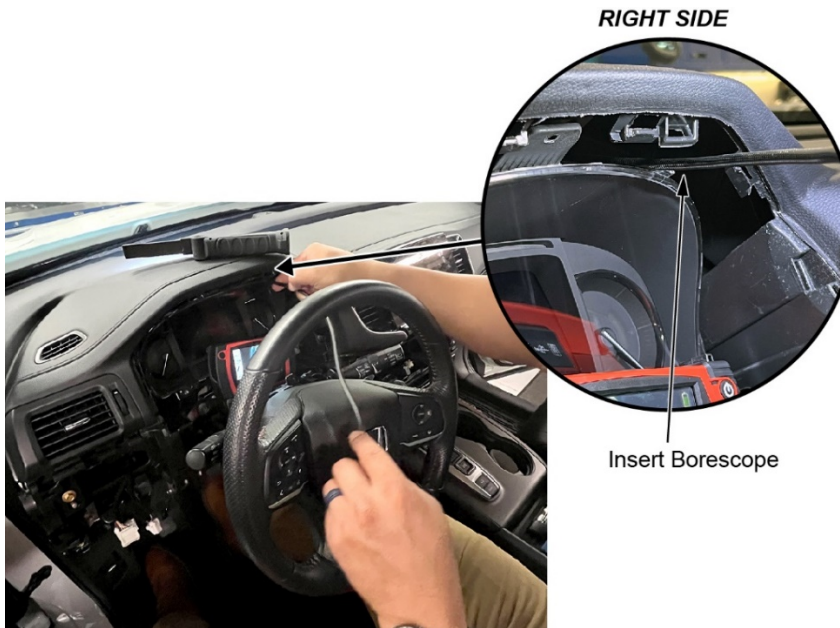
8. Using the digital borescope (T/N BK5600DUAL55) or a commercially available borescope with multiple view angles, inspect the cable routing at the back of the gauge control module as shown below to make sure the cables are routed straight and not bent at the connector(s). Adjust gauge control module harness as needed to achieve proper cable routing.

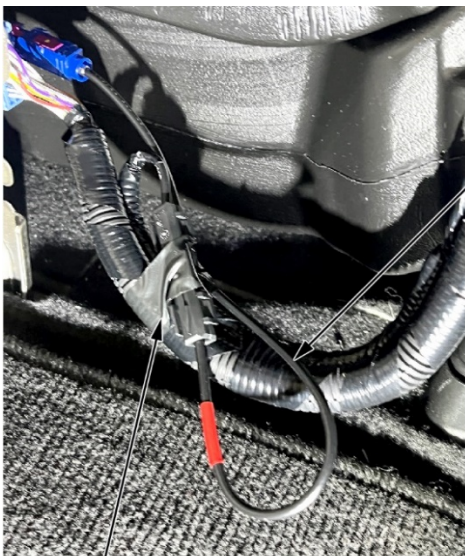
3. Tape the splice box and cable to the in-line harness.

Keep smooth curves
with a radius bend
greater than 25mm.
