AIRSTREAM®

IMPORTANT SAFETY RECALL

Airstream Interstate 24 & Interstate 19 Motorhomes

Incorrect Fuse on Main Cable

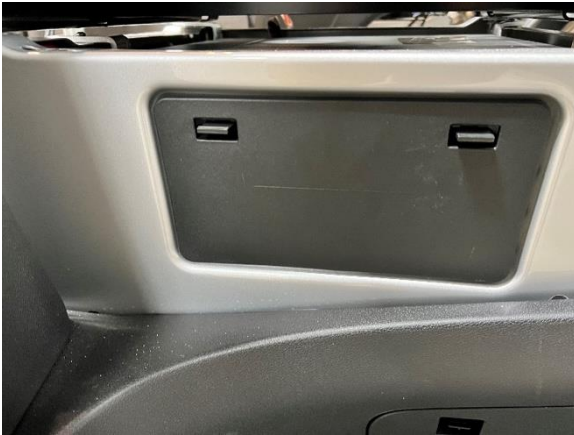
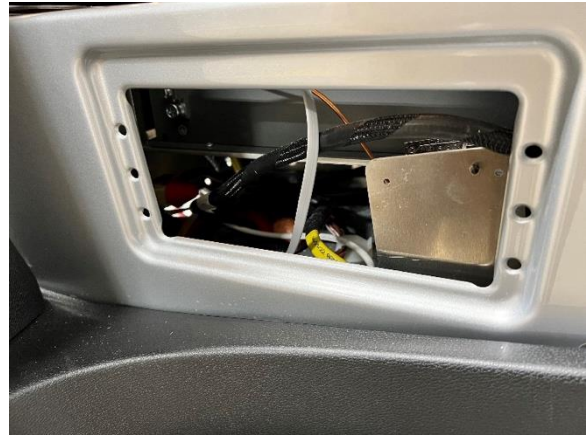
1. To check if the correct fuse is installed, open the passenger's side door, and lift the seat pedestal skirt. Remove the cover panel on the side of the seat pedestal, to gain access.

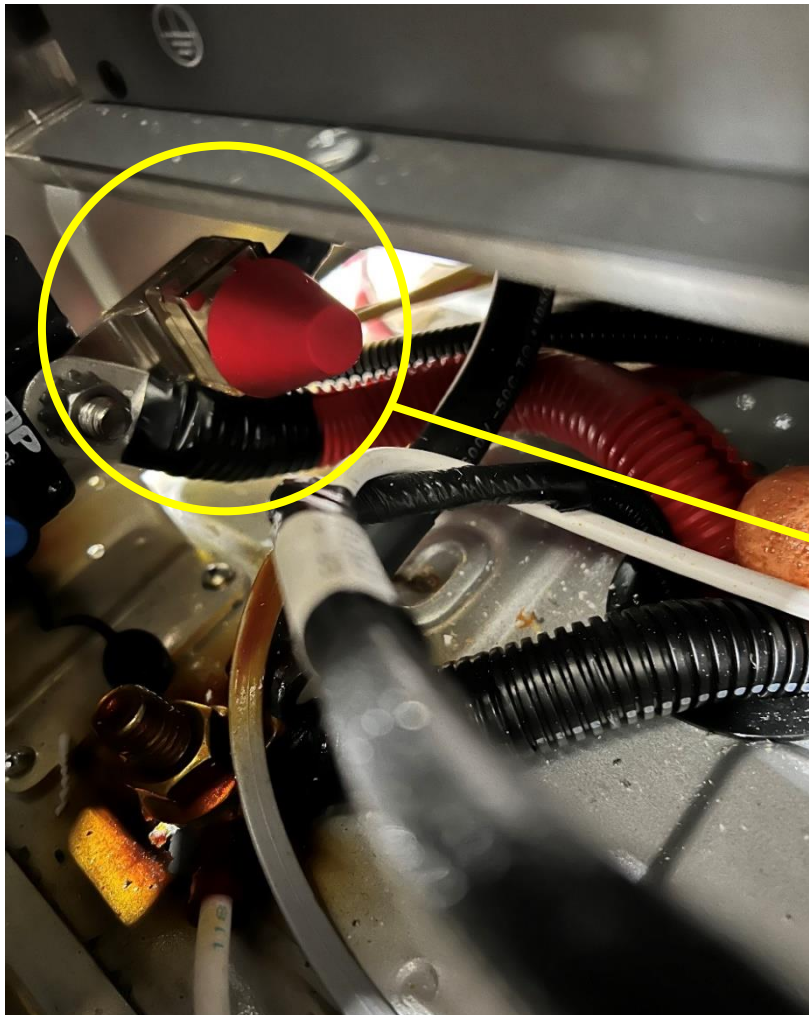
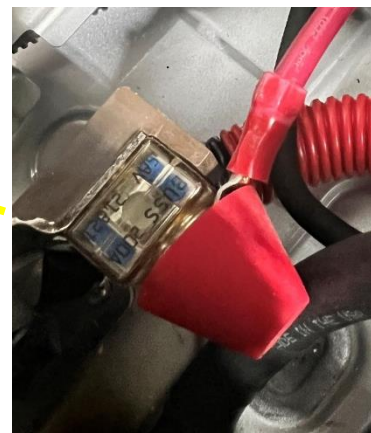
2. Under the pedestal, looking to the left, inspect the fuse block/terminal for a blue colored fuse. A blue fuse represents 200A, which would need replaced by a 50A fuse. If the color of the fuse is red, this represent a 50A fuse, which is the correct size. No further action is required if a 50A fuse has been installed.

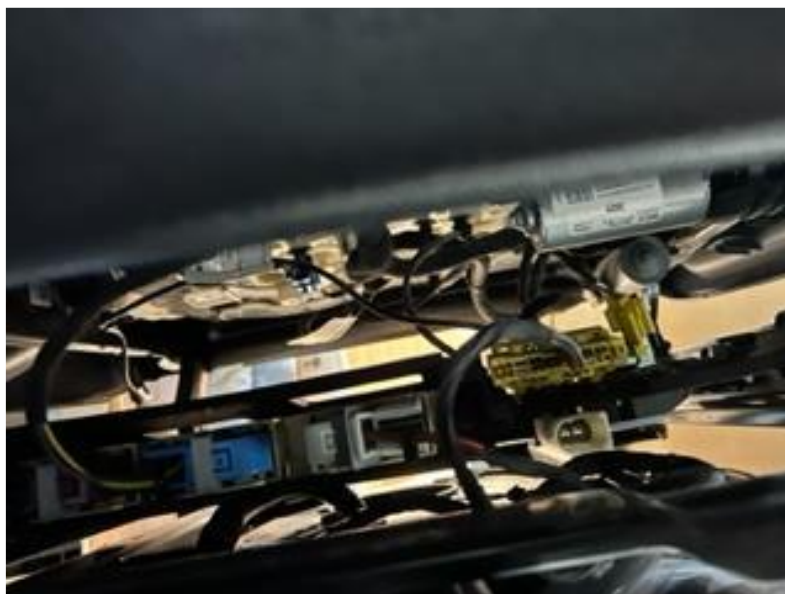
4. Disconnect the yellow airbag connector and white connector from the seat connections. Cut the zip ties securing the seat harness and carefully guide the harness through the pivot hole, located at the center of the seat base. The Passenger's seat should now be detached from the base and can safely be removed.

Note: it is recommended that pictures be taken prior to cutting the ties to ensure the new wires are properly secured before reinstalling the seat.

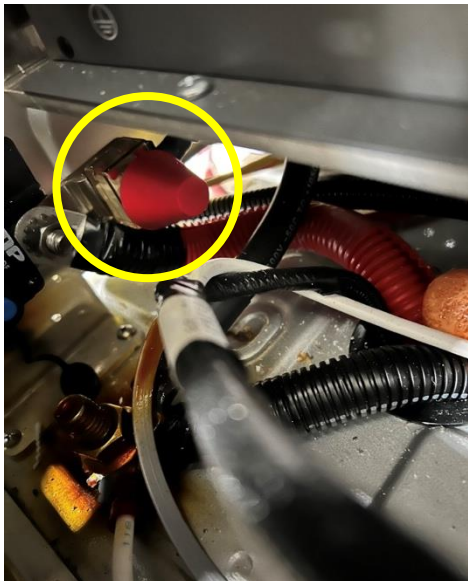
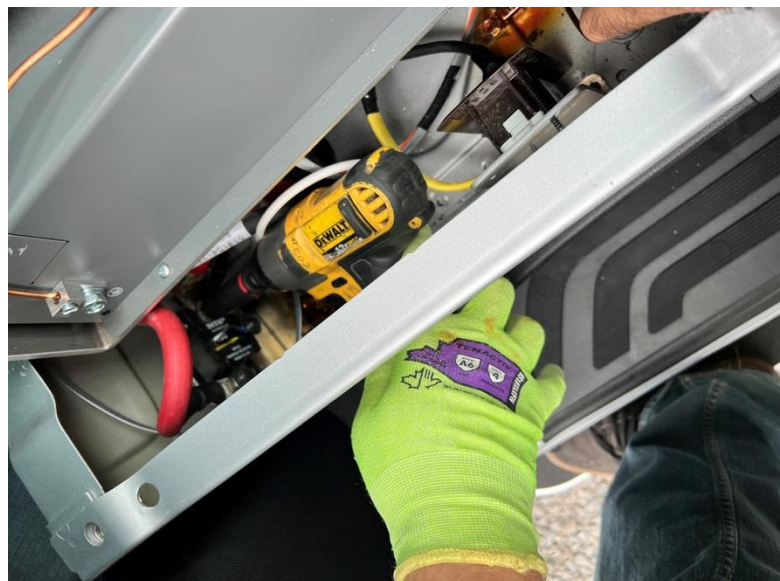
8. Next, remove the red protective fuse cap to gain access to the 13mm nut. Using a 13mm socket, remove the cable from the fuse block. Remove the 200A fuse block and replace it with a new 50A fuse block. Reassemble and torque the 13mm nut back to the fuse stud at 106in/lbs.

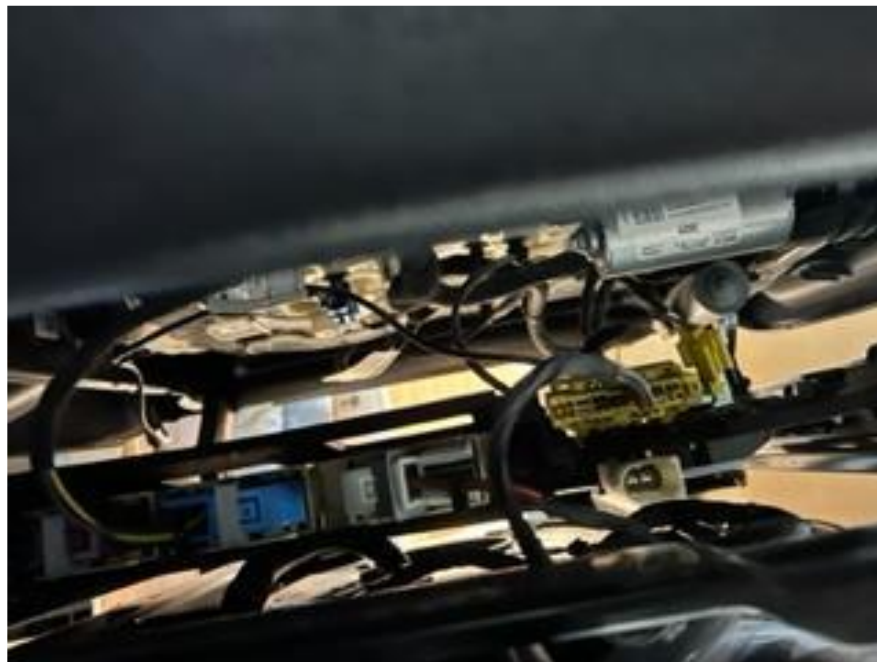
10. Make sure all the wiring is tucked inside the seat pedestal before reinstalling the seat base mount. Carefully guide the seat harness back through the hole in the seat base. Reconnect the yellow air bag connector and white connector to the seat connections. Resecure the harness using zip ties (refer to pictures taken before the zip ties were cut).

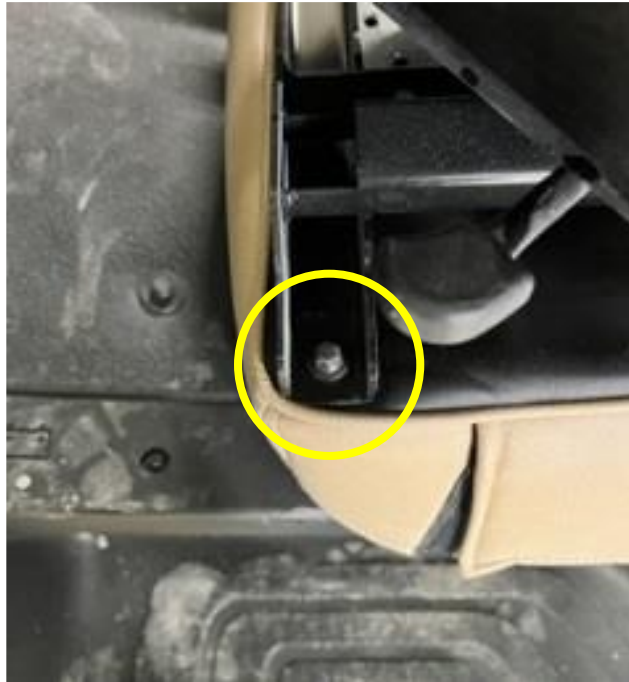
11. Reinstall the four E12 bolts on the passenger's seat. Each bolt must be torqued to 29 ft lbs.
