Recall Campaign Bulletin

Campaign No. 2023070016, August 2023

SUBJECT: **Model C-Class (206 platform)**
Model Year 2022-2023

Inspect 12V and 48V Ground Connections

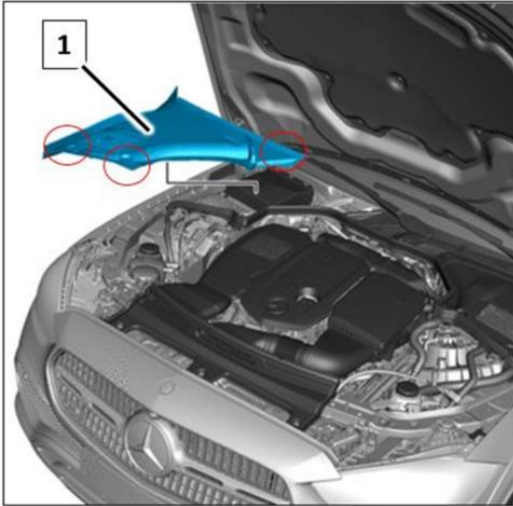
Figure 1, left-hand drive vehicle

1. Open hood.
2. Remove cover (1, **Figure 1**).

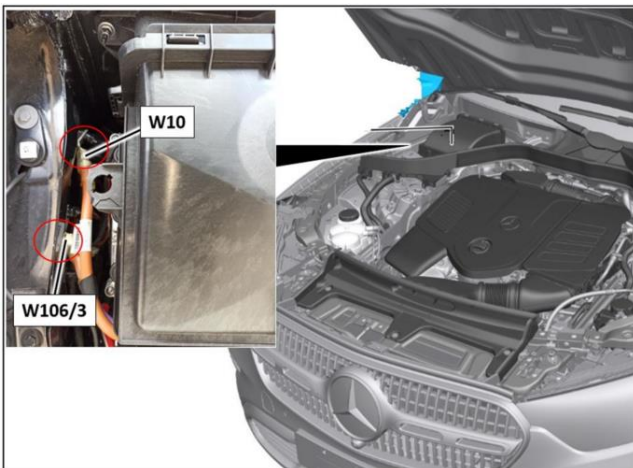
Figure 2, left-hand drive vehicle

3. Check threaded connections of ground points (**W106/3**, **W10**, **Figure 2**) for correct tightening torque.
 - 48 V battery ground point (W106/3) (see BA00.19-P-1039-01O) **16 Nm**
 - On-board electrical system battery ground point (W10) (see BA00.19-P-1012-01O) **16 Nm**

- a. If torque is **not correct**: Carry out **Test Procedure 2**.
- b. If torque is **correct**: **End measure**.

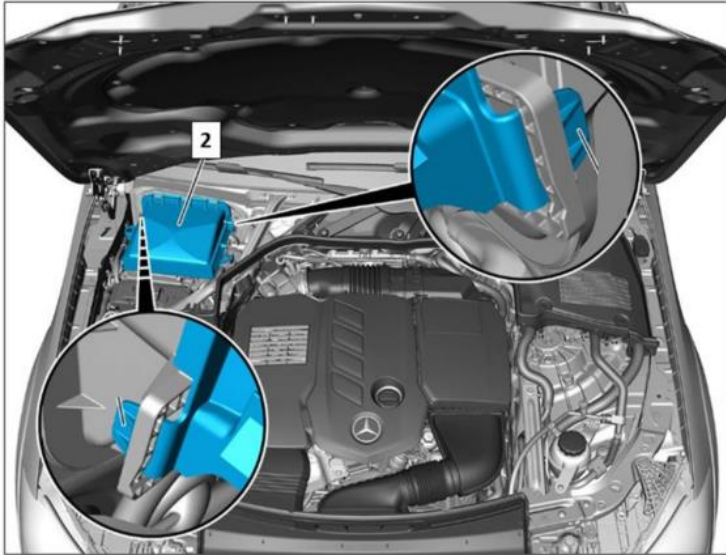
Figure 3, left-hand drive vehicle

1. Remove dust filter with air duct segment (2, Figure 3).

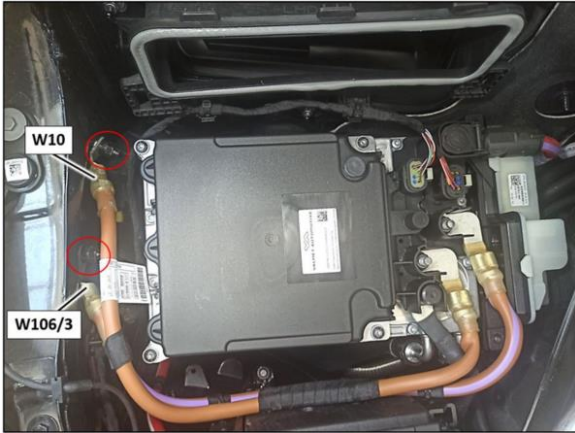
Figure 4, left-hand drive vehicle

2. Remove nut at affected ground point (W106/3, W10, Figure 4).

3. Remove respective affected cable lug from weld stud.
4. Check respective affected electric line, contact areas, and weld stud for damage.

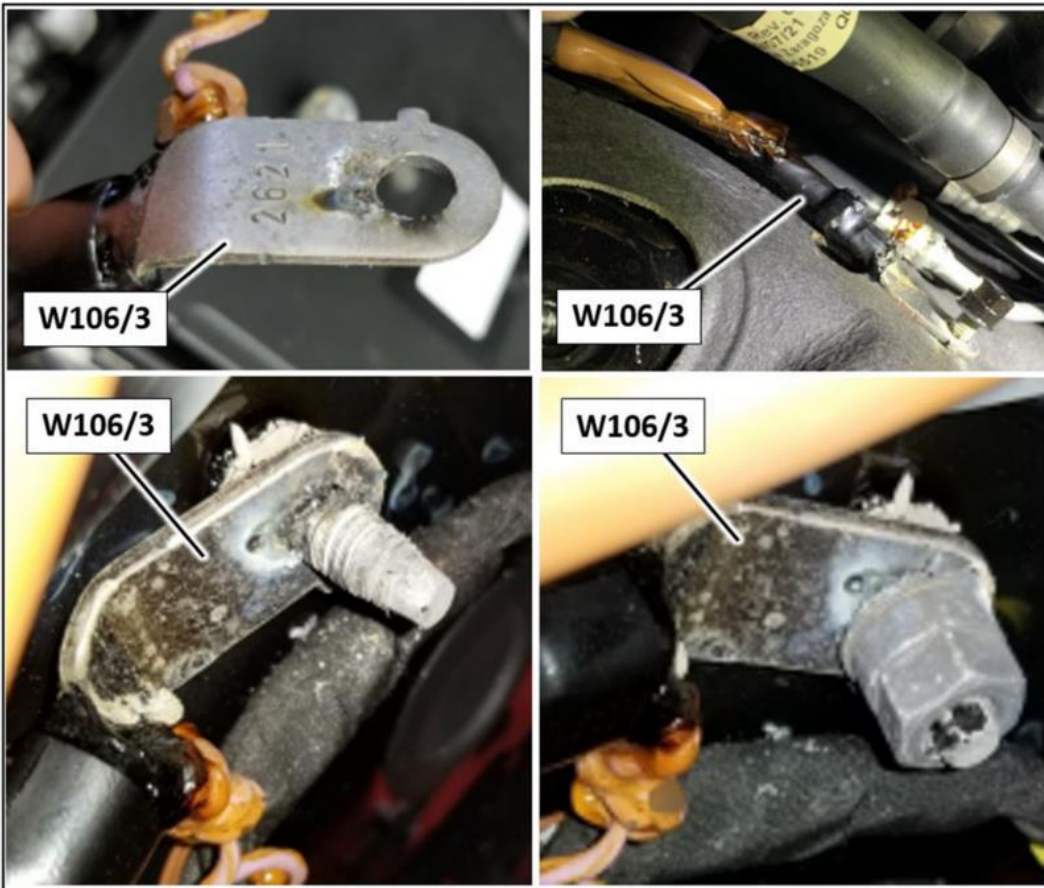
i For an examples of the damage profiles, (Figures 5 and 6).

Figure 5, Example illustration of damage profiles for a 48 V battery ground point (W106/3)

- a. **No** damage to the electric line, contact areas, and weld stud: Carry out **Work Procedure 1**.
- b. One or both electric line(s), contact areas, and weld stud **damaged**: Carry out **Work Procedure 2**.

1. Replace the respective nut and tighten it to the specified tightening torque.
 - i** Clean contact point on weld stud
 - Ground point of 48 V battery (W106/3) (see BA00.19-P-1039-01O) **16 Nm**
 - Ground point of on-board electrical system battery (W10) (see BA00.19-P-1012-01O) **16 Nm**
2. Assemble in reverse order.

1. Remove the battery of the 48 V on-board electrical system.
 - i** For basic information, see AR54.10-P-0022WT.
2. Replace damaged weld stud if necessary.
 - i** For basic information, see AR60.00-P-0100A (part number of weld stud can be found here).
3. If necessary, replace damaged electric line and nut and tighten to the specified tightening torque.
 - Ground point of 48 V battery (W106/3) (see BA00.19-P-1039-01O) **16 Nm**
 - Ground point of on-board electrical system battery (W10) (see BA00.19-P-1012-01O) **16 Nm**
4. Assemble in reverse order.

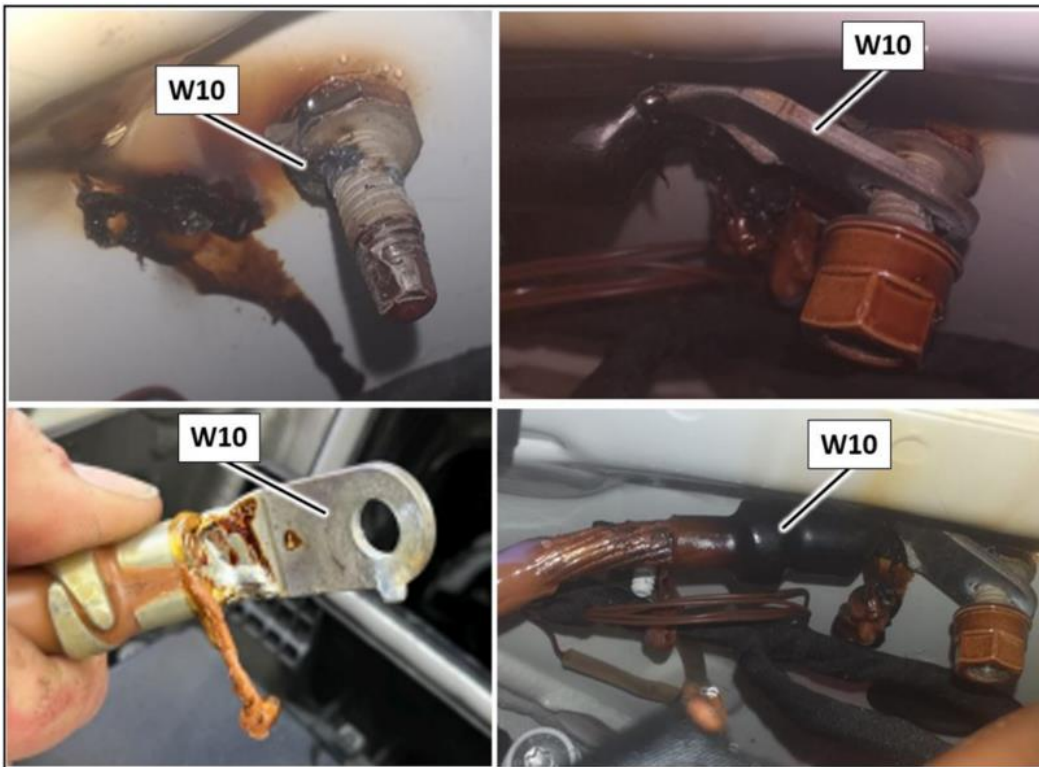
Figure 6, Example illustration of damage profiles for an on-board electrical system battery ground point (W10)

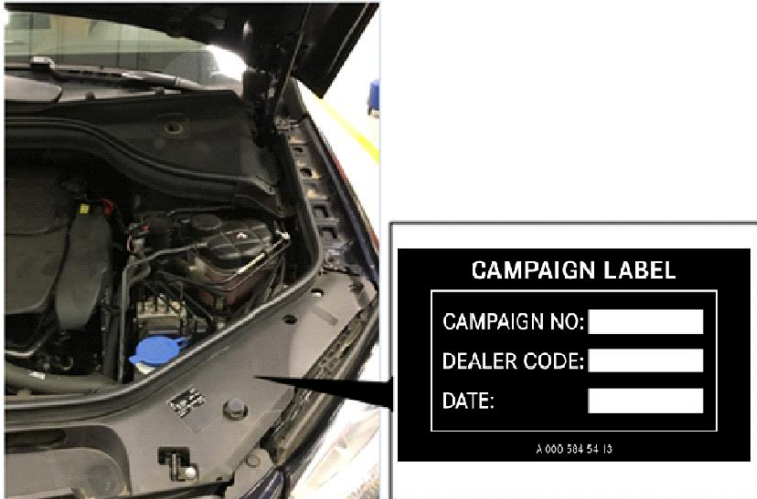
Figure 1

Apply Proof of Correction Label (A 000 584 54 13) to area identified in **Figure 1**. Fill in the blank areas of the label. The campaign number for the California Proof of Correction is unique and must be entered as such (230716), your dealer code, and the date of the repair, using a black permanent marker.
