TECHNICAL INSTRUCTIONS

SAFETY RECALL 23TA08

DRIVER AIRBAG MAY NOT DEPLOY

**CERTAIN MODEL YEAR 2023 Corolla, Corolla Cross, Corolla Cross HV,
Highlander, Highlander HV and Tacoma**

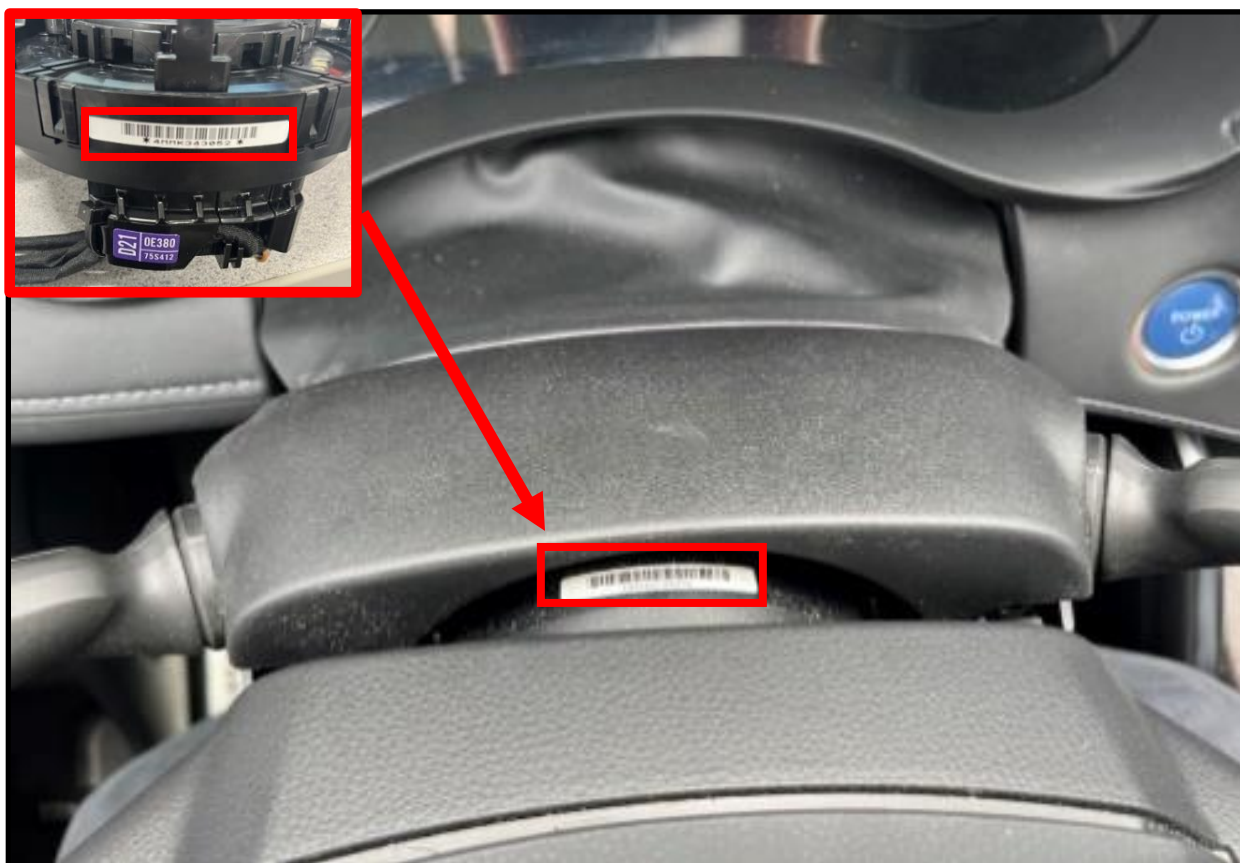
1. **Remove upper steering column cover to access spiral cable serial number.**
Steering – Steering Column – Steering Column Assembly – Removal

Follow the steps in the Repair Manual to remove the upper steering column cover. **DO NOT REMOVE THE LOWER STEERING COLUMN COVER TO ACCESS THE SERIAL NUMBER.**

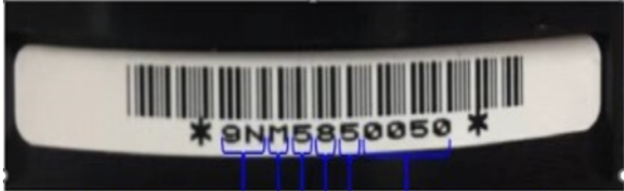
Locate the spiral cable label under the steering column cover and take a clear picture of serial number. Confirm the serial number is clear in the picture. Input the serial number below. Confirm spiral cable serial number is entered correctly before submitting.
