The main action for this recall is an inspection!

Safety Recall 6023G – 2014-2018 Mazda3 5-Door Hatch Repair Procedure

A. VEHICLE INSPECTION PROCEDURE – AND PREPERATION FOR REPAIR

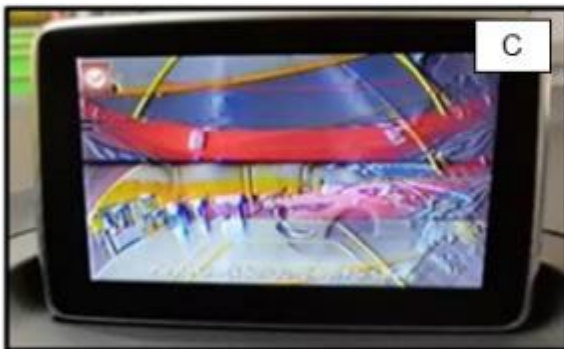
IMAGE DISTORTION THAT IS ACCEPTABLE FOR REPLACEMENT OF THE REAR CAMERA. THE REAR CAMERA MUST BE REPLACED IN THE CONDITIONS BELOW.

A	Image has noise and distortion
B	Lines appear distorted
C	Scrolling or split image
D	Edges are distorted
E	No image is displayed

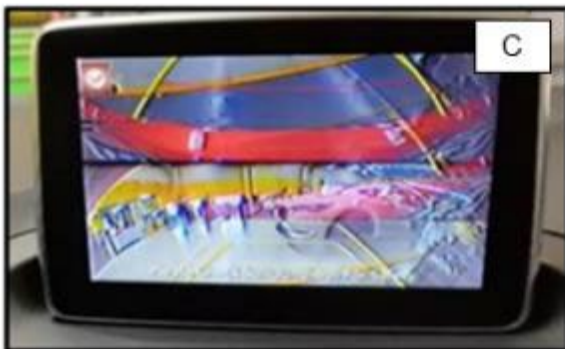
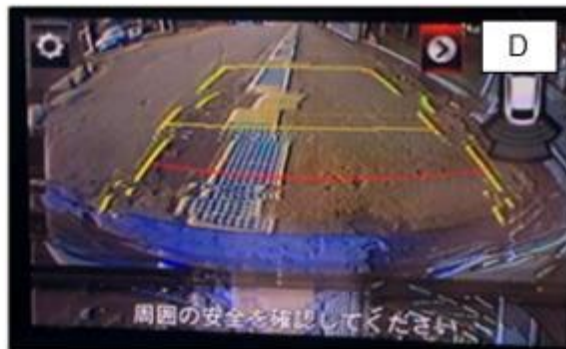
A	Image has noise and distortion
B	Lines appear distorted
C	Scrolling or split image
D	Edges are distorted
E	No image is displayed

7. Technician A – Watch the display for a flickering or distorted image while Technician B raises and lowers the liftgate 5 times. If the image appears similar to A through D – STOP! AND PROCEED to [REPAIR PROCEDURE 2 – REAR CAMERA REPLACEMENT.](#)
