## August 21, 2024 – Added Vehicles are in Open or Prelim Letter Status

# Safety Recall 6023G – 2014-2018 Mazda3 5-Door Hatch Repair Procedure

## A. VEHICLE INSPECTION PROCEDURE – AND PREPERATION FOR REPAIR

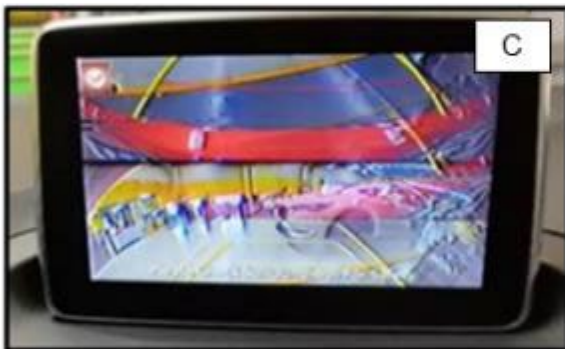
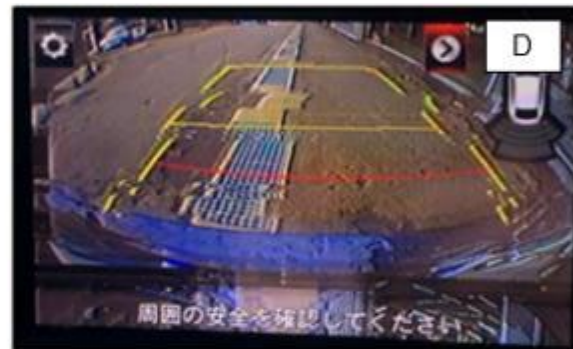
IMAGE DISTORTION THAT IS ACCEPTABLE FOR REPLACEMENT OF THE REAR CAMERA. THE REAR CAMERA MUST BE REPLACED IN THE CONDITIONS BELOW.

A	Image has noise and distortion
B	Lines appear distorted
C	Scrolling or split image
D	Edges are distorted
E	No image is displayed

1. Push the Start button twice, ignition to ON position (engine is not running).
2. Set the parking brake
3. While in the driver seat, place your foot on the brake pedal and move the gear selector to (R) Reverse  
**Look at the rear camera image (SEE NEXT PAGE FOR EXAMPLES):**
  1. If not distorted or flickering, proceed to [REPAIR PROCEDURE 1 – FOAM PAD INSTALLATION](#)
  2. If the image is distorted or flickering as on page 4, proceed to [REPAIR PROCEDURE 2 – REAR CAMERA REPLACEMENT.](#)

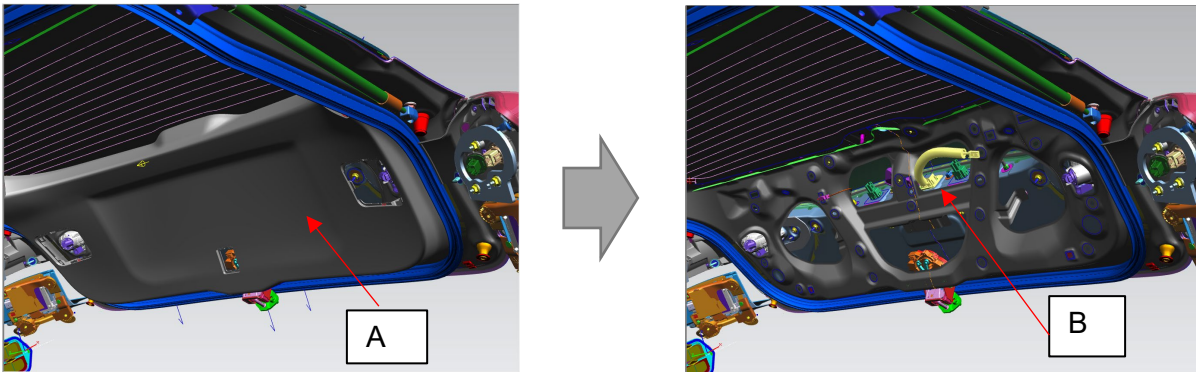
A	Liftgate lower trim
B	Rear camera

1. Shift the gear to (P) Park and switch the ignition to OFF.
2. Disconnect the negative battery cable. (Needs for replacement of rear camera)
3. Remove the liftgate lower trim according to the workshop manual [LIFTGATE LOWER TRIM REMOVAL/INSTALLATION](#)

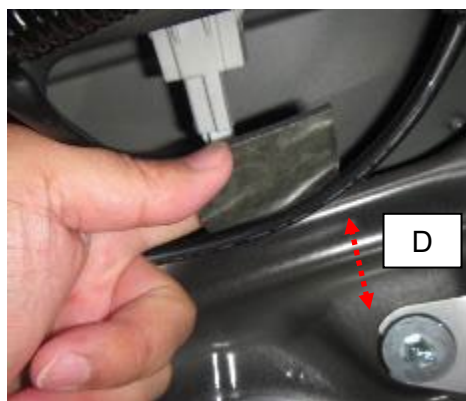
B	2" (50 mm)
C	6" (100 mm)
D	First, stick 1/2 on the underside of the body panel. <b>DO NOT WRAP THE PAD VERY TIGHT AGAINST THE BODY EDGE, THE WIRES MUST BE SECURE AND FLEXIBLE.</b>

7. Fold the foam pad in half and remove 1/2 of the paper from one side.

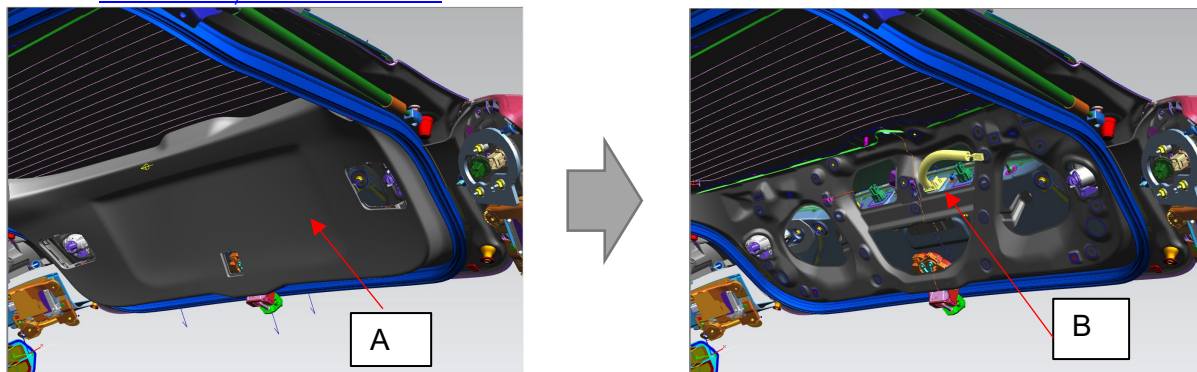
A	Liftgate lower trim
B	Rear camera

1. Make sure the vehicle is in (P) Park and switch the ignition to OFF.
2. Disconnect the negative battery cable.
3. Remove the liftgate lower trim according to the workshop manual [LIFTGATE LOWER TRIM REMOVAL/INSTALLATION](#)

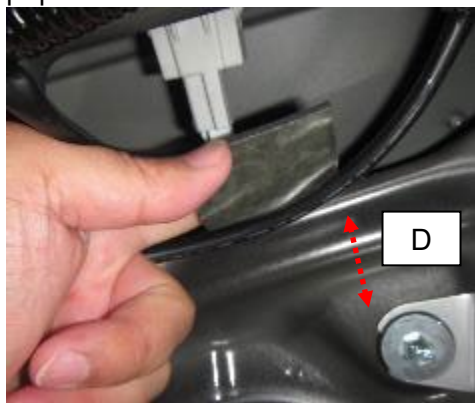
B	2" (50 mm)
C	6" (100 mm)
D	First, stick 1/2 on the underside of the body panel. <b>DO NOT WRAP THE PAD VERY TIGHT AGAINST THE BODY EDGE, THE WIRES MUST BE SECURE AND FLEXIBLE.</b>

7. Fold the foam pad in half and remove 1/2 of the paper from one side.

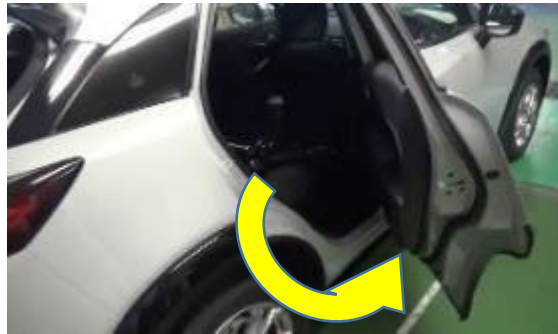
**Technician B:** Open one rear door (RH - right or LH - left door). This is to reduce air resistance

when raising and lowering the liftgate. Raise and lower the liftgate 5 times from the top position with both hands.

If the lift gate does not open while in (R) Reverse, put it in (P) Park range once to open the lift gate, then place in (R) again and repeat raising and lowering the liftgate.

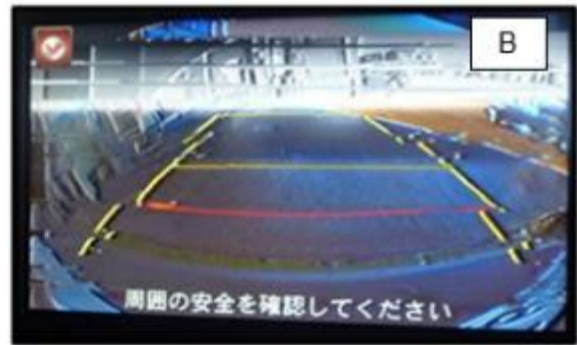
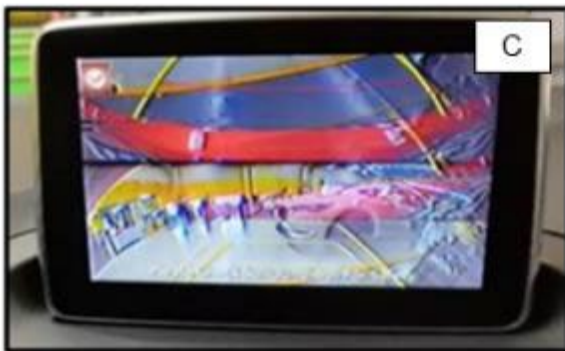
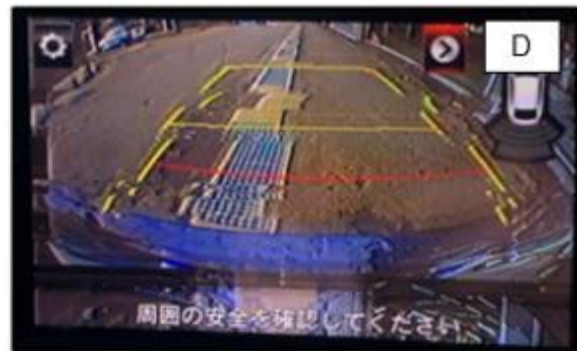
A	Image has noise and distortion
B	Lines appear distorted
C	Scrolling or split image
D	Edges are distorted
E	No image is displayed

7. Technician A – Watch the display for a flickering or distorted image while Technician B raises and lowers the liftgate 5 times. If the image appears similar to A through D – STOP! AND PROCEED to [REPAIR PROCEDURE 2 – REAR CAMERA REPLACEMENT.](#)
