April 2, 2024. Changed part number for some Mazda3 parts. Certain part numbers are now a part kit with a camera and pad.

Safety Recall 6023G – 2014-2018 Mazda3 5-Door Hatch Repair Procedure

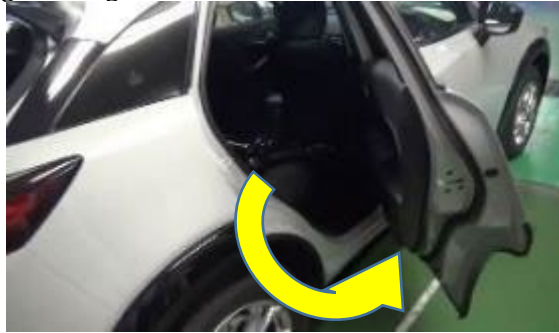
- Technician A:** Switch the ignition to ON twice (no engine running). Move the gearshift into (R) Reverse, place your foot on the brake pedal and set the parking brake. Confirm that the rear view image is displayed on the center display.
- Technician B:** Open one rear door (RH - right or LH - left door). This is to reduce air resistance when raising and lowering the liftgate

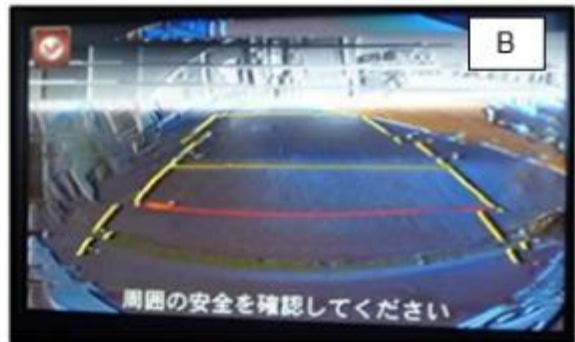
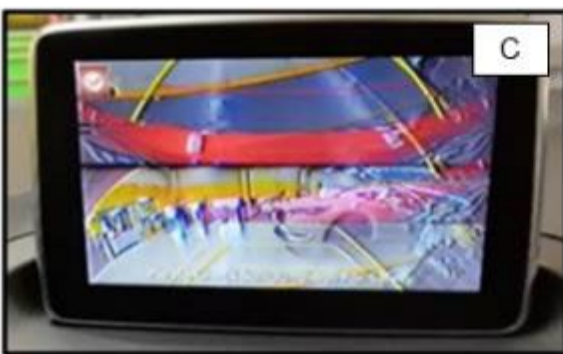
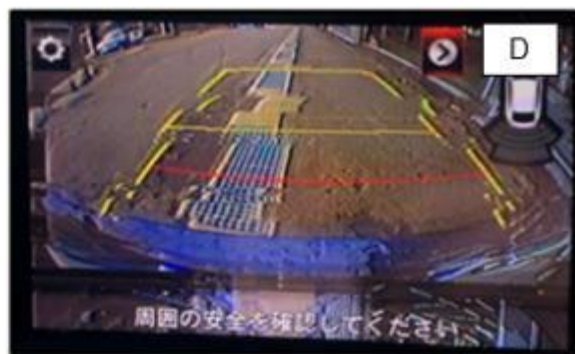
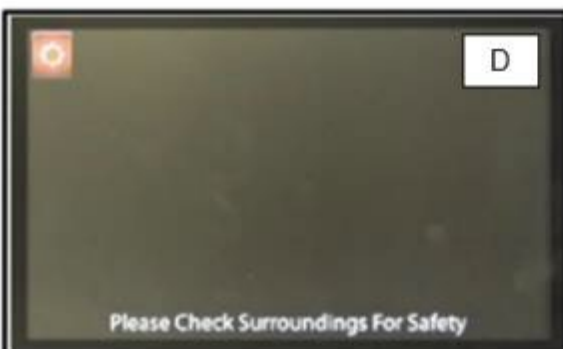
- Technician A –** Watch the display for a flickering or distorted image while Technician B raises and lowers the liftgate 5 times. If the image appears similar to A through D – **STOP! AND PROCEED** to [REPAIR PROCEDURE 2 – REAR CAMERA REPLACEMENT.](#)

A	Image has noise and distortion
B	Lines appear distorted
C	Scrolling or split image
D	Edges are distorted
E	No image is displayed

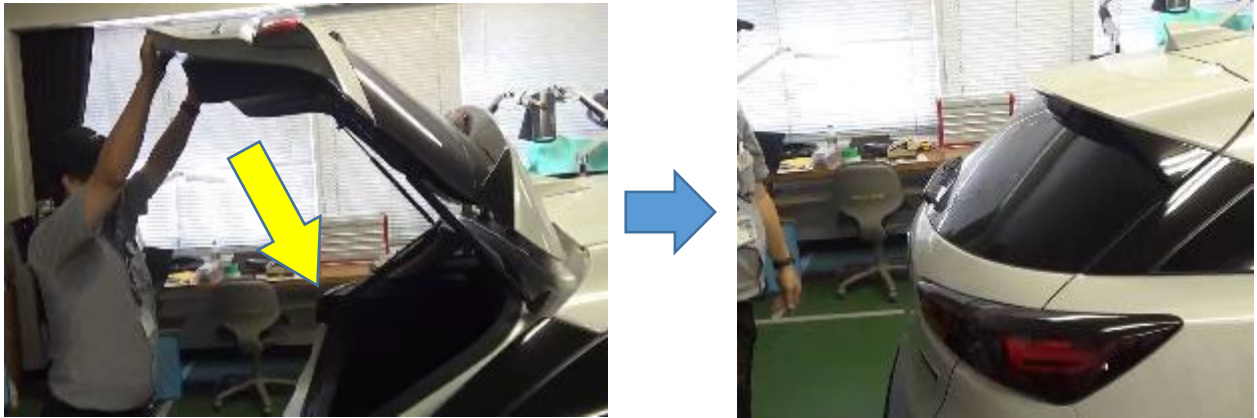
Technician B - Raise and lower the liftgate 5 times from the top position with both hands.

If the lift gate does not open while in (R) Reverse, put it in (P) Park range once to open the lift gate, then place in (R) again and repeat raising and lowering the liftgate.

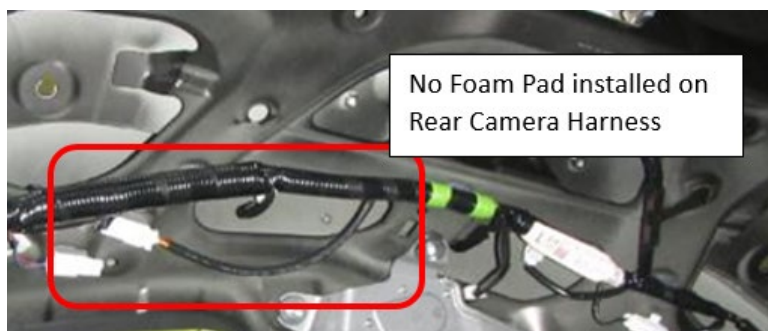
- a. **NO FOAM PAD INSTALLED – REAR CAMERA FUNCTION GOOD.** Place the vehicle in Park, shut the engine OFF and proceed to [REPAIR PROCEDURE 1 – FOAM PAD INSTALLATION](#)

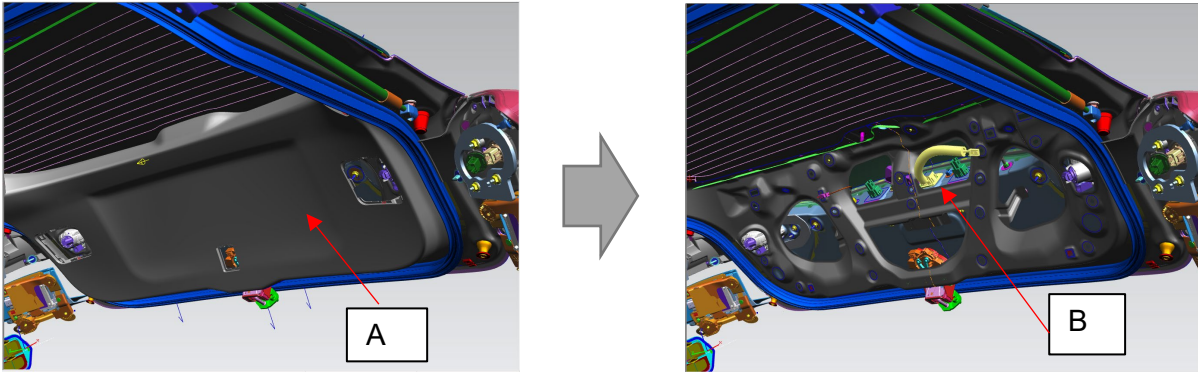
A	Liftgate lower trim
B	Rear camera

1. Shift the gear to (P) Park and switch the ignition to OFF.
2. Disconnect the negative battery cable. (Needs for replacement of rear camera)
3. Remove the liftgate lower trim according to the workshop manual [LIFTGATE LOWER TRIM REMOVAL/INSTALLATION](#)

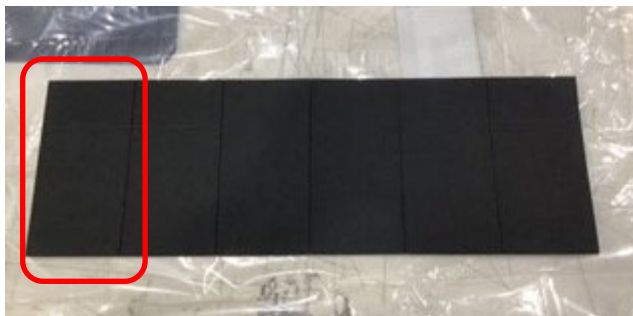
6. Install only one foam pad from kit part # B6Y1-66-1A3. Return any remaining pads to your parts department for use on a future vehicle.

7. Fold the foam pad in half and remove 1/2 of the paper from one side.

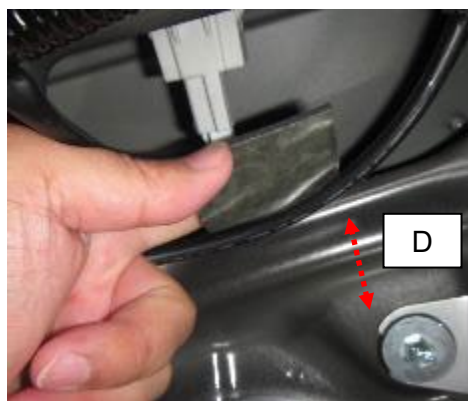
B	2" (50 mm)
C	6" (100 mm)
D	First, stick 1/2 on the underside of the body panel. DO NOT WRAP THE PAD VERY TIGHT AGAINST THE BODY EDGE, THE WIRES MUST BE SECURE AND FLEXIBLE.

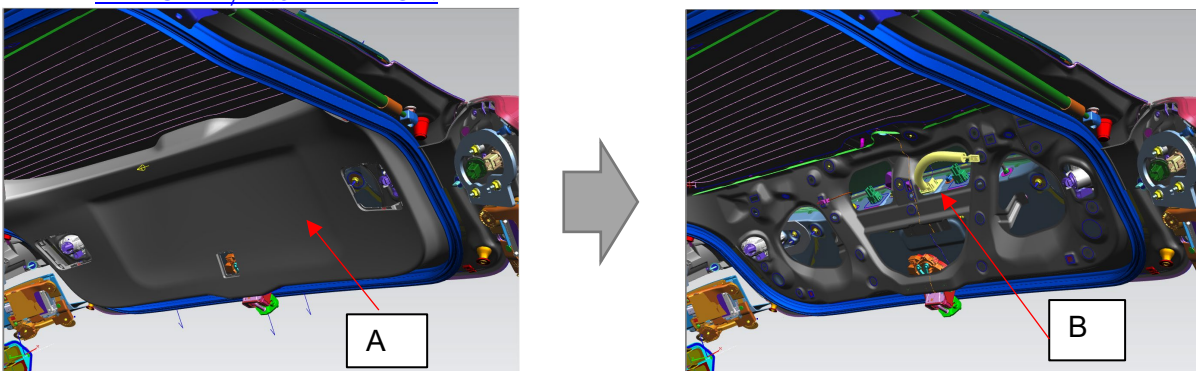
A	Liftgate lower trim
B	Rear camera

1. Make sure the vehicle is in (P) Park and switch the ignition to OFF.
2. Disconnect the negative battery cable.
3. Remove the liftgate lower trim according to the workshop manual [LIFTGATE LOWER TRIM REMOVAL/INSTALLATION](#)

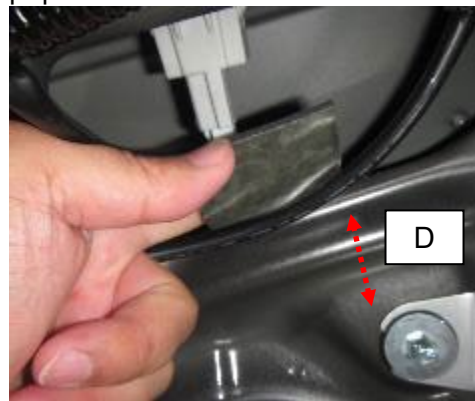
B	2" (50 mm)
C	6" (100 mm)
D	First, stick 1/2 on the underside of the body panel. DO NOT WRAP THE PAD VERY TIGHT AGAINST THE BODY EDGE, THE WIRES MUST BE SECURE AND FLEXIBLE.

8. Fold the foam pad in half and remove 1/2 of the paper from one side.
