July 22, 2024 – Added Repair Calculator and new procedure for pre and post repair rear camera function verification.

Safety Recall 6023G – 2016-2021 CX-3 Repair Procedure

A. VEHICLE INSPECTION PROCEDURE – AND PREPERATION FOR REPAIR

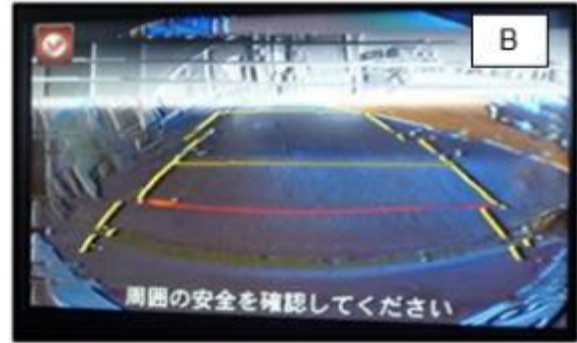
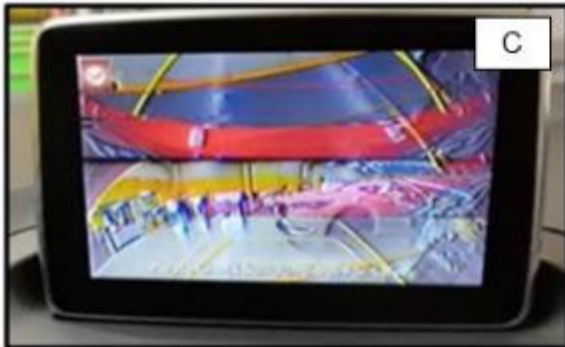
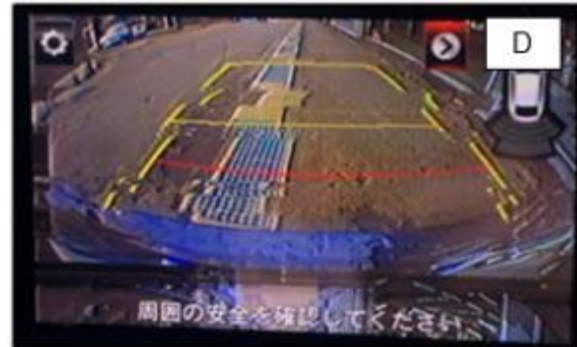
IMAGE DISTORTION THAT IS ACCEPTABLE FOR REPLACEMENT OF THE REAR CAMERA. THE REAR CAMERA MUST BE REPLACED IN THE CONDITIONS BELOW.

A	Image has noise and distortion
B	Lines appear distorted
C	Scrolling or split image
D	Edges are distorted
E	No image is displayed

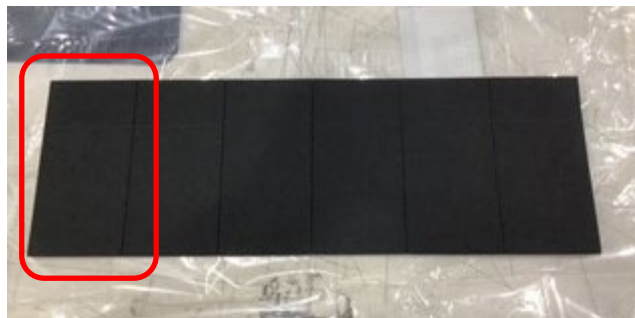
4. Install only one foam pad from kit part # B6Y1-66-1A3. Return any remaining pads to your parts department for use on a future vehicle.

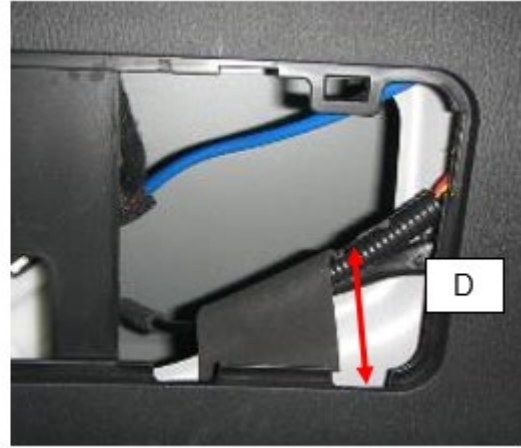
5. Fold the Foam seal to reveal 1.3" (35 mm) of the pad sheet and remove 1/3 of the paper from one side.
6. Stick the 1/3 Foam seal to the front of the liftgate panel. Then, fold over and stick the remaining 2/3 of the Foam pad to the back side. This will bundle the rear camera wiring harness together with the license plate light's wiring harness to the liftgate panel.

NOTE: There should be very little tension on rear camera and license plate wires after pad installation (E in second figure below).

B	2" (50 mm)
C	6" (100 mm)
D	Stick 1/3 of the pad on the front side of the body panel, then fold over. DO NOT WRAP THE PAD VERY TIGHT AGAINST THE BODY EDGE, THE WIRES MUST BE SECURE AND FLEXIBLE.

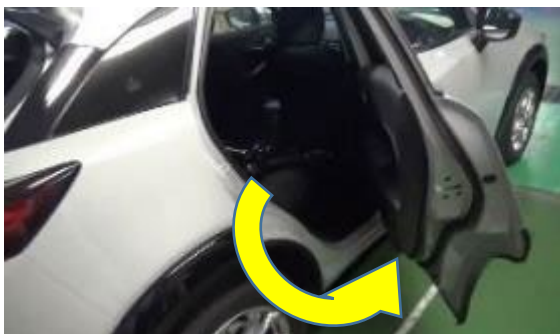
1. **Technician A:** Switch the ignition to ON twice (no engine running). Move the gearshift into (R) Reverse, place your foot on the brake pedal and set the parking brake. Confirm that the rear view image is displayed on the center display.

Technician B: Open one rear door (RH - right or LH - left door). This is to reduce air resistance when raising and lowering the liftgate. Raise and lower the liftgate 5 times from the top position with both hands.

If the lift gate does not open while in (R) Reverse, put it in (P) Park range once to open the lift gate, then place in (R) again and repeat raising and lowering the liftgate.

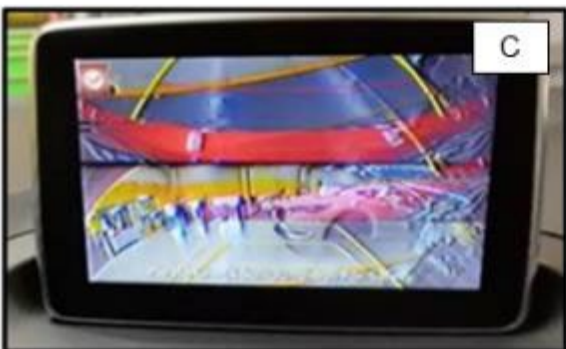
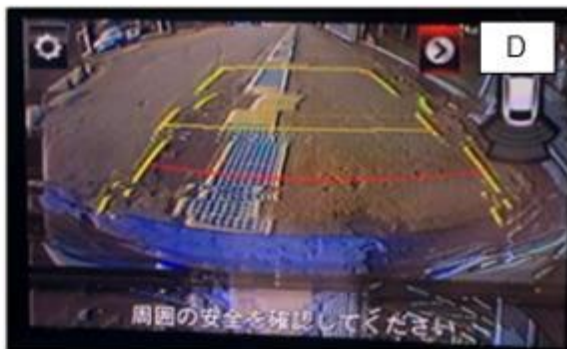
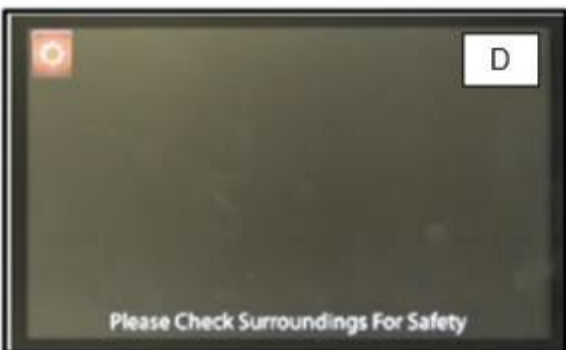
2. Technician A – Watch the display for a flickering or distorted image while Technician B raises and lowers the liftgate 5 times. If the image appears similar to A through D – STOP! AND PROCEED to [REPAIR PROCEDURE 2 – REAR CAMERA REPLACEMENT](#).

A	Image has noise and distortion
B	Lines appear distorted
C	Scrolling or split image
D	Edges are distorted
E	No image is displayed

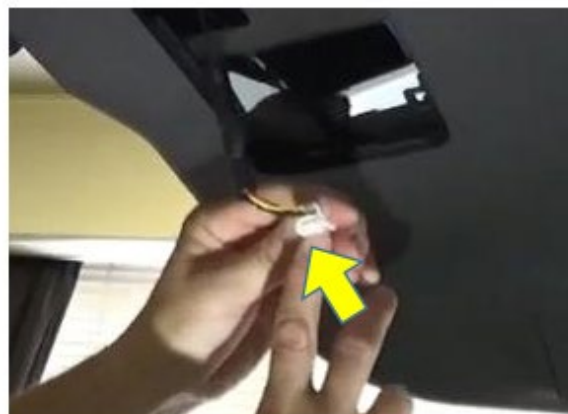
1. Make sure the vehicle is in (P) Park and switch the ignition to OFF.
2. Disconnect the negative battery cable.
3. Remove the rear camera according to the workshop manual [REAR MOUNT CAMERA REMOVAL/INSTALLATION](#) - *Carefully remove all rear camera connectors by pushing the connector tabs from bottom to top (BELOW – A).*

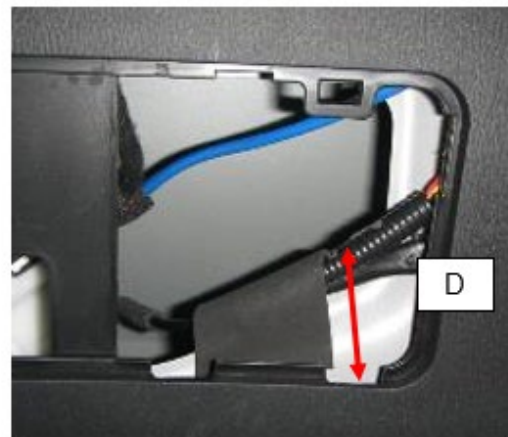
3. Install only one foam pad from the recall parts kit. If you were not sent a recall parts kit (rear camera and 1 pad) then use one pad from B6Y1-66-1A3 and return any remaining pads to your parts department for use on a future vehicle.
4. Fold the Foam seal to reveal 1.3" (1/3 OR 35 mm) of the pad sheet and remove 1.3" (1/3 OR 35 mm) of the paper from one side.
5. Stick the 1/3 Foam seal to the front of the liftgate panel. Then, fold over and stick the remaining 2/3 of the Foam pad to the back side. This will bundle the rear camera wiring harness together with the license plate light's wiring harness to the liftgate panel.

NOTE: There should be very little tension on rear camera and license plate wires after pad installation (E in second figure below).

B	2" (50 mm)
C	6" (100 mm)
D	Stick 1/3 of the pad on the front side of the body panel, then fold over – DO NOT WRAP THE PAD VERY TIGHT AGAINST THE BODY EDGE, THE WIRES MUST BE SECURE AND FLEXIBLE.

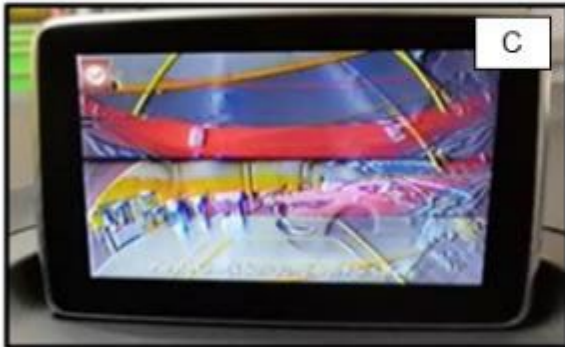
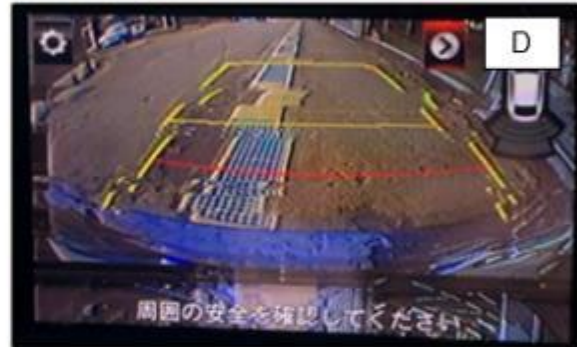
7. Technician A – Watch the display for a flickering or distorted image while Technician B raises and lowers the liftgate 5 times. If the image appears similar to A through D – STOP! AND PROCEED to [REPAIR PROCEDURE 2 – REAR CAMERA REPLACEMENT](#).

A	Image has noise and distortion
B	Lines appear distorted
C	Scrolling or split image
D	Edges are distorted
E	No image is displayed
