October 2, 2024 – changed procedure for rear camera parts ordering and use of the repair calculator only for 2016-2018 Mazda3

Safety Recall 6023G – 2014-2018 Mazda3 5-Door Hatch Repair Procedure

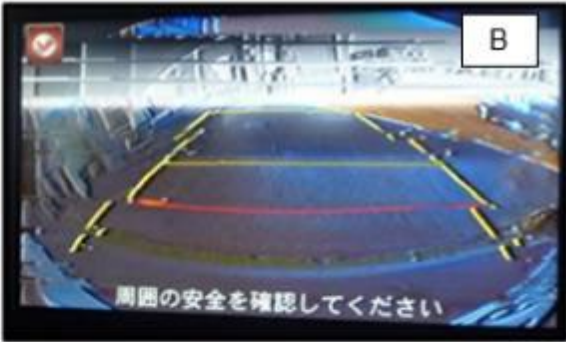
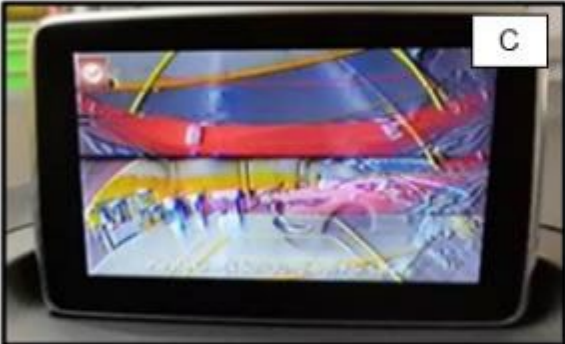
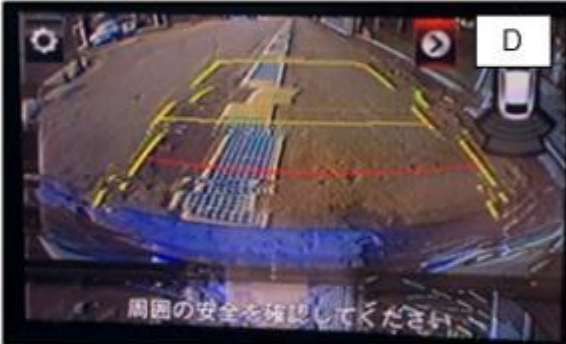
IMAGE DISTORTION THAT IS ACCEPTABLE FOR REPLACEMENT OF THE REAR CAMERA. THE REAR CAMERA MUST BE REPLACED IN THE CONDITIONS BELOW.

A	Image has noise and distortion
B	Lines appear distorted
C	Scrolling or split image
D	Edges are distorted
E	No image is displayed

1. Push the Start button twice, ignition to ON position (engine is not running).
2. Set the parking brake
3. While in the driver seat, place your foot on the brake pedal and move the gear selector to (R) Reverse
Look at the rear camera image (SEE NEXT PAGE FOR EXAMPLES):
 1. If not distorted or flickering, proceed to [REPAIR PROCEDURE 1 – FOAM PAD INSTALLATION](#)
 2. If the image is distorted or flickering as on page 4, proceed to [REPAIR PROCEDURE 2 – REAR CAMERA REPLACEMENT.](#)

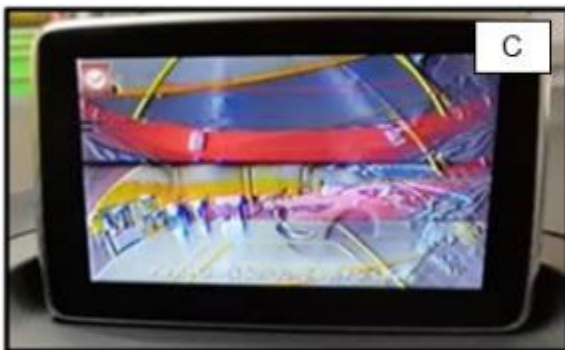
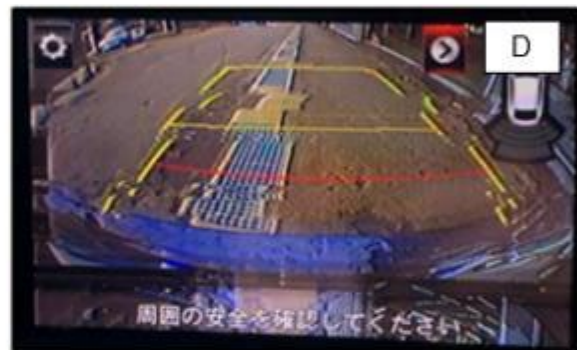
2. Technician A – Watch the display for a flickering or distorted image while Technician B raises and lowers the liftgate 5 times. If the image appears similar to A through D – STOP! AND PROCEED to [REPAIR PROCEDURE 2 – REAR CAMERA REPLACEMENT.](#)

A	Image has noise and distortion
B	Lines appear distorted
C	Scrolling or split image
D	Edges are distorted
E	No image is displayed

3. If function is **GOOD** - there is no image distortion or flickering, Move to Step 5.
4. If function is **NO GOOD** - [GO TO REPAIR PROCEDURE 2. REPLACE THE REAR CAMERA.](#)
5. Reinstall all parts according to the workshop manual. Installation is the reverse of removal. Move to Section [G. Campaign Label Installation.](#)

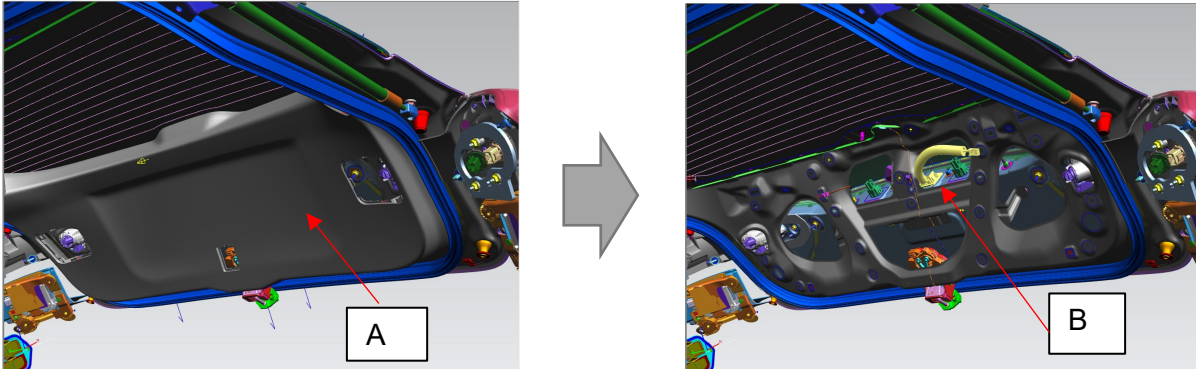
1. Make sure the vehicle is in (P) Park and switch the ignition to OFF.
2. Disconnect the negative battery cable.
3. Remove the liftgate lower trim according to the workshop manual [LIFTGATE LOWER TRIM REMOVAL/INSTALLATION](#)

A	Liftgate lower trim
B	Rear camera

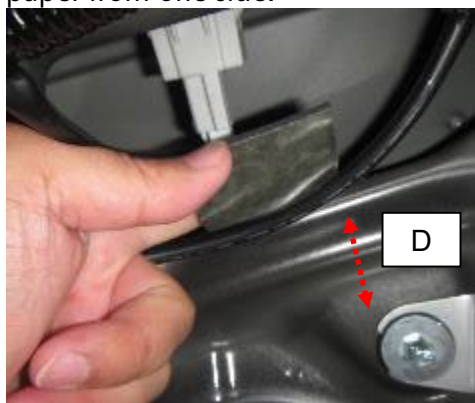
8. Fold the foam pad in half and remove 1/2 of the paper from one side.

B	2" (50 mm)
C	6" (100 mm)
D	First, stick 1/2 on the underside of the body panel. DO NOT WRAP THE PAD VERY TIGHT AGAINST THE BODY EDGE, THE WIRES MUST BE SECURE AND FLEXIBLE.

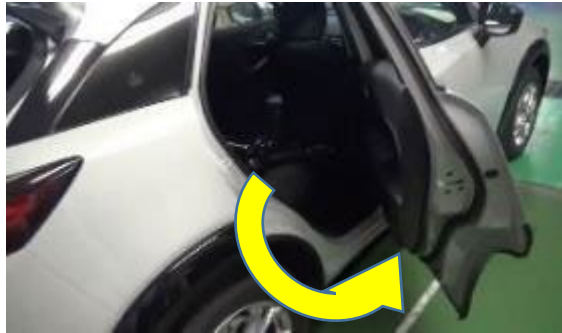
1. **Technician A:** Switch the ignition to ON twice (no engine running). Move the gearshift into (R) Reverse, place your foot on the brake pedal and set the parking brake. Confirm that the rear view image is displayed on the center display.

Technician B: Open one rear door (RH - right or LH - left door). This is to reduce air resistance when raising and lowering the liftgate. Raise and lower the liftgate 5 times from the top position with both hands.

If the lift gate does not open while in (R) Reverse, put it in (P) Park range once to open the lift gate, then place in (R) again and repeat raising and lowering the liftgate.

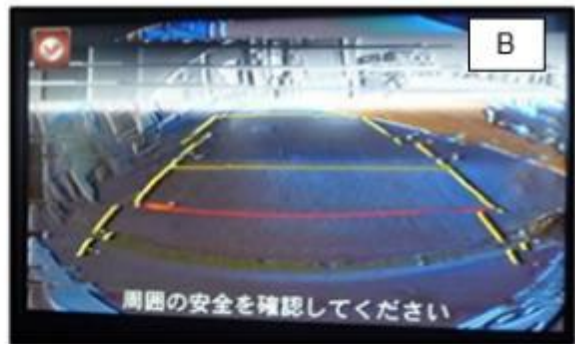
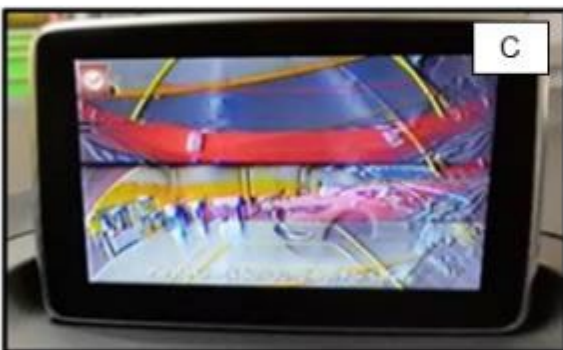
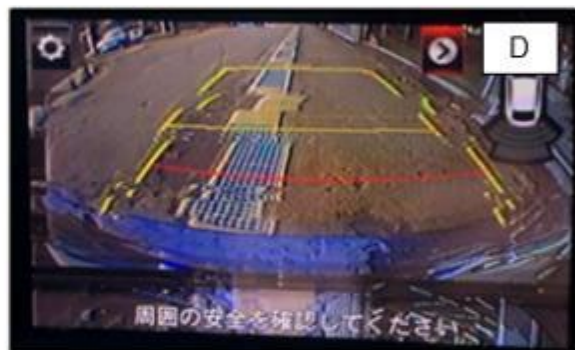
2. Technician A – Watch the display for a flickering or distorted image while Technician B raises and lowers the liftgate 5 times. If the image appears similar to A through D – STOP! AND PROCEED to [REPAIR PROCEDURE 2 – REAR CAMERA REPLACEMENT](#).

A	Image has noise and distortion
B	Lines appear distorted
C	Scrolling or split image
D	Edges are distorted
E	No image is displayed

3. If function is **GOOD** - there is no image distortion or flickering, Move to Step 5.
4. If function is **NO GOOD** – CHECK CONNECTIONS AND REVIEW STEPS IN [REPAIR PROCEDURE 2. REPLACE THE REAR CAMERA.](#)
5. Reinstall all parts according to the workshop manual. Installation is the reverse of removal. Move to Section [G. Campaign Label Installation.](#)
