# Safety Recall 6023G – 2014-2018 Mazda3 5-Door Hatch Repair Procedure

## A. VEHICLE INSPECTION PROCEDURE – AND PREPERATION FOR REPAIR

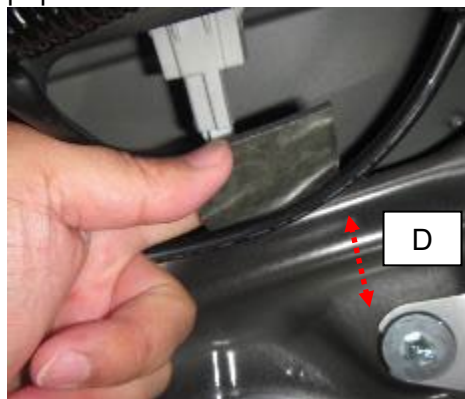
B	2" (50 mm)
C	6" (100 mm)
D	First, stick 1/2 on the underside of the body panel. <b>DO NOT WRAP THE PAD VERY TIGHT AGAINST THE BODY EDGE, THE WIRES MUST BE SECURE AND FLEXIBLE.</b>

7. Fold the foam pad in half and remove 1/2 of the paper from one side.

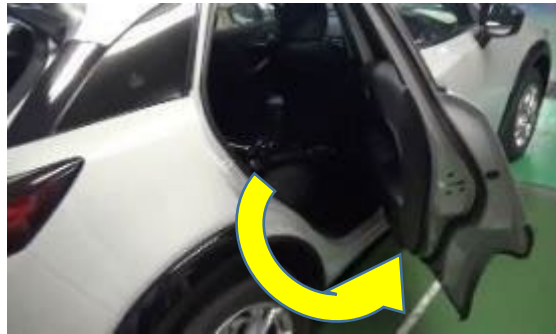
when raising and lowering the liftgate. Raise and lower the liftgate 5 times from the top position with both hands.

If the lift gate does not open while in (R) Reverse, put it in (P) Park range once to open the lift gate, then place in (R) again and repeat raising and lowering the liftgate.

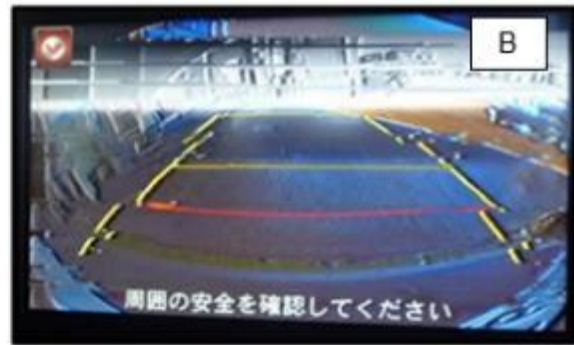
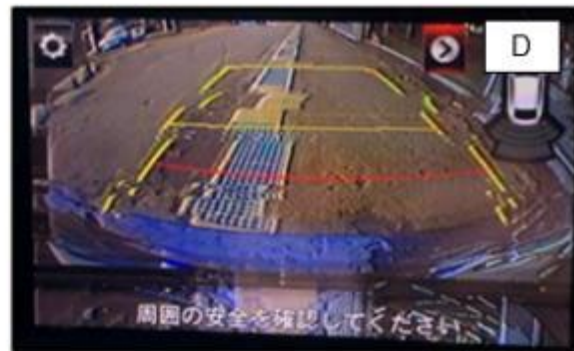
A	Image has noise and distortion
B	Lines appear distorted
C	Scrolling or split image
D	Edges are distorted
E	No image is displayed

7. Technician A – Watch the display for a flickering or distorted image while Technician B raises and lowers the liftgate 5 times. If the image appears similar to A through D – STOP! AND PROCEED to [REPAIR PROCEDURE 2 – REAR CAMERA REPLACEMENT.](#)
