Recall 6023G Rear Camera Recall Job Aid - Repair Calculator <u>GOOGLE SHEETS OR EXCEL - MACROS MUST BE ENABLED</u>	
	Please Read the ENTIRE Instructions: 1. Hit the Button "CLEAR VIN" to make sure the VIN area is blank. 2. Enter the VIN# (Vehicle Identification Number in full), in Cell B3 next to the Red Arrow. Ensure the VIN does not contain a SPACE at the beginning or end of the VIN number 3. Hit "Enter" on your keyboard 4. The answer of which part to install and claim is in GREEN. 5. To enter another VIN, Click the "Clear VIN" Button and Enter another 17 digit VIN <i>*Note: You must copy all 17 characters of the VIN. It is better to copy and paste the VIN from the Warranty Inquiry Screen on eMDCS. This tool will return an error code if the VIN is not 17 digits, or does not match the affected vehicle list.</i>	WARNING!! - NOT FOLLOWING THESE RULES CAN RESULT IN DEBITS, RE-REPAIRS WITH A NEW RO, POOR CUSTOMER EXPERIENCE AND POSSIBLE FEDERAL (NHTSA) FINES AND MISSED RECALLS. THERE ARE NO EXCEPTIONS TO THESE RULES. PLEASE SHARE WITH ALL PARTS PERSONNEL, WARRANTY ADMINISTRATOR, SERVICE ADVISOR AND TECHNICIANS! THE CLAIM MUST MATCH THE PARTS CHARGED OUT ON THE REPAIR ORDER. IF THEY AR

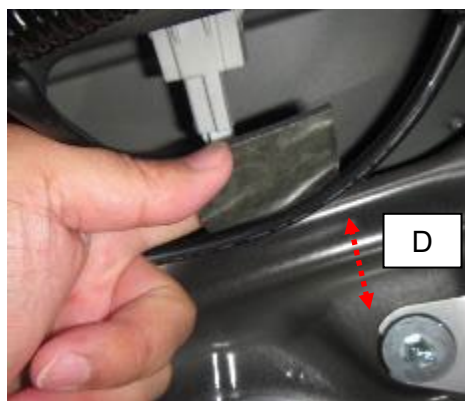
B	2" (50 mm)
C	6" (100 mm)
D	First, stick 1/2 on the underside of the body panel. DO NOT WRAP THE PAD VERY TIGHT AGAINST THE BODY EDGE, THE WIRES MUST BE SECURE AND FLEXIBLE.

7. Fold the foam pad in half and remove 1/2 of the paper from one side.
