## March 26, 2025 - Clarified repair guidelines

## A. VEHICLE INSPECTION PROCEDURE – AND PREPERATION FOR REPAIR

### C. REPAIR PROCEDURE 1 – FOAM PAD INSTALLATION (Mazda3)

**E. REPAIR PROCEDURE 2 – REAR CAMERA REPLACEMENT (Mazda3) – DO NOT INSTALL THE PAD AND THEN THE REAR CAMERA LATER, THE PAD AND REAR CAMERA MUST ALWAYS BE INSTALLED TOGETHER.**

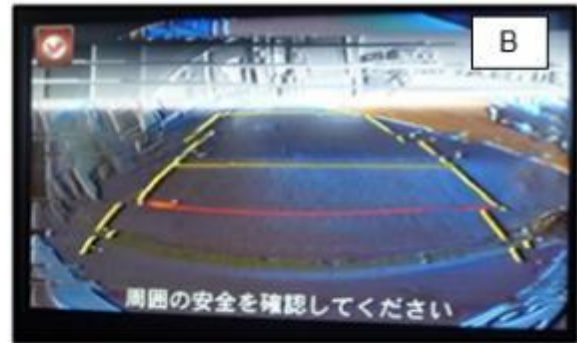
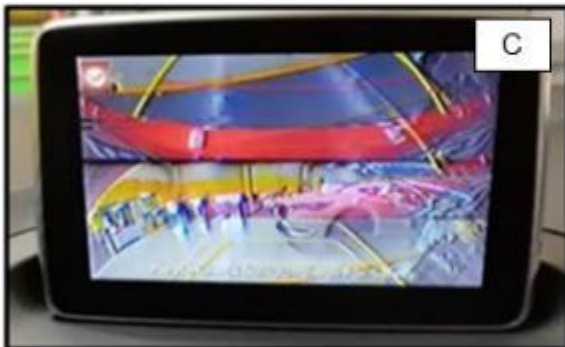
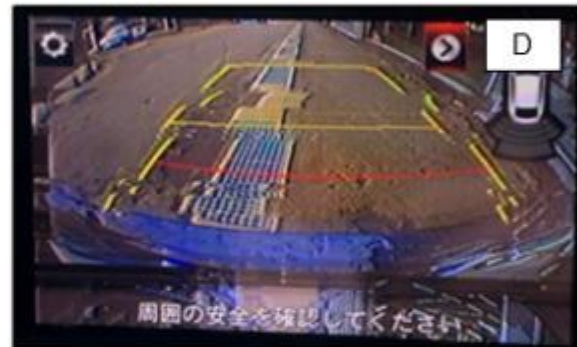
IMAGE DISTORTION THAT IS ACCEPTABLE FOR REPLACEMENT OF THE REAR CAMERA. THE REAR CAMERA MUST BE REPLACED IN THE CONDITIONS BELOW.

A	Image has noise and distortion
B	Lines appear distorted
C	Scrolling or split image
D	Edges are distorted
E	No image is displayed

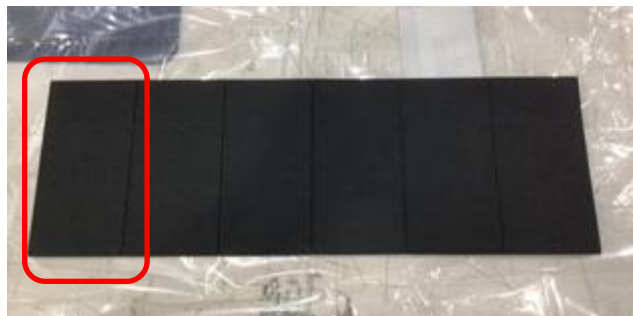
6. Install only one foam pad from kit part # B6Y1-66-1A3. Return any remaining pads to your parts department for use on a future vehicle.

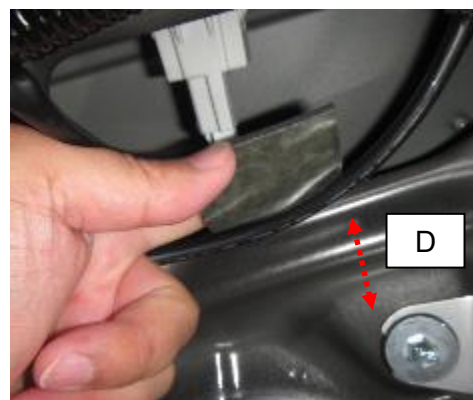
7. Fold the foam pad in half and remove 1/2 of the paper from one side.

B	2" (50 mm)
C	6" (100 mm)
D	First, stick 1/2 on the underside of the body panel. <b>DO NOT WRAP THE PAD VERY TIGHT AGAINST THE BODY EDGE, THE WIRES MUST BE SECURE AND FLEXIBLE.</b>

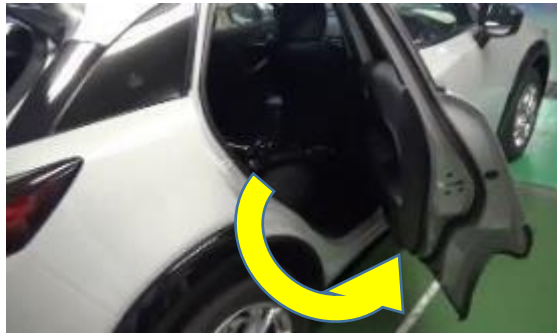
1. **Technician A:** Switch the ignition to ON twice (no engine running). Move the gearshift into (R) Reverse, place your foot on the brake pedal and set the parking brake. Confirm that the rear view image is displayed on the center display.

**Technician B:** Open one rear door (RH - right or LH - left door). This is to reduce air resistance when raising and lowering the liftgate. Raise and lower the liftgate 5 times from the top position with both hands.

If the lift gate does not open while in (R) Reverse, put it in (P) Park range once to open the lift gate, then place in (R) again and repeat raising and lowering the liftgate.

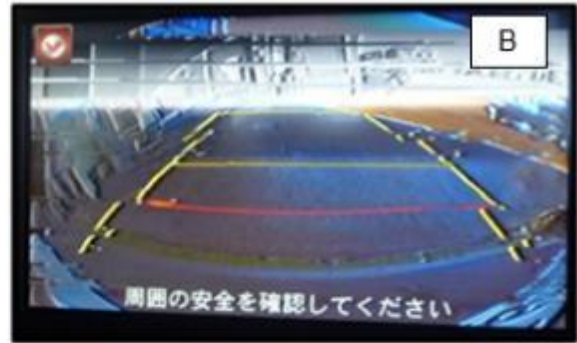
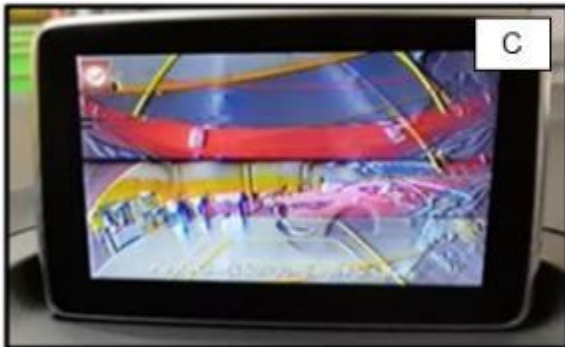
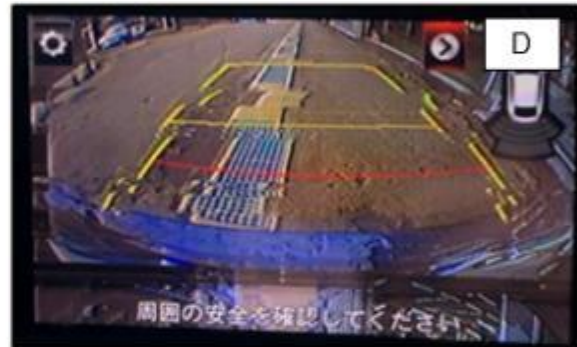
2. **Technician A** – Watch the display for a flickering or distorted image while Technician B raises and lowers the liftgate 5 times. If the image appears similar to A through D – STOP! AND PROCEED to [REPAIR PROCEDURE 2 – REAR CAMERA REPLACEMENT.](#)

A	Image has noise and distortion
B	Lines appear distorted
C	Scrolling or split image
D	Edges are distorted
E	No image is displayed

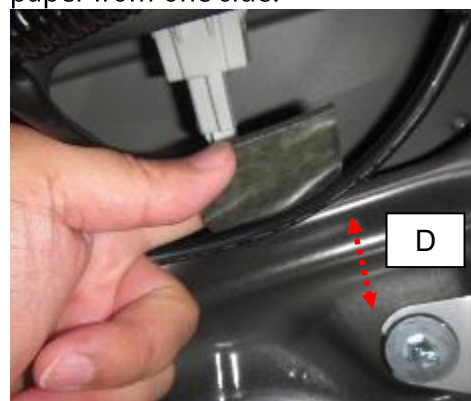
8. Fold the foam pad in half and remove 1/2 of the paper from one side.

B	2" (50 mm)
C	6" (100 mm)
D	First, stick 1/2 on the underside of the body panel. <b>DO NOT WRAP THE PAD VERY TIGHT AGAINST THE BODY EDGE, THE WIRES MUST BE SECURE AND FLEXIBLE.</b>

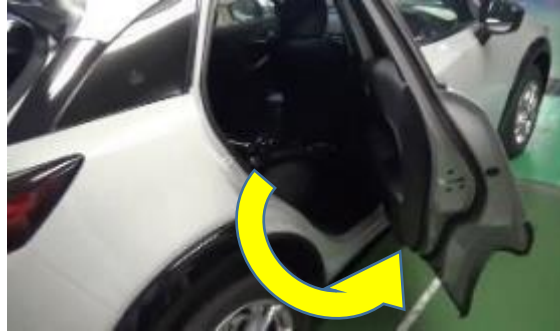
1. **Technician A:** Switch the ignition to ON twice (no engine running). Move the gearshift into (R) Reverse, place your foot on the brake pedal and set the parking brake. Confirm that the rear view image is displayed on the center display.

**Technician B:** Open one rear door (RH - right or LH - left door). This is to reduce air resistance when raising and lowering the liftgate. Raise and lower the liftgate 5 times from the top position with both hands.

If the lift gate does not open while in (R) Reverse, put it in (P) Park range once to open the lift gate, then place in (R) again and repeat raising and lowering the liftgate.

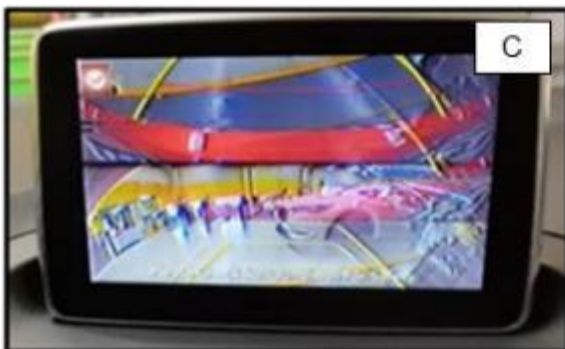
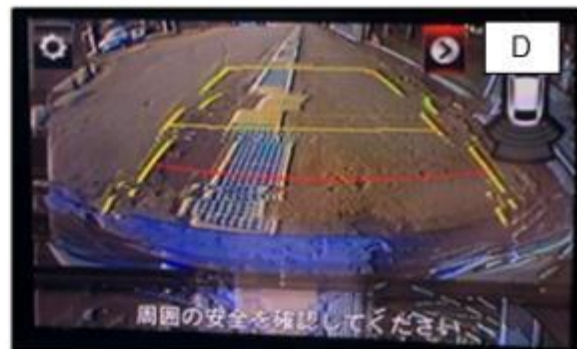
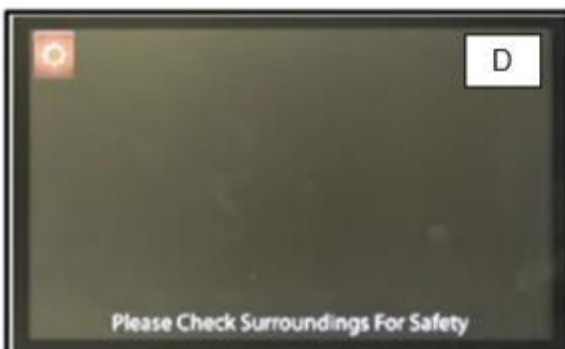
2. Technician A – Watch the display for a flickering or distorted image while Technician B raises and lowers the liftgate 5 times. If the image appears similar to A through D – STOP! AND PROCEED to [REPAIR PROCEDURE 2 – REAR CAMERA REPLACEMENT](#).

A	Image has noise and distortion
B	Lines appear distorted
C	Scrolling or split image
D	Edges are distorted
E	No image is displayed
