Remedy available for
 2023 (RU) Chrysler Pacifica PHEV

SYMPTOM DESCRIPTION

An improperly extruded fuel line could lead to uncontained fuel in the engine compartment on about 967 of the above vehicles. Operators may observe a spill / drip or fuel odor. Uncontained fuel in the presence of competent ignition source can result in a vehicle fire which increases the risk of injury to occupants and persons outside the vehicle, as well as property damage.

Inspect the fuel line date code, and if necessary, replace the suspect fuel line.

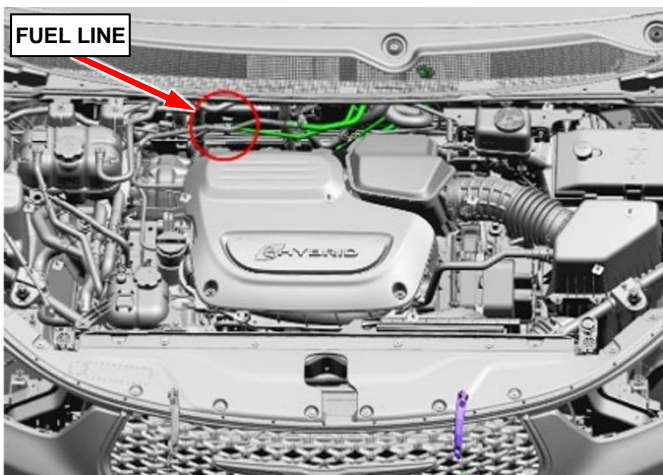
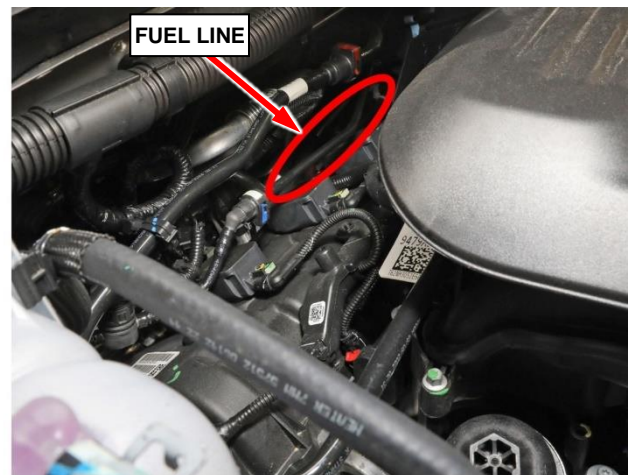
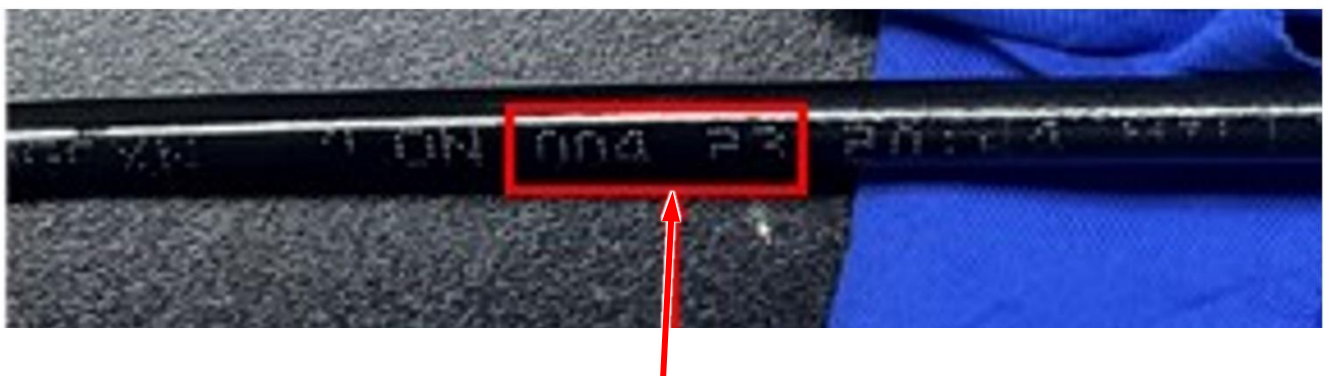
Julian Date

1. Open the engine compartment hood then locate the fuel supply line to inspect the date code which follows the word NYLON (Figure 1).
 - If date code is NOT **004 23** – Vehicle passes inspection and may be returned to inventory or customer.
 - If date code is **004 23** – Proceed to the Fuel Line Replacement Procedure section.
 - If date code not visible - Proceed to next Inspection step.

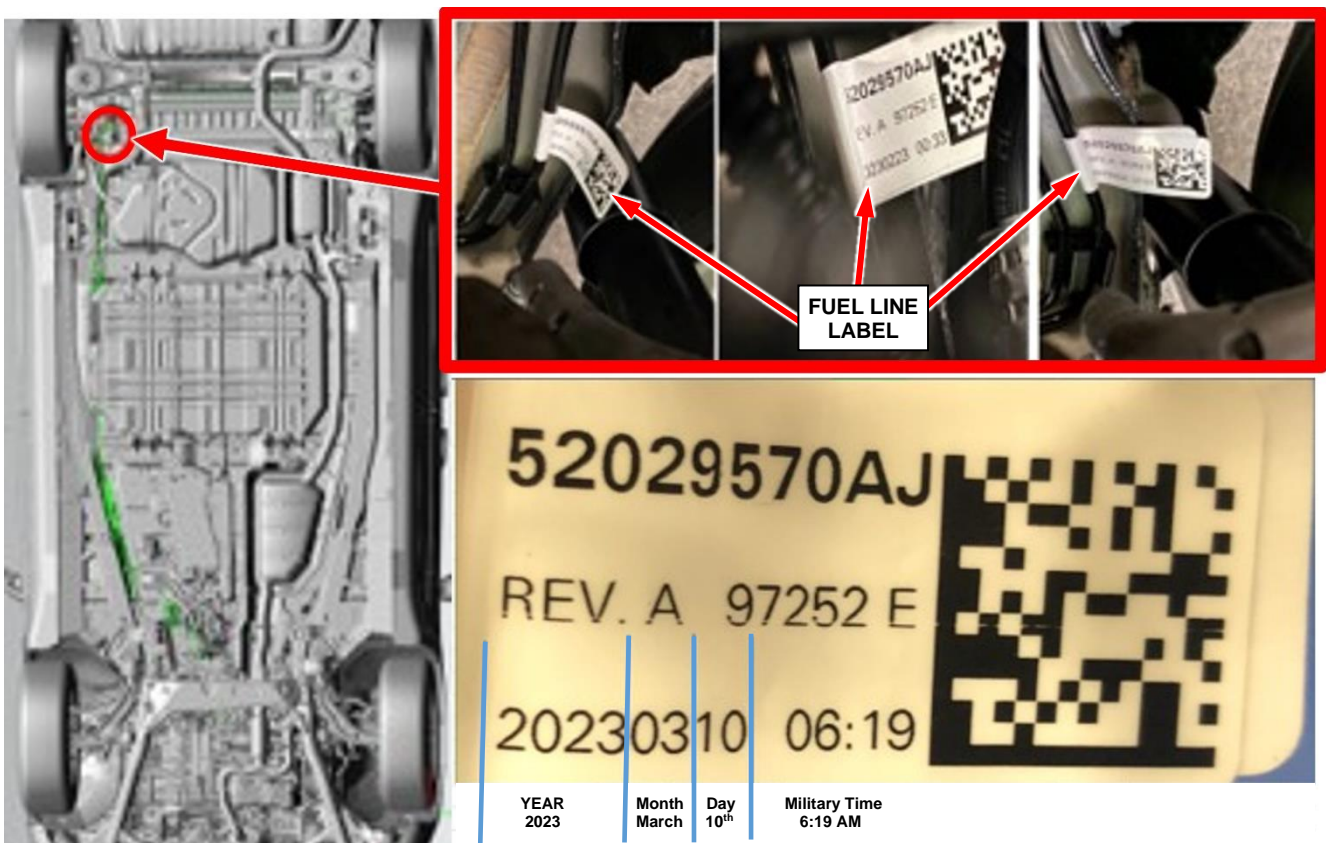
Figure 2 – Fuel Line Label Date Code Inspection

2. Raise and support the vehicle.
3. Forward of the left rear wheel, locate the fuel line label to inspect the date (Figure 2).
 - If date on label is **20230209** or earlier – Vehicle passes inspection and may be returned to inventory or customer.
 - If date on label is **20230224** or later – Vehicle passes inspection and may be returned to inventory or customer.
 - If date on label is between **20230210** to **20230223** – Proceed to the Fuel Line Replacement Procedure section.
 - If label is missing - Proceed to next Inspection step.

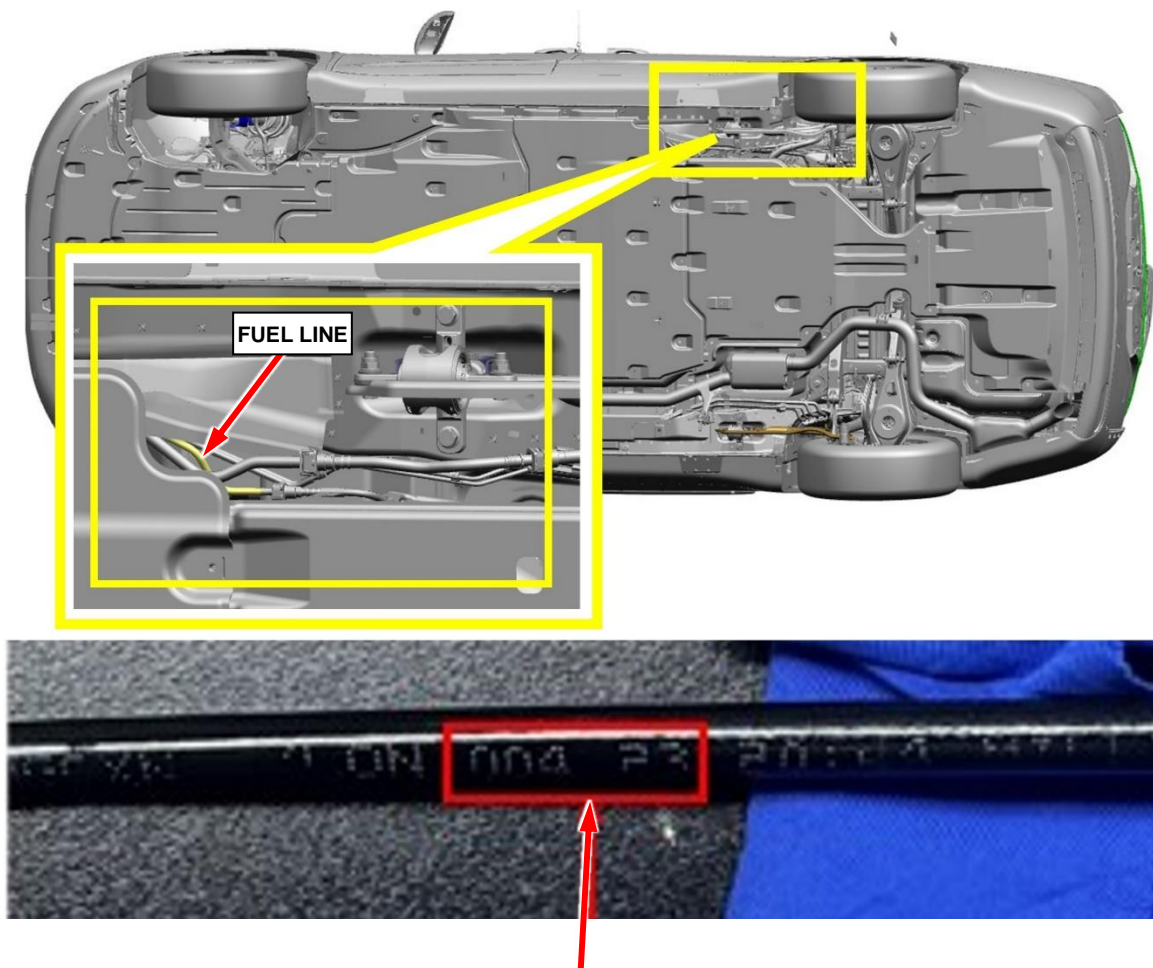
Julian Date
004 23
Jan 4, 23

4. Forward of the left rear wheel, locate the fuel supply line to inspect the date code which follows the word NYLON (Figure 3).
- If date code is NOT **004 23** – Vehicle passes inspection and may be returned to inventory or customer.
 - If date code is **004 23** – Proceed to the Fuel Line Replacement Procedure section.
 - If date code on the fuel supply line and label are both not readable in any location – Proceed to the Fuel Line Replacement Procedure section.

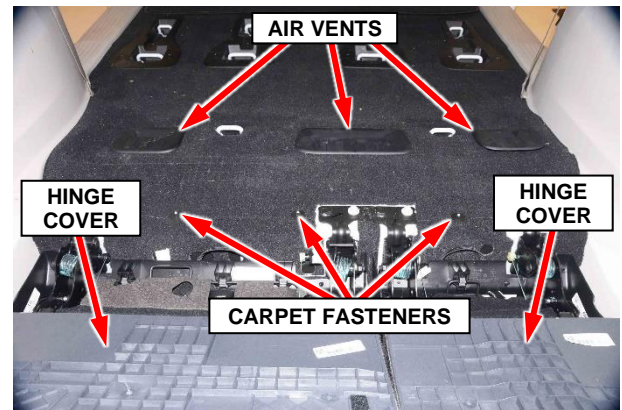
Figure 4 – Floor Carpet

1. Stow the 3rd row seats.
2. Remove the 2nd row seats.
3. Fold the hinge covers back to expose the carpet fasteners (Figure 4).
4. Remove the carpet fasteners (Figure 4).
5. Remove the three floor air vents by lifting up on the rear facing edge to release the push pin retainers (Figure 4).
6. Fold the floor carpet forward to expose the fuel pump module access cover (Figure 5).

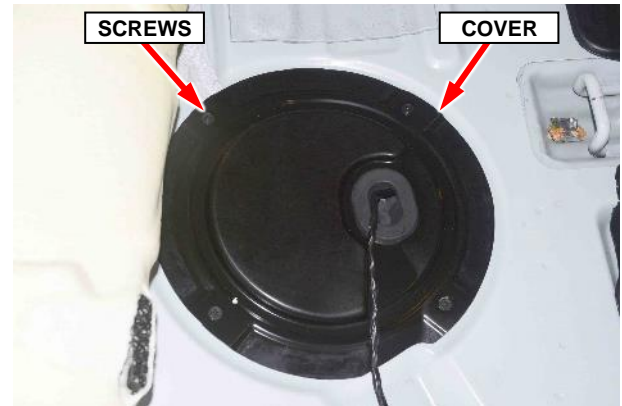
Figure 6 – Fuel Pump Module Access Cover

7. Remove the screws and the fuel pump module access cover (Figure 6).
8. Disconnect the fuel pump module wire harness electrical connector (Figure 7).
9. Start and run the engine until it stalls.
10. Attempt restarting the engine until it will no longer run.
11. Turn the ignition switch to the OFF position.

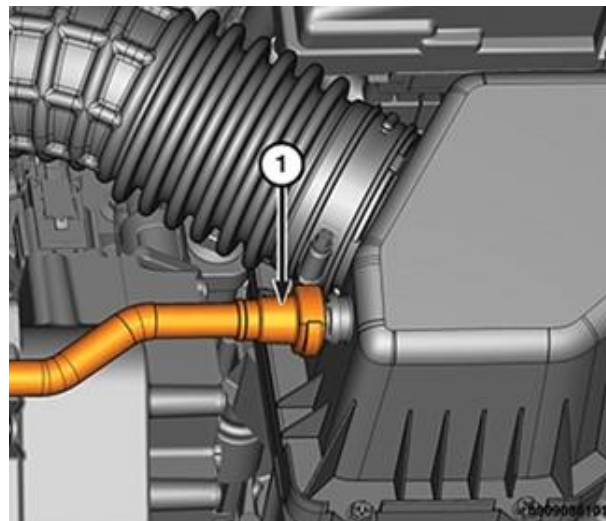
Figure 8 – Make-Up Air Hose

16. Disconnect the make-up air hose (1) from the air cleaner body (Figure 8).

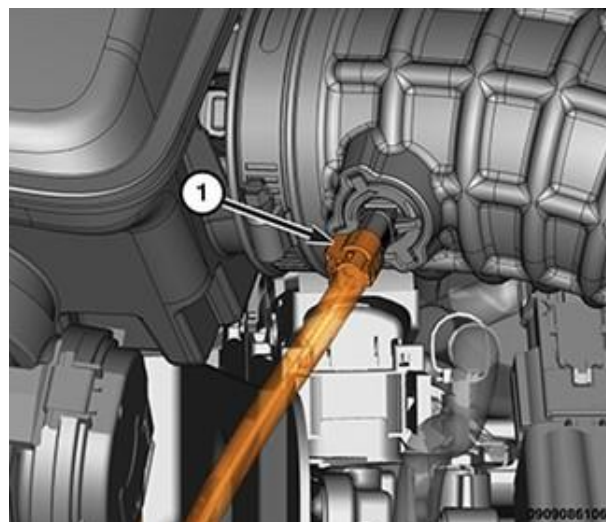
Figure 9 – Inlet Air Temperature Sensor

17. Disconnect the wire harness connector (1) from the Inlet Air Temperature (IAT) sensor (Figure 9).

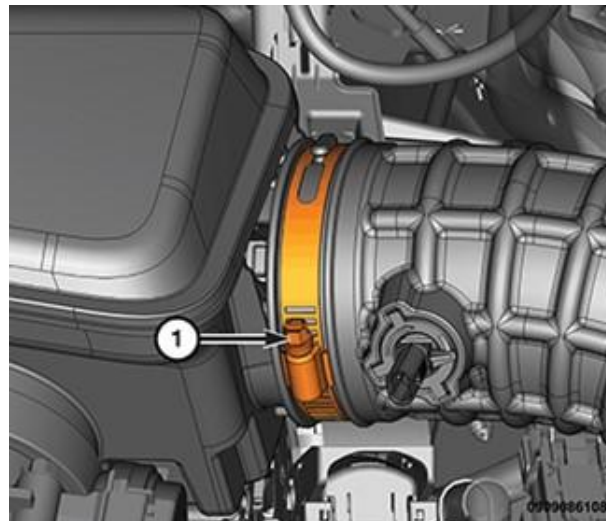
Figure 10 – Inlet Air Hose Clamp

18. Loosen the clamp (1) and disengage the clean air inlet hose from the resonator (Figure 10).

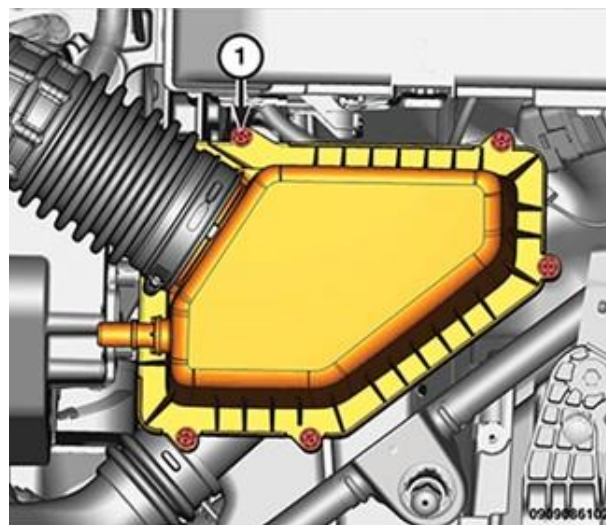
Figure 11 – Air Cleaner Housing Cover

19. Loosen the retaining screws (1) and remove the air cleaner housing cover (Figure 11).

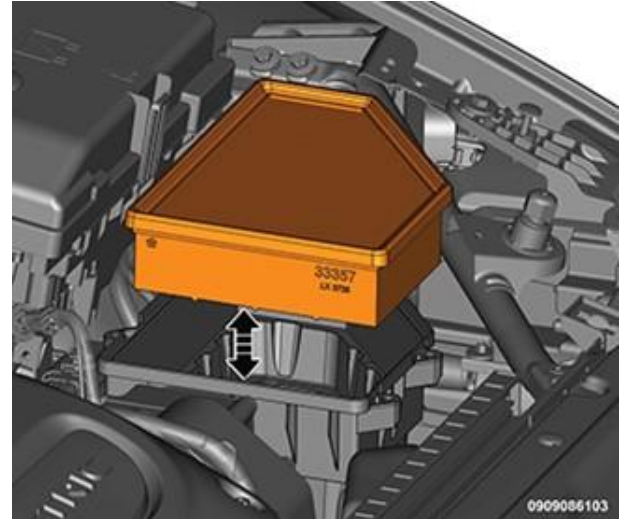
Figure 12 – Air Cleaner

20. Remove the air cleaner element (Figure 12).

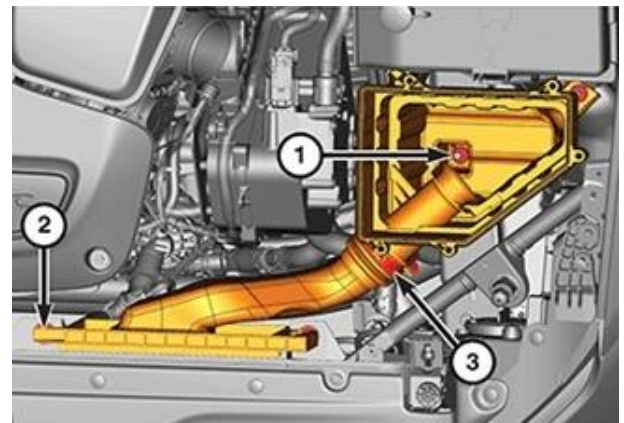
Figure 13 – Air Cleaner Body

21. Loosen the clamp (3) and pull the air inlet duct straight up to disengage the locating pins (2) from the rubber mount sockets (Figure 13).
22. Disengage the locating pins from the rubber mount sockets (1) and remove the air cleaner body (Figure 13).

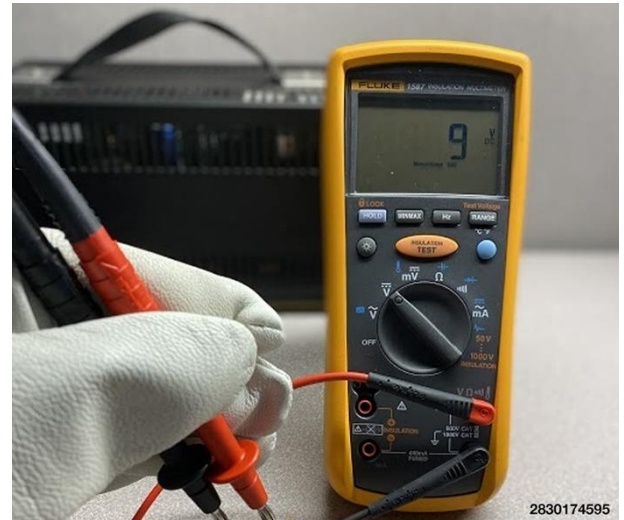
Figure 14 – Fluke Meter

23. Use of an insulation tester such as the Fluke Meter, Multi 126-1587 is recommended for PHEV circuit testing. Perform the multi-meter functionality tests per the manufacturer's directions. Verify the multi-meter is operating correctly by measuring voltage from a known good power source, such as the vehicle's 12-volt battery. If at any point during the procedure, the multi-meter settings are changed, or the probes are repositioned in the meter, verification with a known good power source must be repeated (Figure 14).

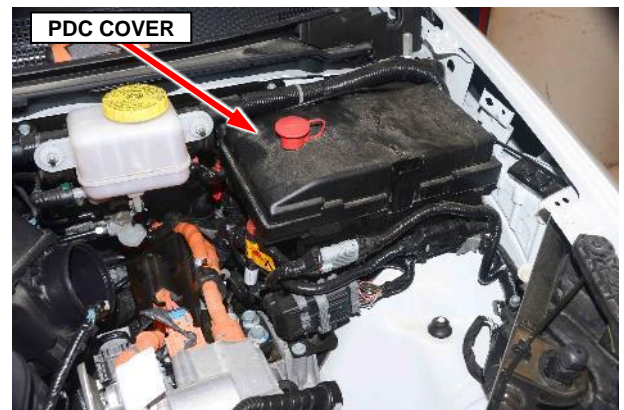
Figure 15 – PDC Cover

24. Remove the Power Distribution Center (PDC) cover (Figure 15).

136. Install the PDC cover (Figure 15).

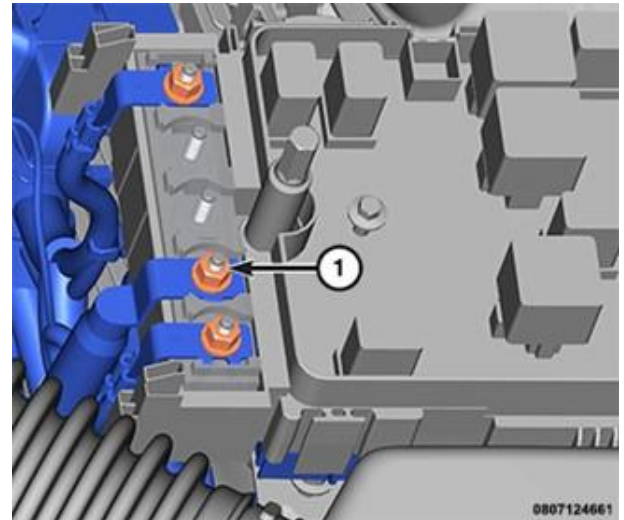
Figure 16 – Battery Positive Cable

25. Disconnect the B(+) battery cable (1) from the 12-volt PDC (Figure 16).

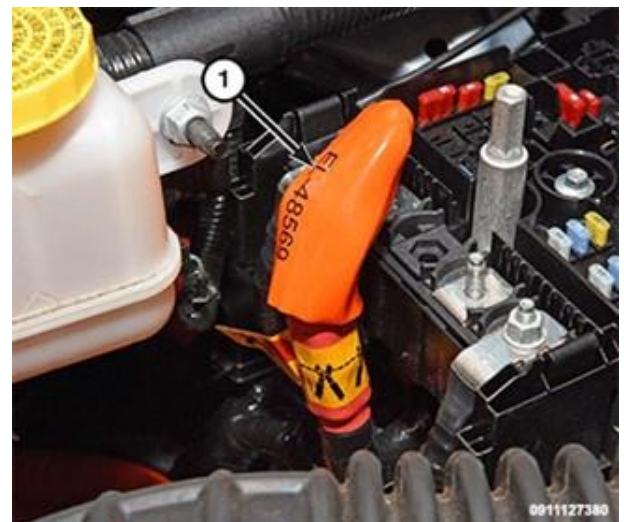
Figure 17 – Terminal Cover

26. Isolate the cable terminal using Covers, Hybrid Electric Vehicle (HEV) Battery Terminal 2035100082 (1) (Figure 17).

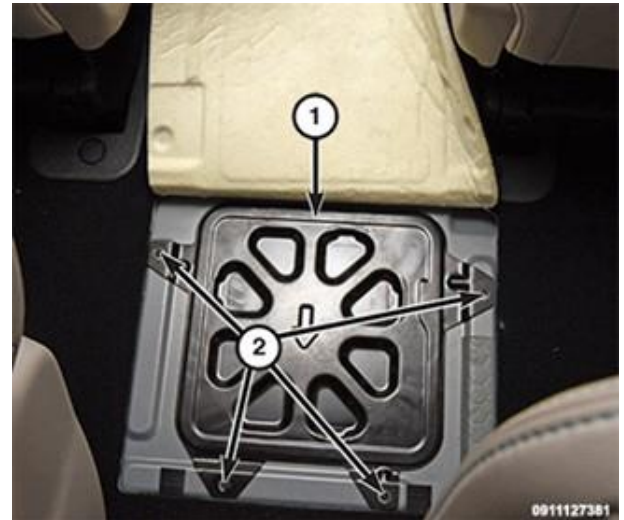
Figure 18 – MDS Floor Access Cover

27. Lift the carpet away from the high-voltage Manual Service Disconnect (MSD) floor access cover (Figure 18).
28. Remove the four screws (2) and remove the high-voltage MSD access cover (1) (Figure 18).

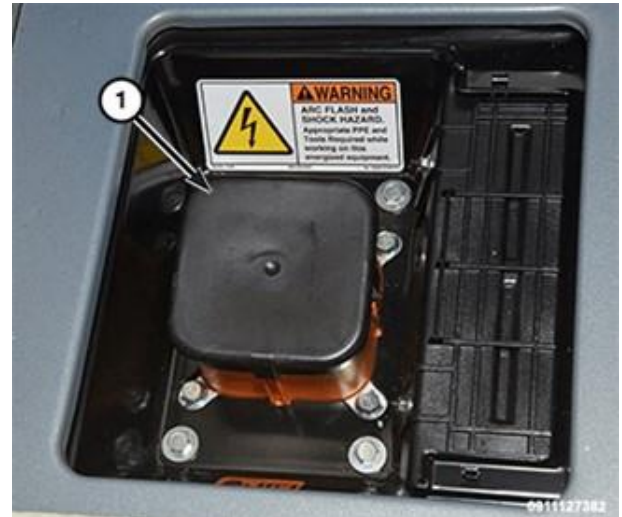
Figure 22 – MDS Cover

32. Cap the receptacle (1) on the high-voltage battery with the Covers, HEV Battery Terminal 2035100082 to prevent foreign objects from entering (Figure 22).

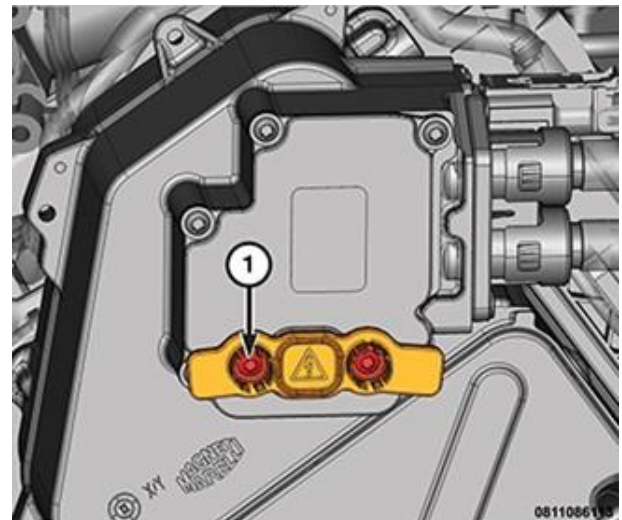
Figure 23 – HVIL Connector

33. Loosen the two captive screws (1) and remove the single High Voltage Inter-Lock (HVIL) connector from the Power Inverter Module (PIM) cover (Figure 23).

123. Install the single High Voltage Inter-Lock (HVIL) connector to the PIM cover and tighten the two captive screws (1) to 7 N·m (62 in. lbs.) (Figure 23).

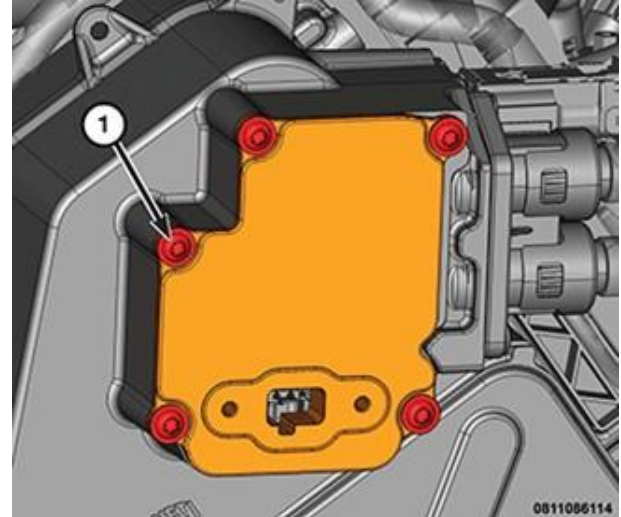
Figure 24 – PIM Cover

34. Loosen the captive screws (1) and remove the PIM cover (Figure 24).

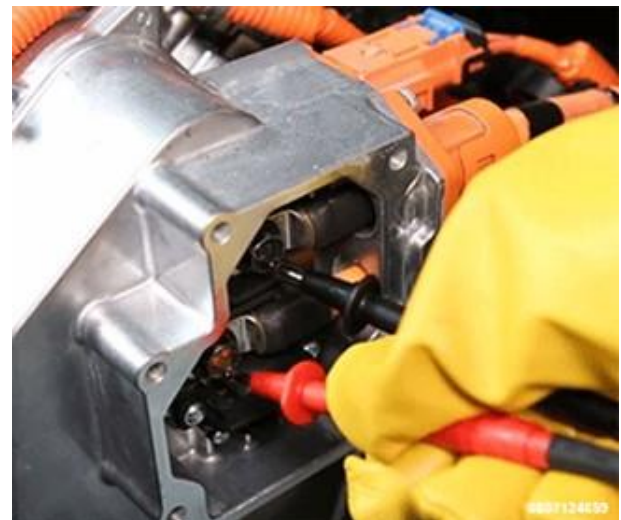
Figure 25 – Voltage Check

36. The measured voltage should be near 0 volts. (Some residual voltage may be present, up to 2.0 volts may be normal.) (Figure 25).

- If the voltage measured is below 2.0 volts, it is safe to work on the high-voltage components with the exception of the high-voltage battery internal components.
- If the voltage is greater than 60 volts, an internal condition exists within the high-voltage battery that is preventing it from being powered down. Do not attempt to carry out repairs on any of the vehicle's high-voltage components or wiring. Perform the HIGH VOLTAGE LOSS OF ISOLATION TEST PROCEDURE. Refer to the detailed procedures available in DealerCONNECT > Service Library > under: 08 - Electrical/Standard Procedure).

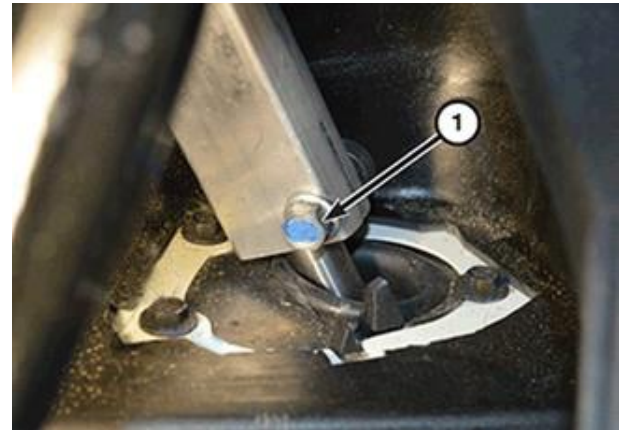
Figure 26 – Steering Gear Pinch Bolt

38. Remove the steering shaft to steering gear pinch bolt (1) and discard the pinch bolt. Do not start to remove (or break free) the steering shaft to steering gear pinch bolt (1) with an impact wrench/gun (Figure 26).

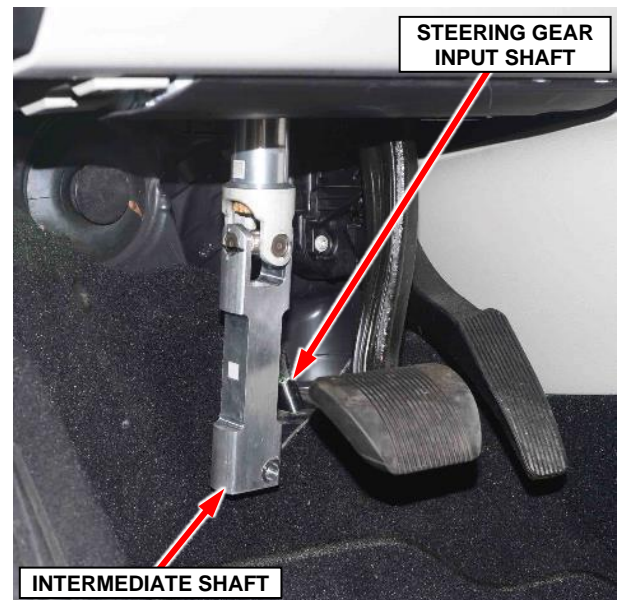
Figure 27 – Steering Gear Pinch Bolt

39. Release the intermediate shaft from the steering gear input shaft (Figure 27).

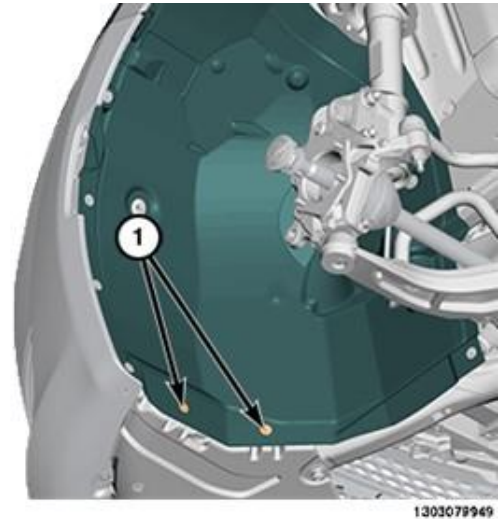
Figure 28 – Wheelhouse Fasteners

40. Raise and support the vehicle.
41. Remove the screws (1) attaching the wheelhouse splash shields to the front belly pan (Figure 28).

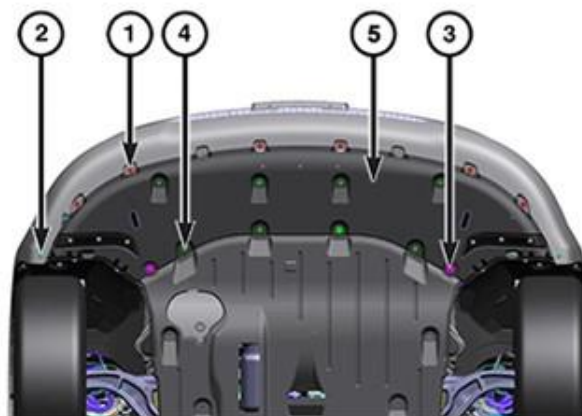
44. Remove the rear screws (4) (Figure 29).

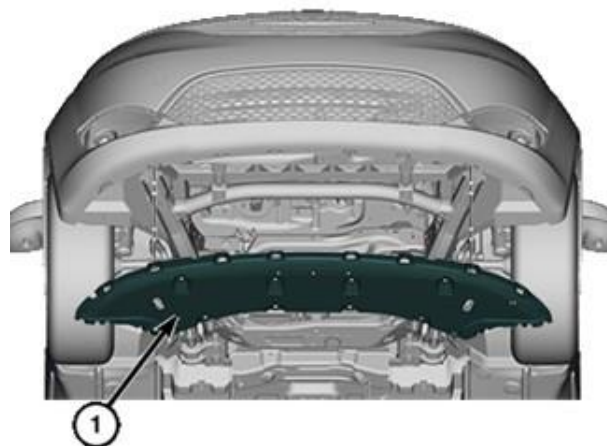
45. Remove the front belly pan (1) (Figure 30).

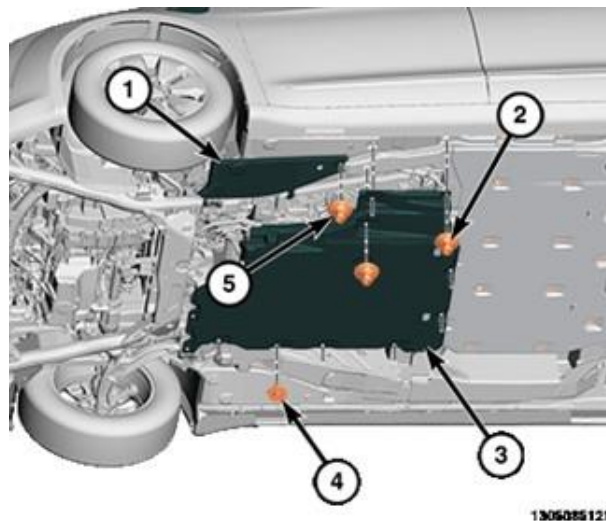
Figure 33 – Charger Belly Pan

48. Remove the fasteners (2, 4, 5) from the charger belly pan (1, 3) then remove the charger belly pan (Figure 33).

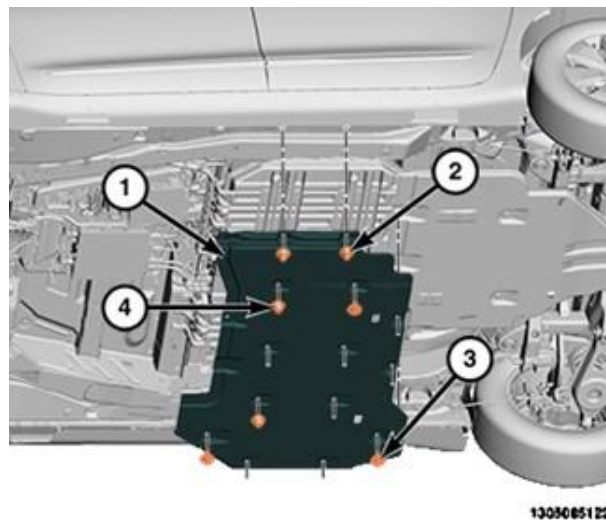
Figure 34 – Battery Belly Pan

49. Remove the fasteners (2, 3, 4) from the battery belly pan (1) then remove the battery belly pan (Figure 34).

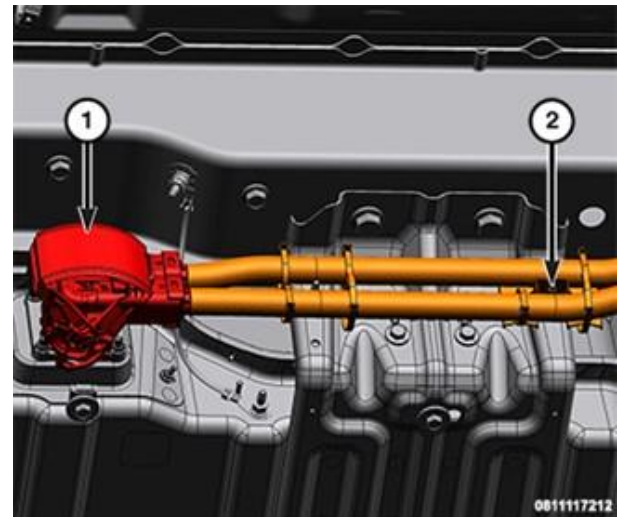
Figure 38 – PIM Wire Harness Connector

54. Disengage the two wire harness retainers (2) from the high-voltage battery (Figure 38).
55. Unlock and disconnect the Power Inverter Module (PIM) high-voltage wire harness connector (1) from the high-voltage battery. Cap the connector on the high-voltage battery with the Covers, HEV Battery Terminal 2035100082 (Figure 38).

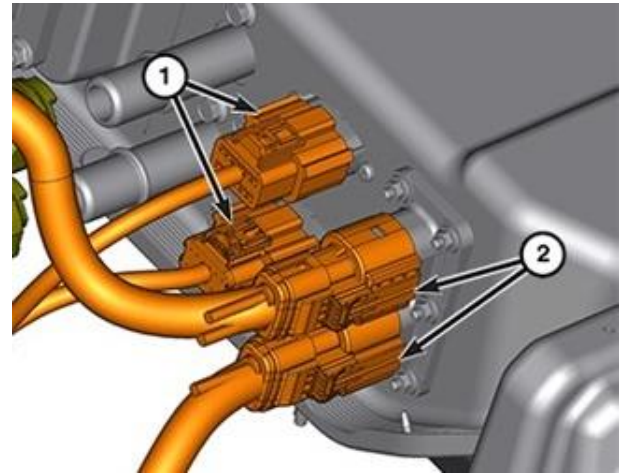
Figure 39 – Wire Harness Connectors

- 56. Unlock and disconnect the low-voltage wire harness connectors (1) from the high-voltage battery (Figure 39).
- 57. Unlock and disconnect the On-board Charging Module (OBCM) and Electric Coolant Heater (ECH) high-voltage wire harness connectors (2) from the high-voltage battery (Figure 39).
- 58. Cap the connectors on the high-voltage battery with the Covers, HEV Battery Terminal 2035100082 (Figure 39).

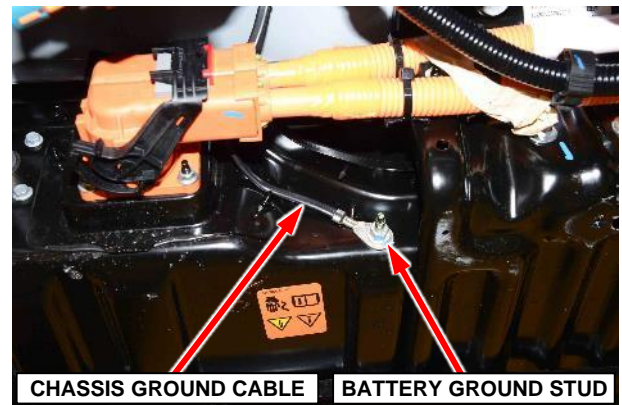
Figure 40 – HV Battery Ground

- 59. Remove the High-Voltage (HV) battery ground stud nut and the chassis ground cable from the stud (Figure 40).

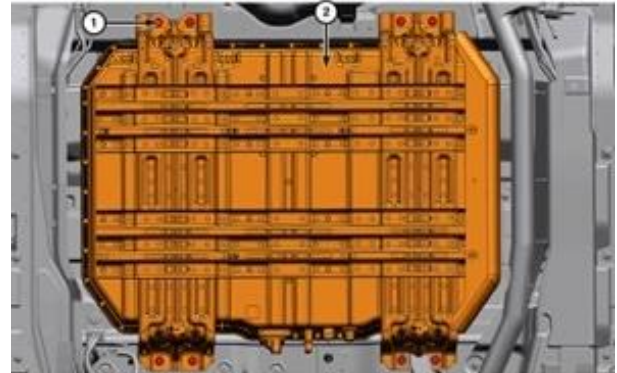
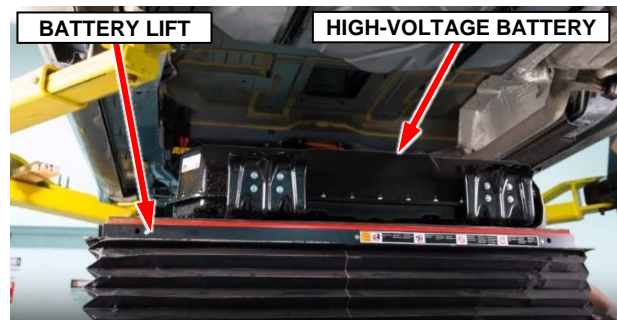
Figure 42 – High-Voltage Battery

63. Lower the high-voltage battery from the vehicle (Figure 42).

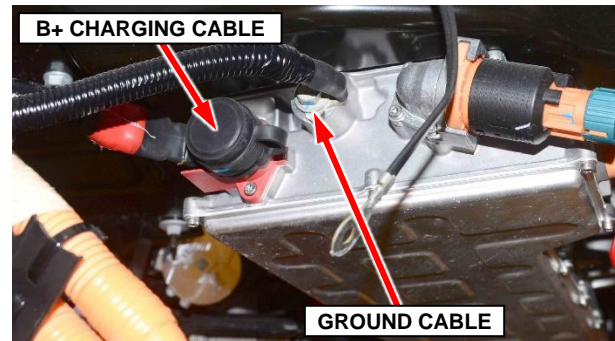
Figure 43 – IDCM Charging Cables

- 64. Open the protective cover and loosen the captured nut that secures the B+ charging cable to the Integrated Dual Charge Module (IDCM) (Figure 43).
- 65. Remove the bolt securing the ground cable to the IDCM (Figure 43).
- 66. Place a suitable coolant recovery container under the coolant inlet and outlet coolant hoses then disconnect the quick-connect fittings from the IDCM (Figure 44).
- 67. Allow the coolant to drain into a suitable coolant recovery container then cap the ports on the IDCM.
- 68. Disconnect the IDCM electrical connector and the wire harness connector (Figure 44).
- 69. Place a suitable coolant recovery container under the coolant hoses then disconnect the seven coolant hoses for battery electronics (Figure 45).

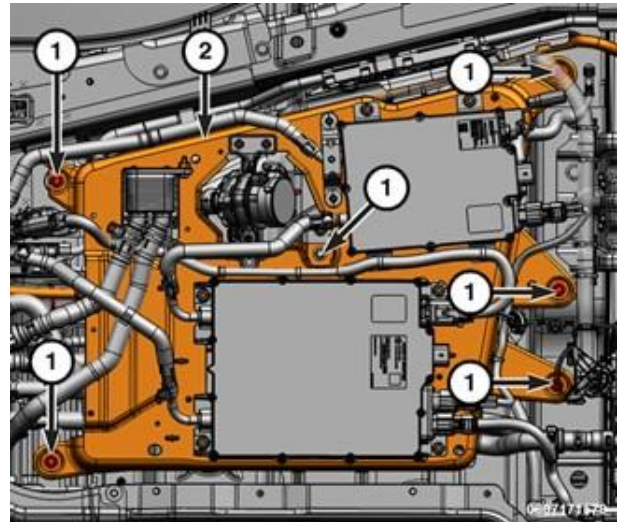
Figure 46 – Battery Charger Bracket

70. Position a suitable stand to support the battery charger bracket (2) then remove the fasteners (1) (Figure 46).

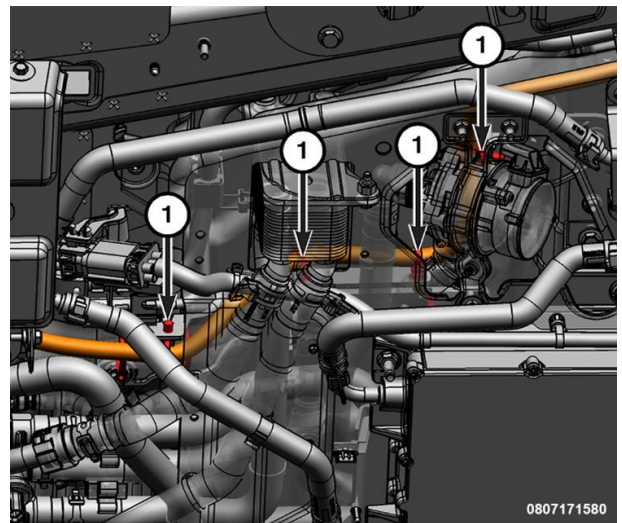
Figure 47 – Battery Charger Bracket Wire Harness

71. Carefully lower the battery charger bracket while releasing the wire harness electrical connectors and retaining clips (1) (Figure 47).
72. Remove the battery charger bracket containing the IDCM and Auxiliary Power Module (APM) from the vehicle.

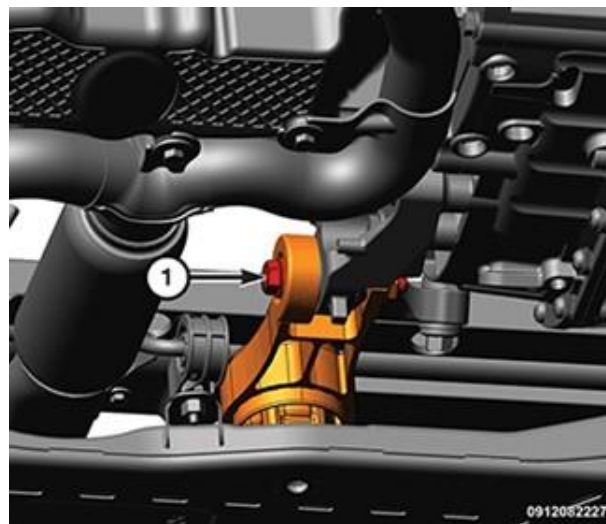
Figure 48 – Rear Transmission Mount

73. Remove the bolt (1) releasing the rear transmission mount (Figure 48).

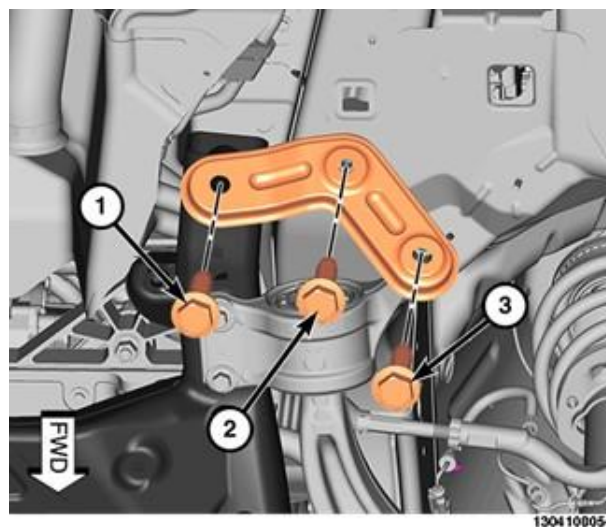
Figure 49 – Shear Bracket

74. Remove and **DISCARD** the three shear bracket bolts then remove the shear bracket on each side of the vehicle (Figure 49).

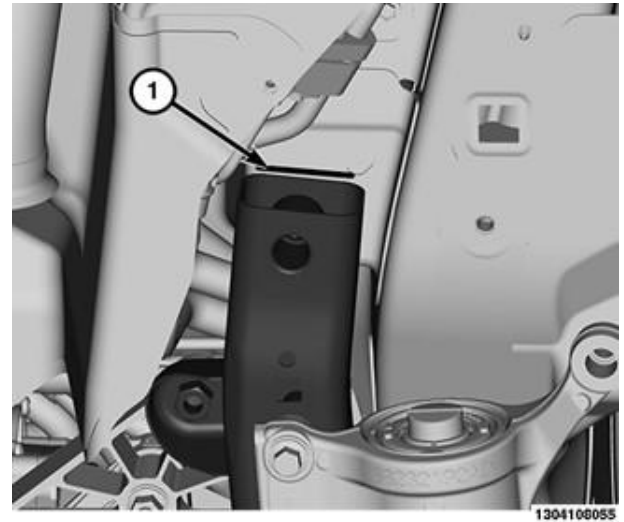
Figure 50 – Mark Crossmember

75. Using a marker or equivalent, mark the position of the crossmember on the vehicle body (1) (Figure 50).

100. Align the crossmember assembly to the reference marks and install the **NEW** bolts then tighten to 160 N·m (118 ft. lbs.) (Figures 50 and 51).
101. Position the shear bracket to the vehicle and install the three **NEW** bolts (Figure 62).
 - Tighten the M16 bolt (1) securing the shear bracket to the subframe to 169 N·m (125 ft. lbs.)
 - Tighten the M14 bolt (3) securing the shear bracket and lower control arm to the vehicle body to 160 N·m (118 ft. lbs.)
 - Tighten the M10 bolt (2) securing the shear bracket to the vehicle body to 50 N·m (37 ft. lbs.).

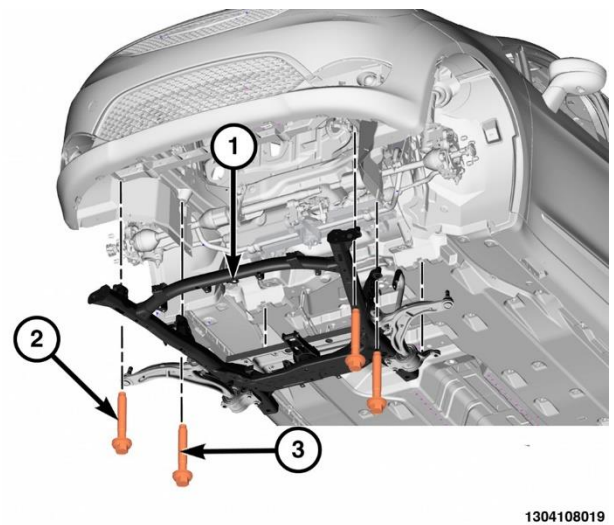
Figure 51 – Crossmember Bolts

76. Remove and **DISCARD** the crossmember bolts (2 and 3) then allow the crossmember assembly (1) to hang from the suspension components (Figure 51).

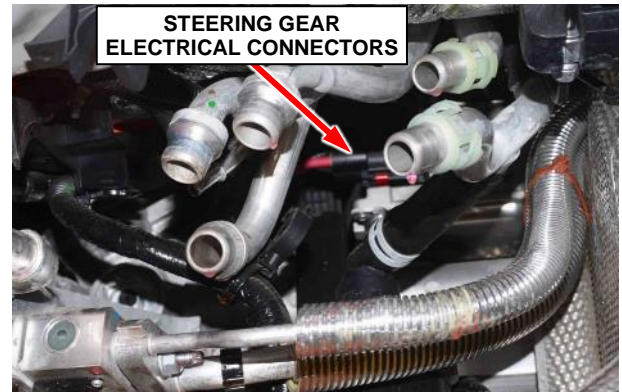
Figure 52 – Steering Gear Electrical Connectors

- 77. Disconnect the power steering gear electrical connectors (Figure 52).
- 78. Open the protective cover and loosen the B+ charging cable captured nut then remove the cable from the isolator stud (Figure 53).
- 79. Remove the fasteners securing the high voltage cable brackets to the vehicle underbody then allow the cables and brackets to hang down providing access to the fuel lines (Figure 53).

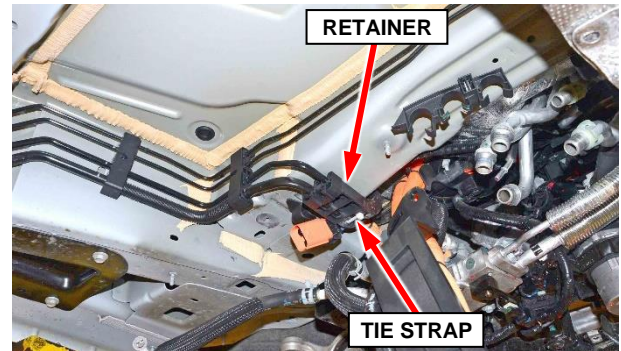
Figure 56 – Fuel Lines Tie Strap

82. Cut the cable tie strap securing the fuel lines to the front retainer. A replacement cable tie strap Mopar part number 04641780 or equivalent will be required during reassembly (Figure 56).

91. Install the fuel supply and return lines into all the retainers (Figures 55, 56, 57). A replacement cable tie strap Mopar part number 04641780 or equivalent will be required for retainer shown in (Figure 56).

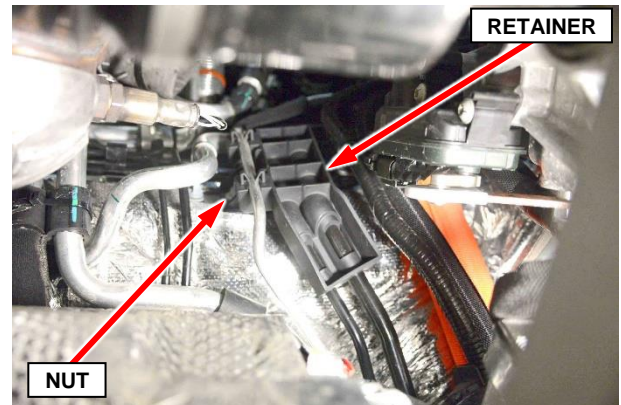
Figure 57 – Fuel Line Retainer Nut

83. Remove the nut securing the fuel line retainer to the engine compartment cowl then release the fuel lines from the retainer and remove the retainer (Figure 57).

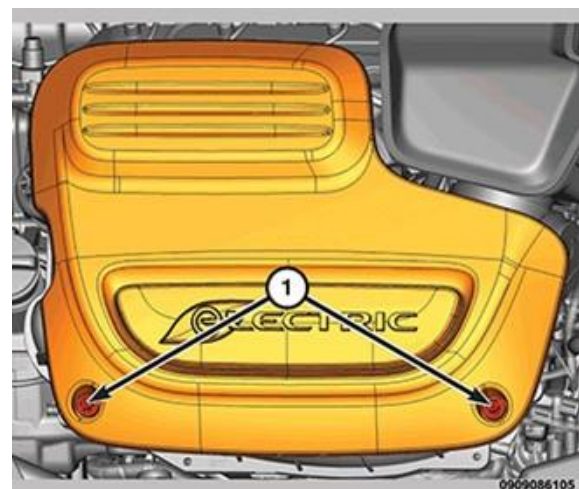
Figure 58 – Engine Cover

85. Remove the bolts (1) from the engine cover then pull upward on the engine cover to release from the ball stud mounting brackets and remove the engine cover (Figure 58).

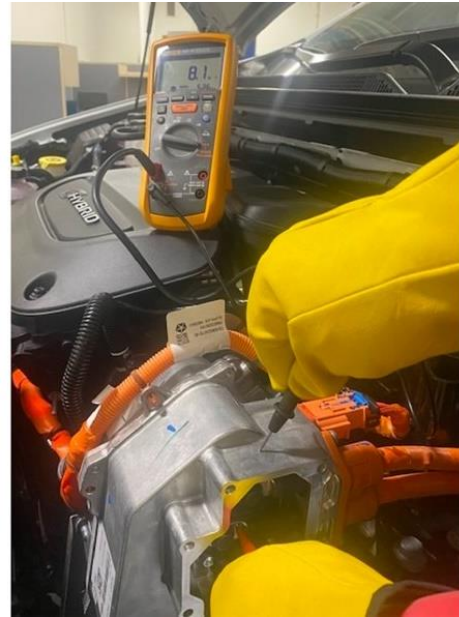
Figure 63 – Isolation Test

121. During the following isolation checks press and hold the TEST button on the FLUKE 1587 until the voltage displayed in the lower right corner of the screen stabilizes. Record the resistance value displayed in the middle of the screen.

- a. Connect the BLACK multi-meter lead to the ground strap located between the Transmission and the Chassis or to another suitable unpainted metal chassis ground and connect the RED multi-meter lead on the (H300) High Voltage DC 300V (+) terminal inside the PIM. Record the reading (Figure 63).
- b. Connect the Red multi-meter on the (H301) High Voltage DC 300V (-) terminal inside the PIM. Record the reading (Figure 64).
 - If the measured resistance value is within the range of 7.8 Mega Ohms and 8.6 Mega Ohms then the bus rail and chassis are safely isolated.
 - If the recorded value is outside of the acceptable range, 7.8 MΩ and 8.6 MΩ, a loss of isolation condition exists within the high-voltage circuitry. Do not continue the High Voltage Power Up procedure until the condition causing the loss of isolation is corrected.

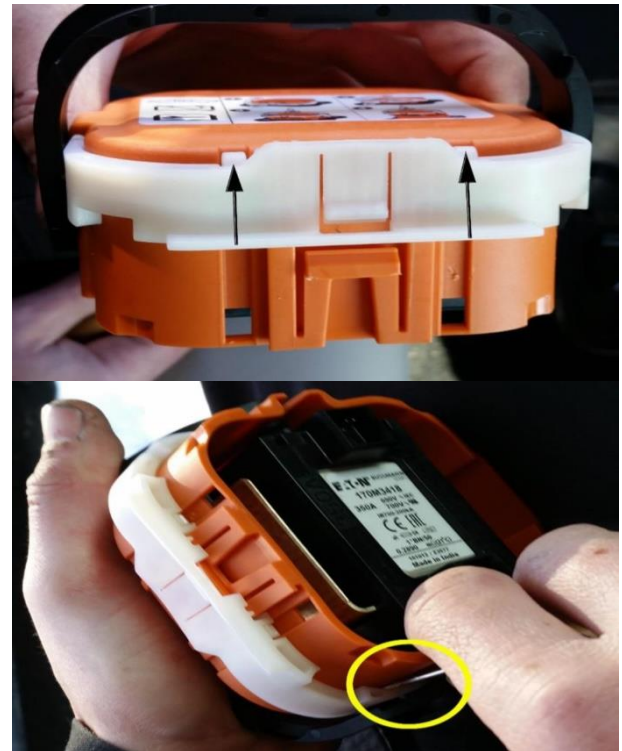
Figure 65 – MDS

125. If necessary, use a small screwdriver to loosen and guide the white sleeve to the full upward position as shown (Figure 65).

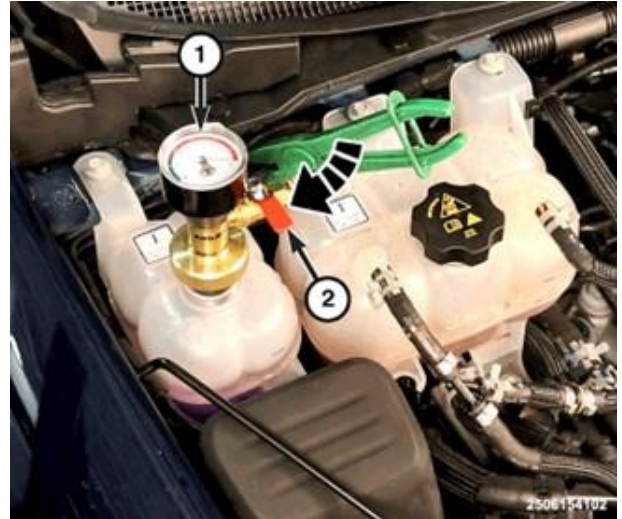
Figure 68 – Cooling System Refill

- e) Position the adaptor cone/vacuum gauge assembly (1) into the filler neck. Ensure that the adapter cone is sealed properly (Figure 68).
- f) Close the vacuum generator/venturi ball valve (2) (Figure 68).

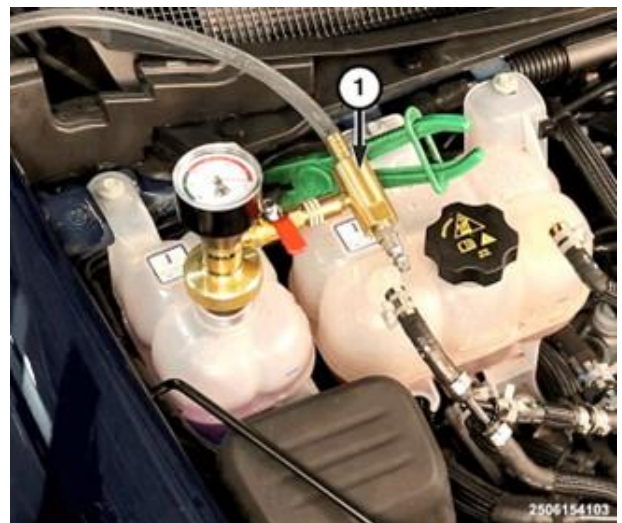
Figure 69 – Cooling System Refill

- g) Connect the vacuum generator/venturi (1) to the positioned adaptor cone/vacuum gauge assembly (Figure 69).

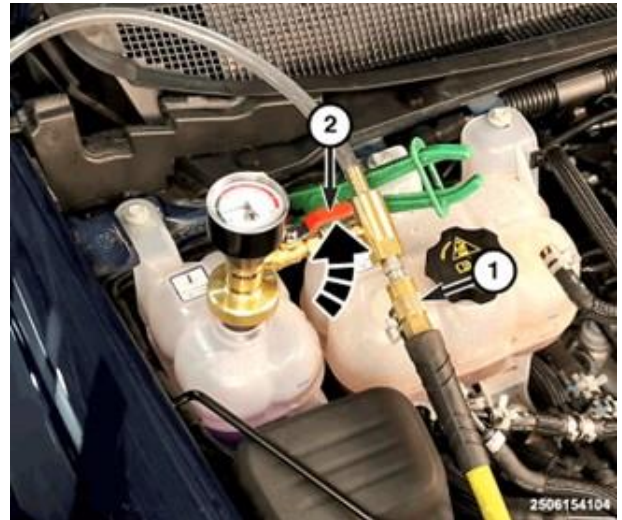
Figure 70 – Cooling System Refill

- h) Make sure the vacuum generator/venturi ball valve is closed and attach an airline hose (1) (minimum shop air requirement of 80 PSI/5.5 bar) to the vacuum generator/venturi (Figure 70).
- i) Open the vacuum generator/venturi ball valve (2) (Figure 70).

- j) Let the system run until the vacuum gauge shows a good vacuum through the cooling system. Refer to the tool's operating manual for appropriate pressure readings.

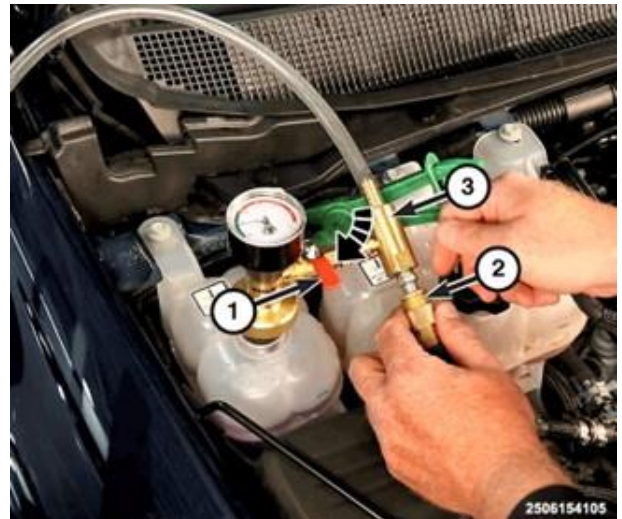
Figure 71 – Cooling System Refill

- k) Close the vacuum generator/venturi ball valve (1) (Figure 71).
- l) Disconnect the airline (2) and the vacuum generator/venturi (3) from the adaptor cone/vacuum gauge assembly (Figure 71).
- m) Wait approximately 20 seconds, if the pressure readings do not move, the system has no leaks. If the pressure readings move, a leak could be present in the system. Check for leaks and repeat the procedure.

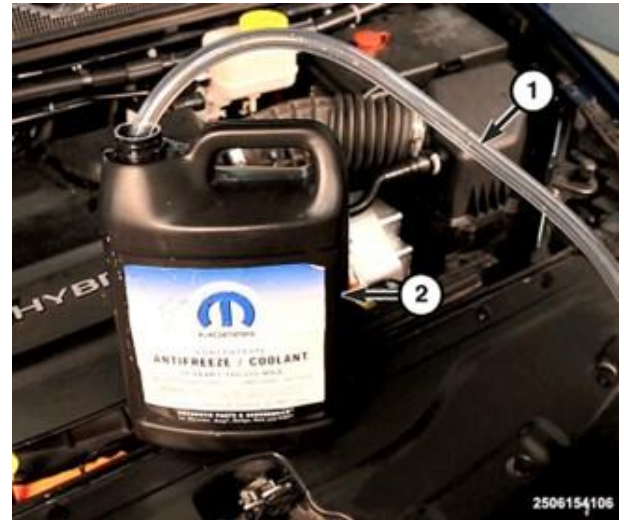
Figure 72 – Cooling System Refill

- n) Place the tool's suction hose (1) into the coolant's container (2) (Figure 72).

NOTE: Ensure there is a sufficient amount of coolant, mixed to the required strength/protection level available for use. For best results and to assist the refilling procedure, place the coolant container at the same height as the filler neck. Always draw more coolant than required. If the coolant level is too low, it will pull air into the cooling system which could result in airlocks within the system.

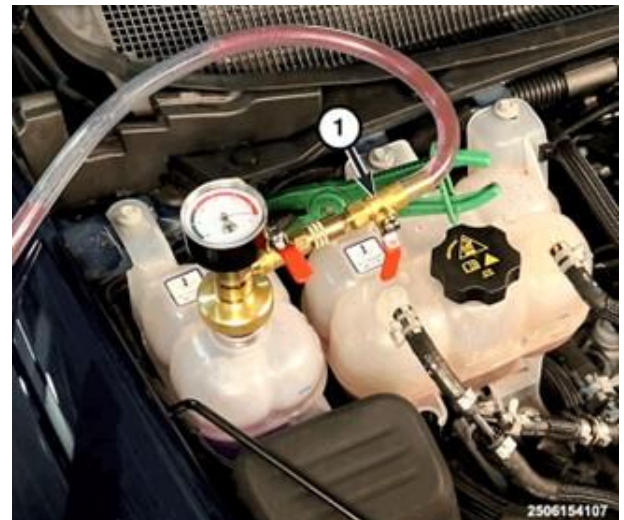
Figure 73 – Cooling System Refill

- o) Pre-fill the tool suction hose (1) with coolant (Figure 73).
- p) Connect the tool's suction hose (1) to the adaptor cone/vacuum gauge assembly (Figure 73).

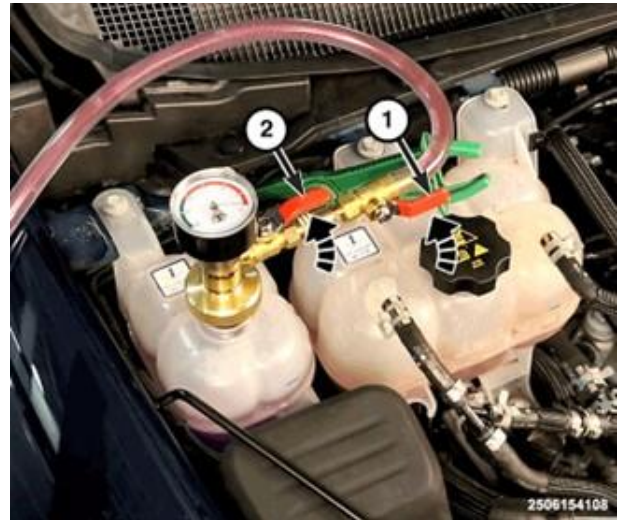
Figure 74 – Cooling System Refill

- q) Open the suction hose's ball valve (1) (Figure 74).
- r) Open the vacuum generator/venturi ball valve (2) to begin filling the cooling system (Figure 74).
- s) When the vacuum gauge reads zero, the system is filled.

NOTE: Stop filling when the proper level is reached in the pressurized coolant bottle.

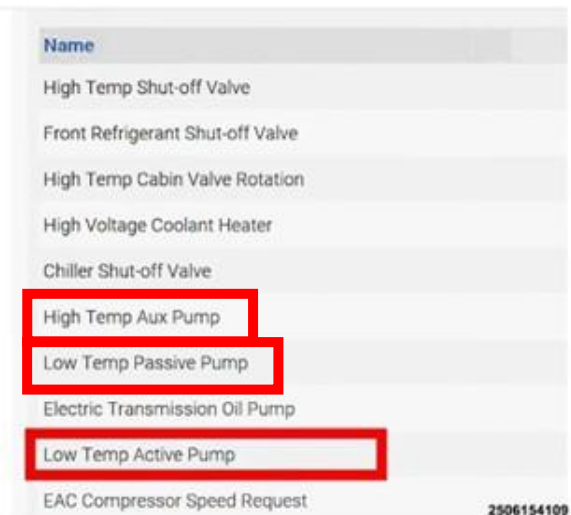
Figure 76 – Active Pump Routine

155. Using a scan tool, go to HCP Misc Functions then run the following pump routines to purge any trapped air from the power electronics cooling systems (Figure 76).
