SAFETY RELATED RECALL

Global Recall Action
Number: H445v2

Subject: Rear View Camera Image Display	Publication No.: H445v2
	Model: XE (X760)
	Model Year: 2019
	Date of Issue: 09 December 2025

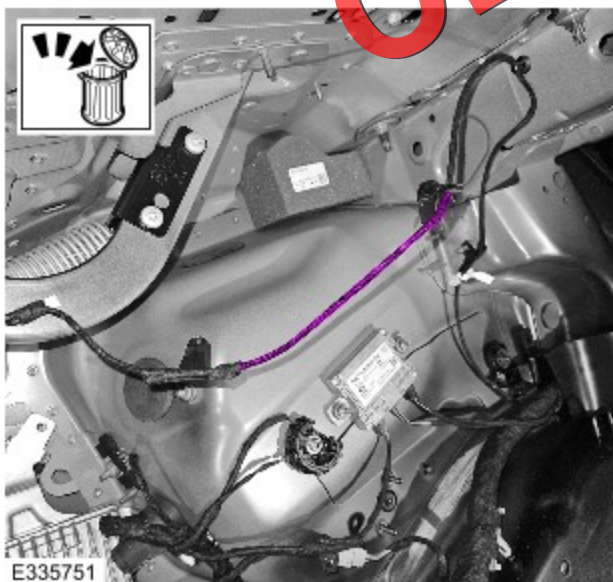
4.

If the Touchscreen displayed a blue screen during step 1, the rear view camera wiring harness, located on the left tailgate hinge, may have become damaged.

- Remove and discard the adhesive tape from the harness and locate the damaged wires.
- Repair any wires that have become damaged (see TOPIx Workshop Manual section 418-02: Wiring Harnesses - Description and Operation - Wiring Harness - Wiring Harness Repair).

- If the wiring harness has become damaged the repair must be claimed as part of the 'Related Damage Process'.
- If no damage to the wiring harness can be found, continue to diagnose possible rear view camera related concerns as part of a separate repair before continuing with this Service Instruction.

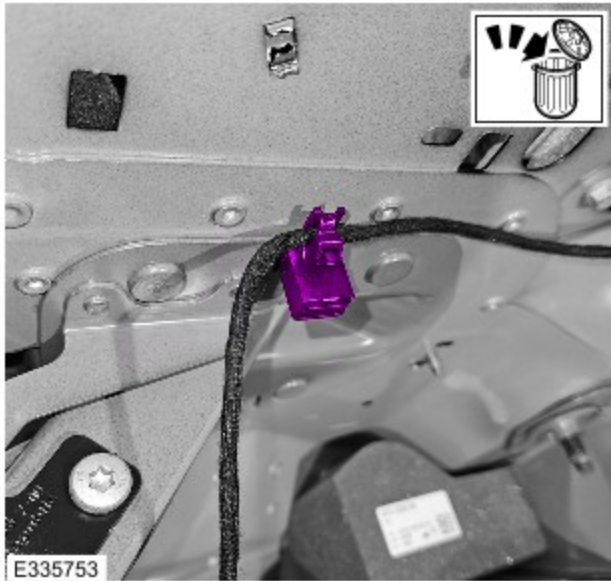
6. Renew the wiring harness retaining clip.

- Remove and discard the clip from the wiring harness.
- Using a suitable measuring ruler, measure **215 mm** from the center of the new clip installed during step 5.
- Install the new clip onto the wiring harness.
