Safety Recall

N232413120 Driver Front Airbag Inflator May Rupture

Release Date: September 2023

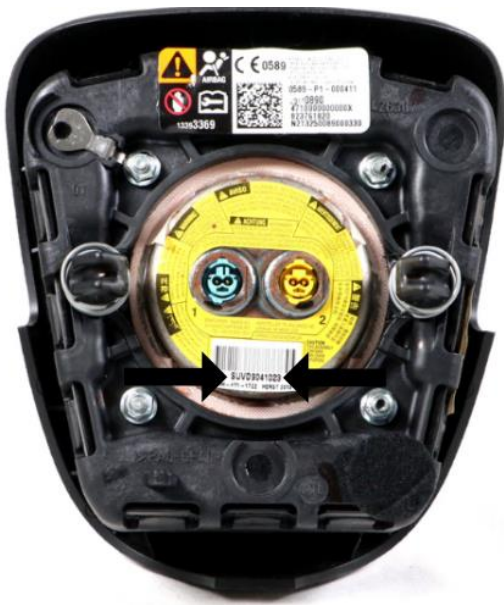
6431834

Important: (TECHNICIAN and WARRANTY ADMINISTRATOR) SERIAL NUMBER RECORDING REQUIREMENT. The replacement steering wheel airbag serial number must be captured by the technician and recorded on the job card. The Warranty Administrator **MUST** enter the serial numbers in GWM (Global Warranty Management) or in DMS (Dealer Management System). Enter the serial number of the **replacement airbag** in the 'Labor Operation Dependency Code' field per the screen shown.

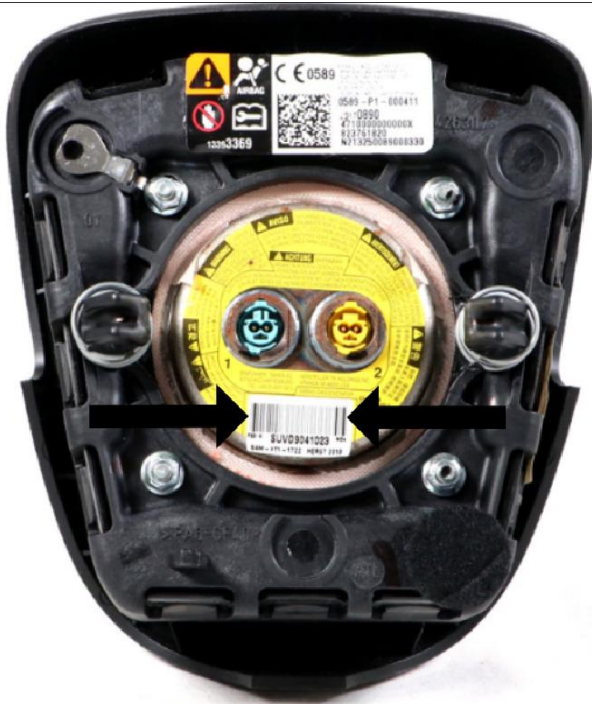
6431905

If the App is already loaded to your phone, simply:

1. Scan the VIN (door pillar QR code or windshield VIN barcode) and
2. Scan the new part barcode and
3. Check the information and if correct then, Submit.
