Safety Recall

N232413120 Driver Front Airbag Inflator May Rupture

Release Date: November 2023

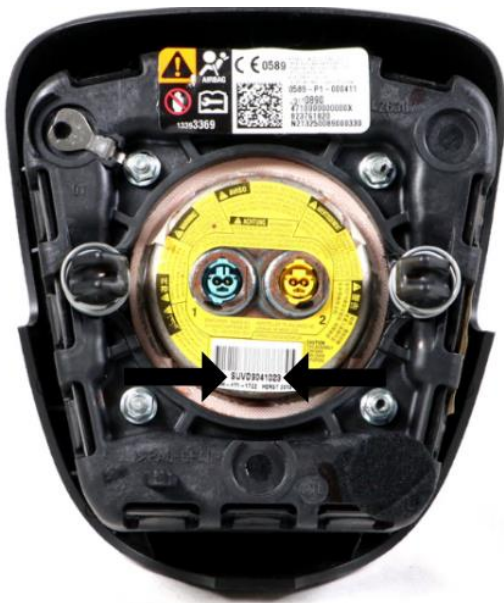
6431834

Important: (TECHNICIAN and WARRANTY ADMINISTRATOR) SERIAL NUMBER RECORDING REQUIREMENT. The replacement steering wheel airbag serial number must be captured by the technician and recorded on the job card. The Warranty Administrator **MUST** enter the serial numbers in GWM (Global Warranty Management) or in DMS (Dealer Management System). Enter the serial number of the **replacement airbag** in the 'Labor Operation Dependency Code' field per the screen shown.

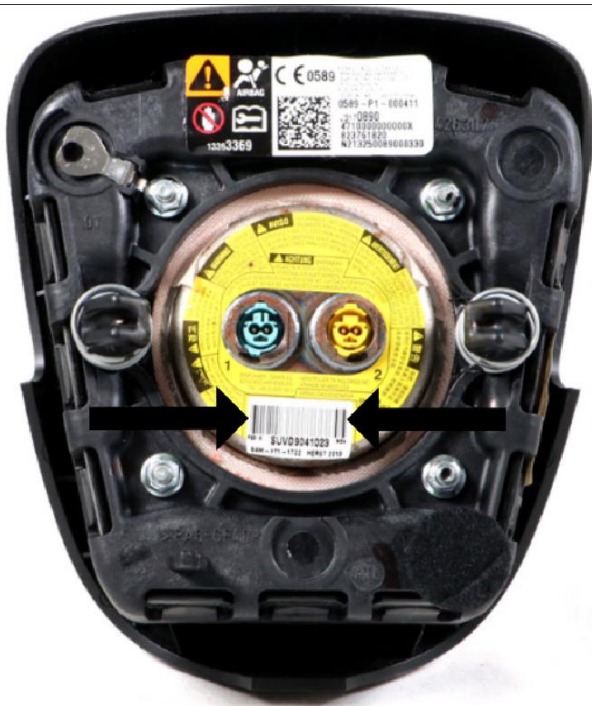
6431905

If the App is already loaded to your phone, simply:

1. Scan the VIN (door pillar QR code or windshield VIN barcode) and
2. Scan the new part barcode and
3. Check the information and if correct then, Submit.
