## **SAFETY RECALL**

### **CONVENTIONAL HEADLAMP ANTI- ADJUSTMENT CAP**

RECALL NO: M0430  
DATE: 8-3-2023  
REFERENCE: RCB-004-23

Certain 2022 and 2023 model year Hino Conventional trucks equipped with a Cummins B6.7 engine that were assembled at the Mineral Wells, West Virginia, USA assembly plant.

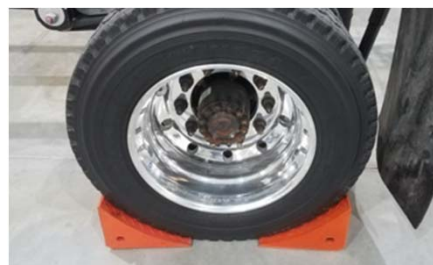
2. Apply the parking brake. Chock all of the wheels.

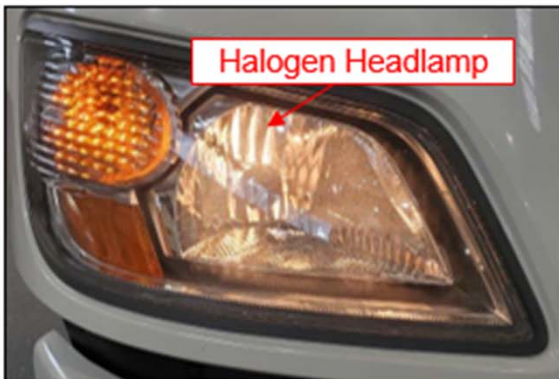
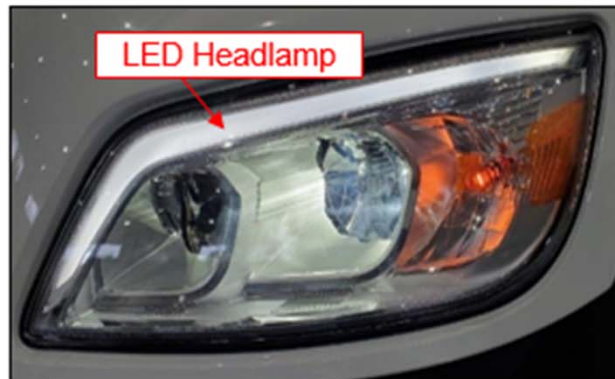
**1.** Inspect the vehicle's headlamps and determine if the vehicle is equipped with LED headlamps or halogen headlamps.

LED Headlamps - Proceed to **Step 2**.

Halogen Headlamps - Proceed to **Step 5**.

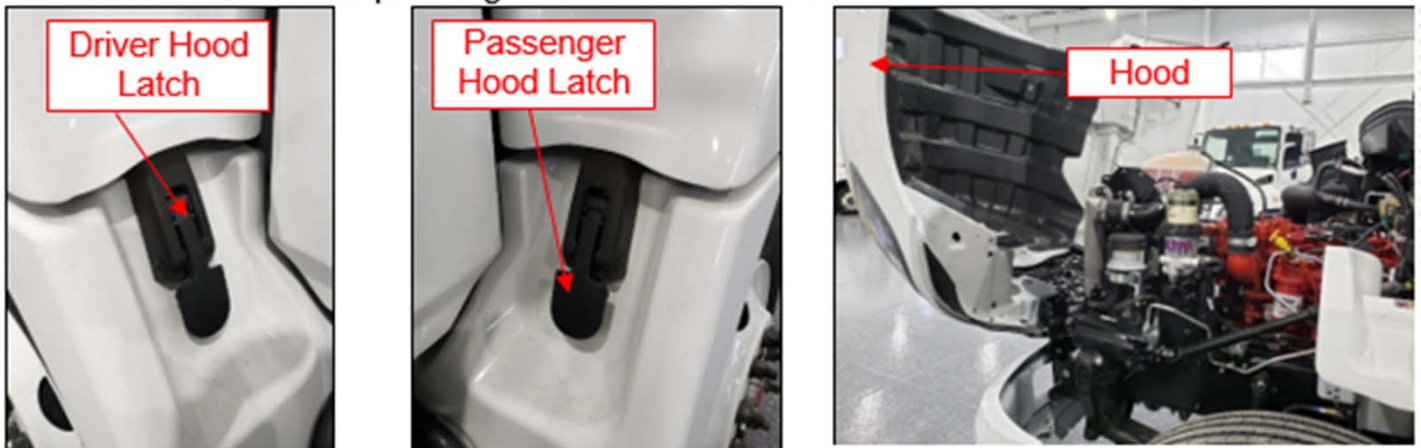
2. Release the driver and passenger side hood latches and raise the hood.

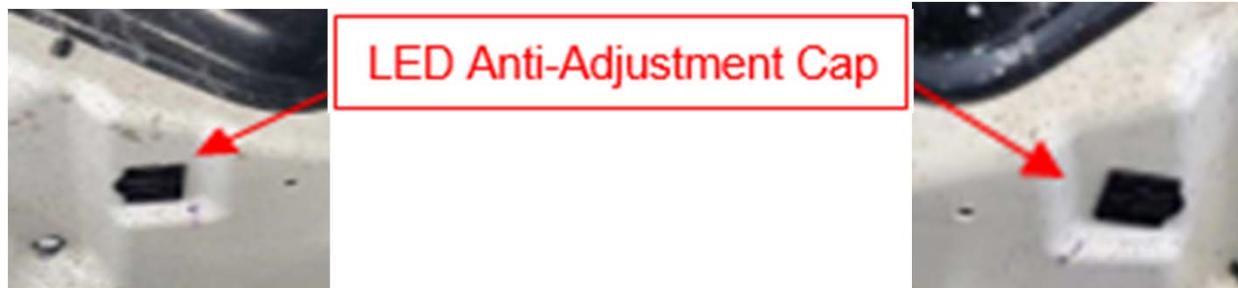
4. Locate and inspect to see if anti-adjustment caps are installed on the driver side and passenger side of the vehicle. Are both anti-adjustment caps installed?

**Yes** – No additional repairs are necessary, proceed to the FINAL INSPECTION section.

**No** – Close the hood, close the hood latches and proceed to the **HEADLAMP ALIGNMENT CHECK PROCEDURE, Step 1**

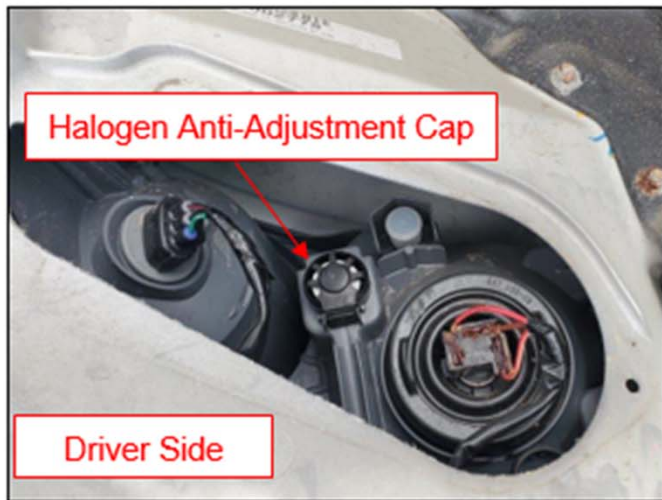
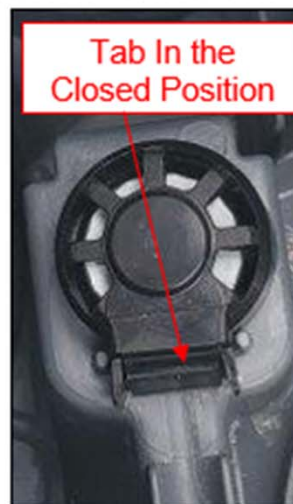
7. Inspect the tab on the halogen anti-adjustment cap. Is the tab in the closed position?

**Yes** – Proceed to **Step 8**.

**No** – Close the hood, latch the hood latches and proceed to the **HEADLAMP ALIGNMENT CHECK PROCEDURE, Step 1**

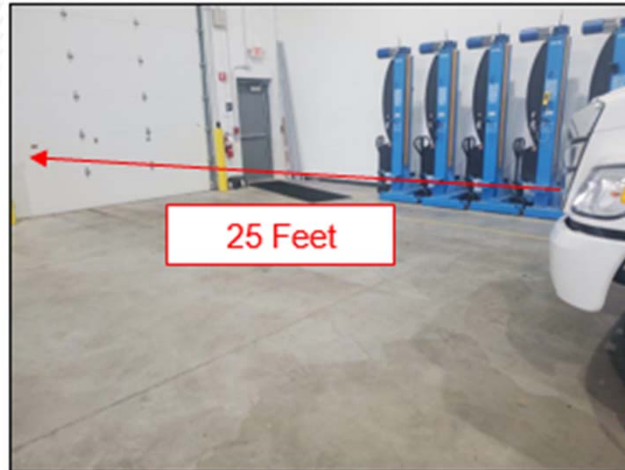
1. Position and park vehicle on a level surface 25 feet from a wall. Ensure the vehicle is straight and both headlamps are an equal distance from the wall. Proceed to **Step 2**.

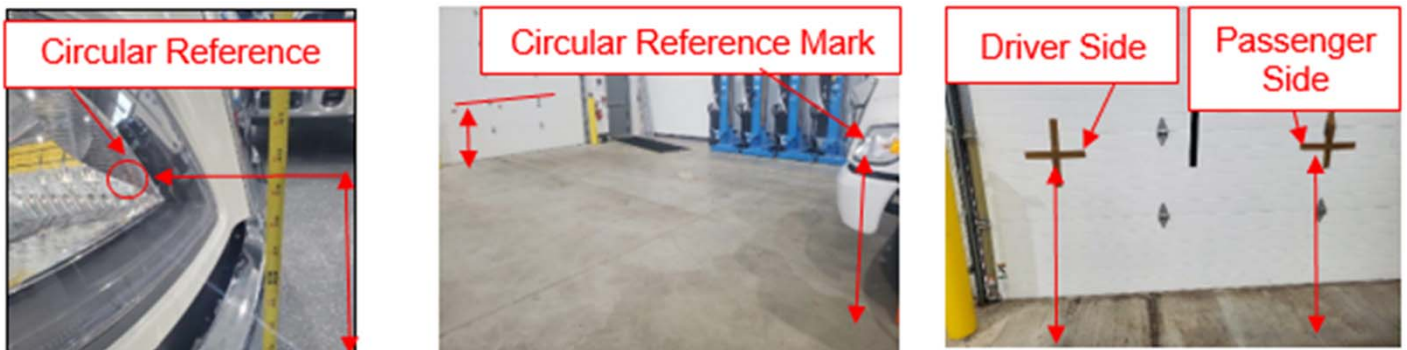
5. Using the vehicle's headlamp assemblies, measure and record the distance from the driver side circular reference mark to the ground. Then measure and record the distance from the passenger side circular reference mark to the ground. Now transfer these measurements to their corresponding positions on the wall and mark their positions.

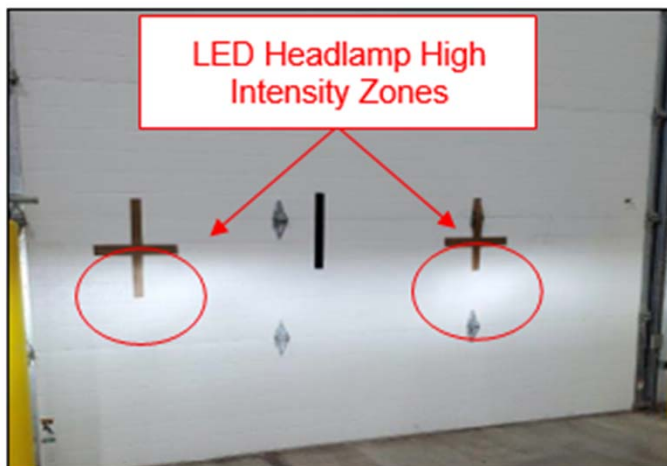
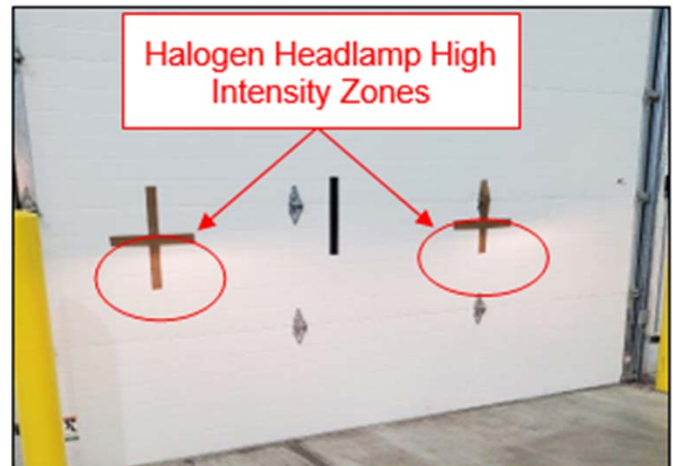
6. Turn the low beam headlamps on and observe the light pattern. The high intensity zones of the light pattern should be located below the horizontal marks and centered with the vertical marks as shown.

Are the high intensity zones of the light pattern located below horizontal marks and centered with the vertical marks on the wall?

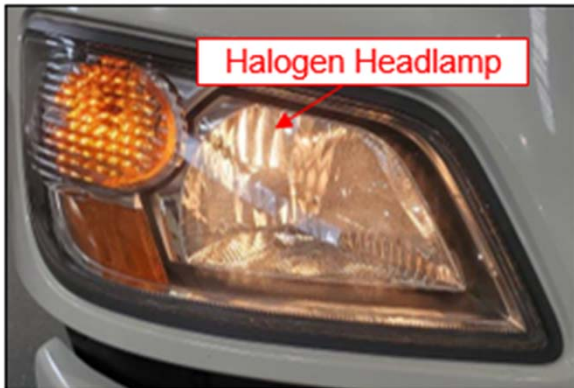
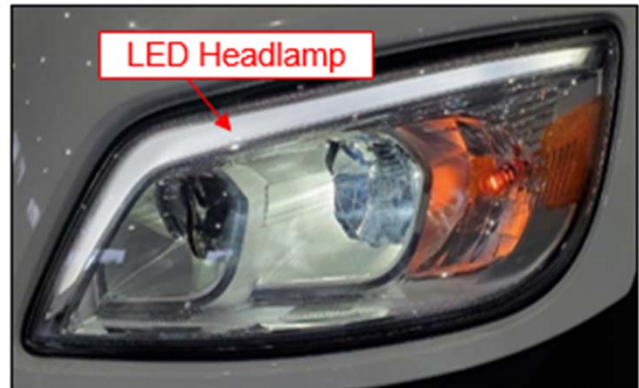
2. . Adjustment to the horizontal position of the halogen headlamp assembly requires the headlamp back cover to be removed and the anti-adjustment locking tab placed into the open position. Remove the fasteners and covers if installed and retain them for later reassembly. With the anti-adjustment locking tab's now accessible, place them in the open position.

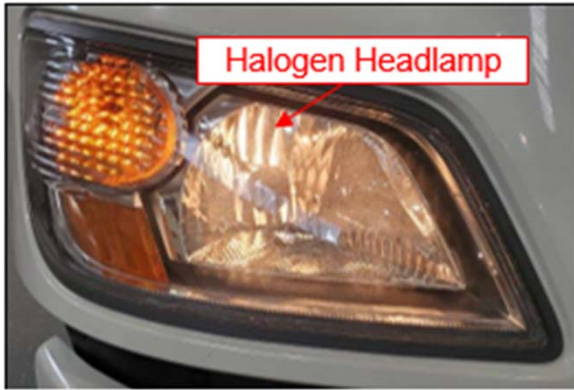
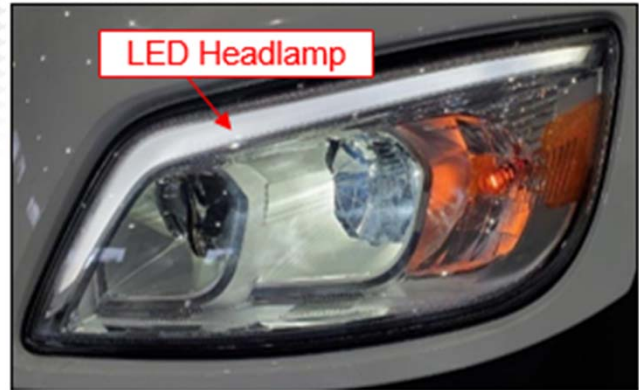
6. Install the anti-adjustment caps on the driver side and passenger side positions. Close the hood and latch both the right and left hood latches in the locked position.
