Technical Service Bulletin

GROUP	NUMBER
RECALL	23-01-077G
DATE	MODEL(S)
SEPTEMBER 2023	GV60 (JW1)

SUBJECT: FRONT PASSENGER SEAT BELT REPLACEMENT (RECALL 015G)

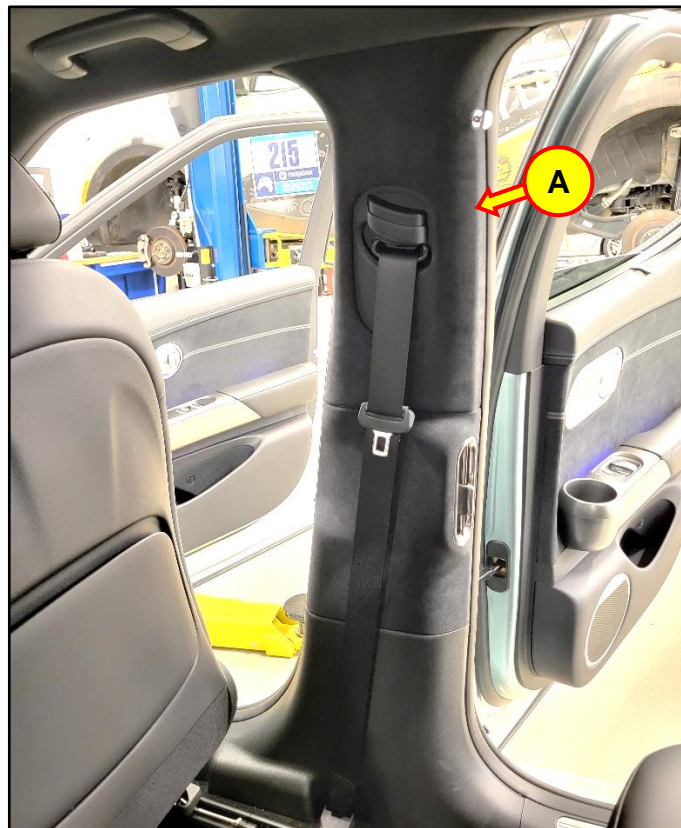
1. Disconnect the negative (-) battery terminal.
2. Remove the center pillar trim (A).

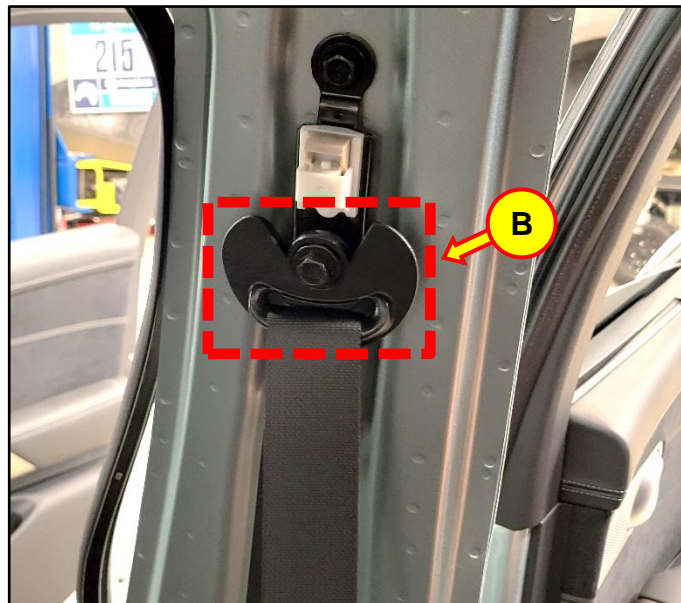
3. Remove the front seat belt upper anchor (B) after removing the bolt.

Tightening Torque:

lb-ft	39
N.m	53

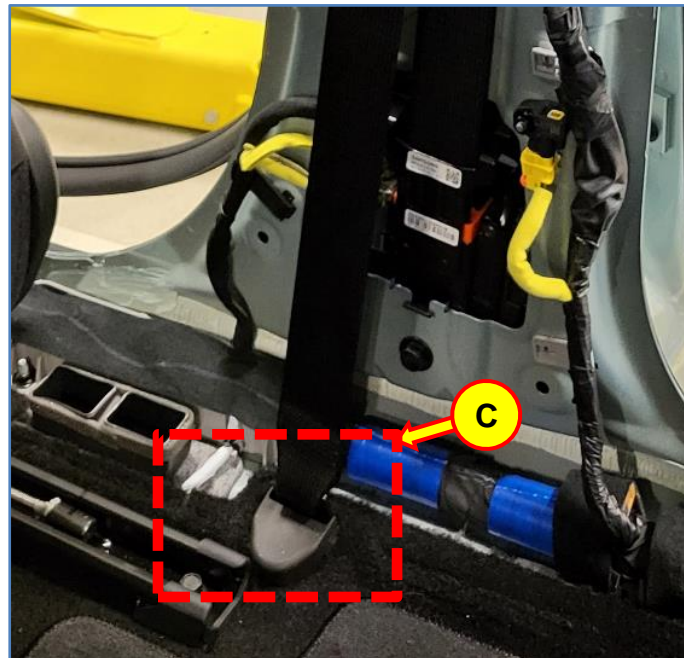
- Remove the front seat belt lower anchor bolt (C).

Tightening Torque:

lb-ft	39
N.m	53

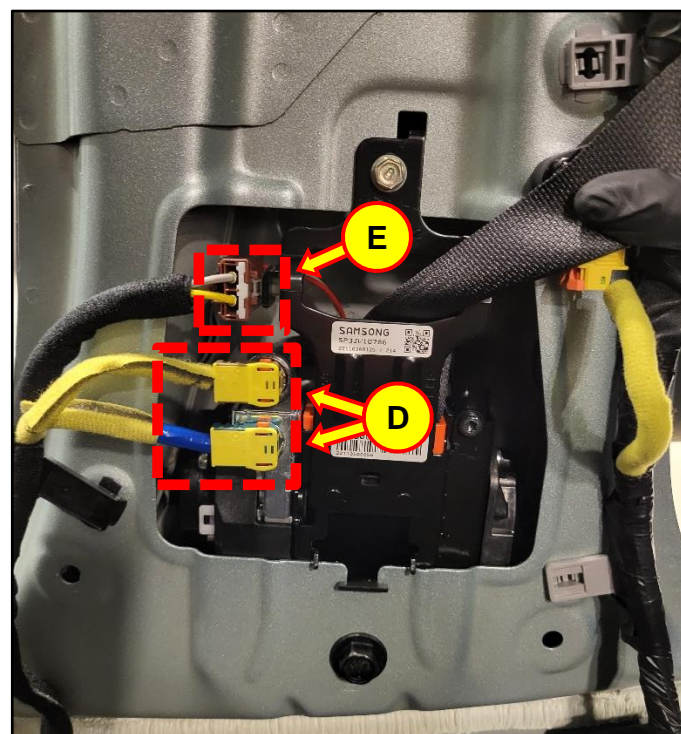
- Disconnect the front seat belt pretensioner connectors (D) and ALR connector (E).

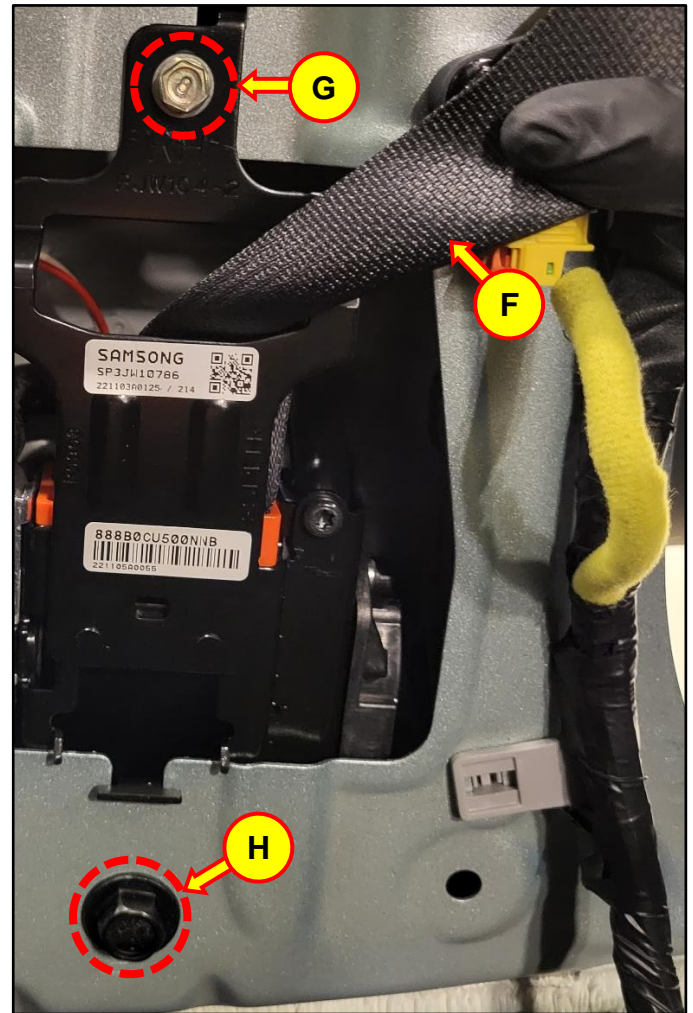
6. Remove the front seat belt pretensioner assembly(F) after removing the bolts (G, H).

Tightening Torque – Bolt F:

lb-ft	7.3
lb-in	87
N.m	9.8

Tightening Torque – Bolt G:

lb-ft	39
N.m	53

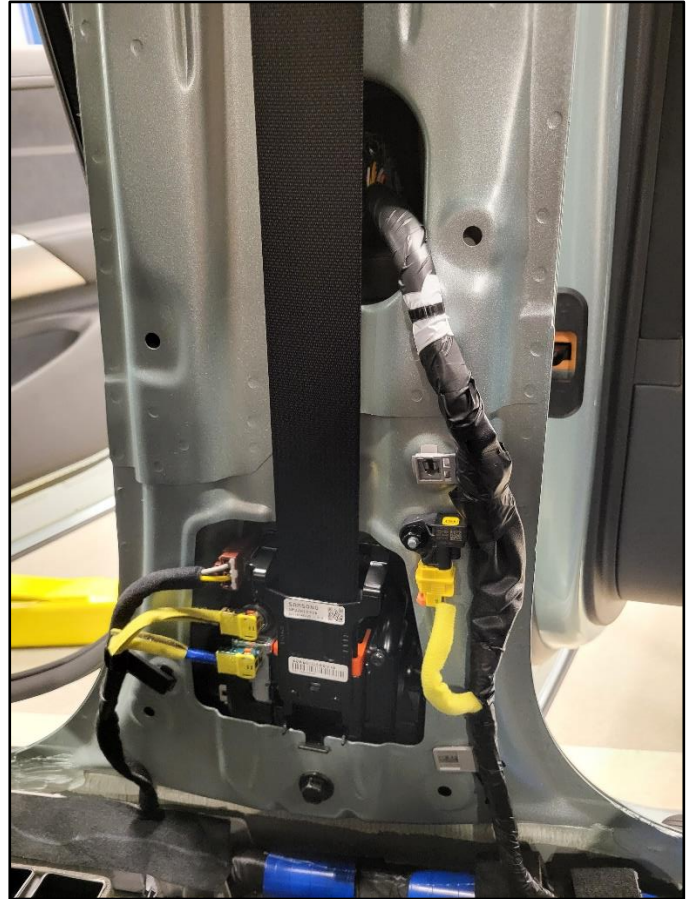
7. Install the supplied new front seat belt assembly.

Be careful not to twist the seat belt during installation.

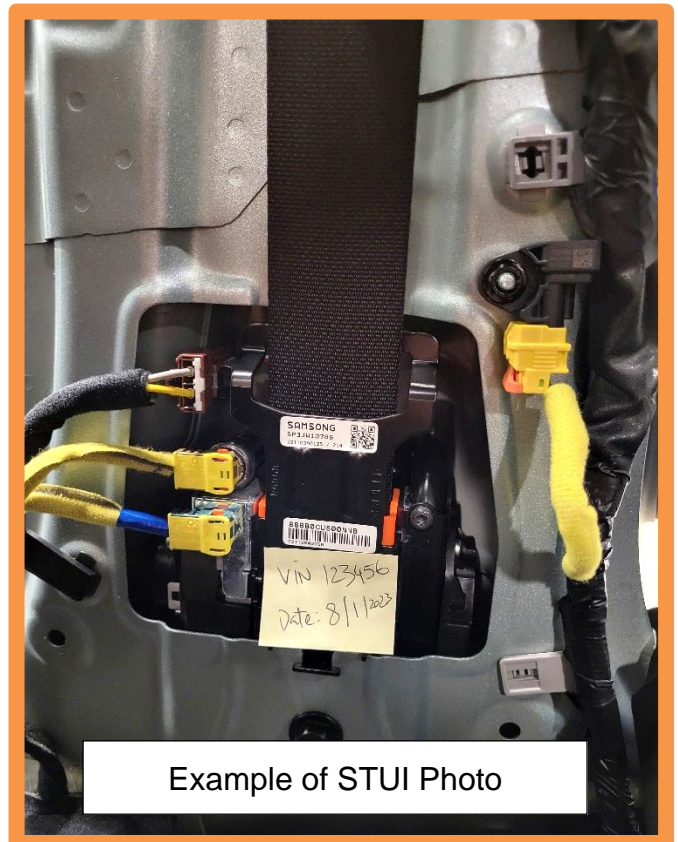
Example of STUI Photo

Using STUI, take a photo of the new seat belt assembly with the last 6 digits of the VIN and the date of repair on a piece of paper.
